SDMC Training Programme

Retrofitting Techniques of Existing Buildings

Reinforced Concrete Structures

CSIR-Central Building Research Institute, Roorkee (India)

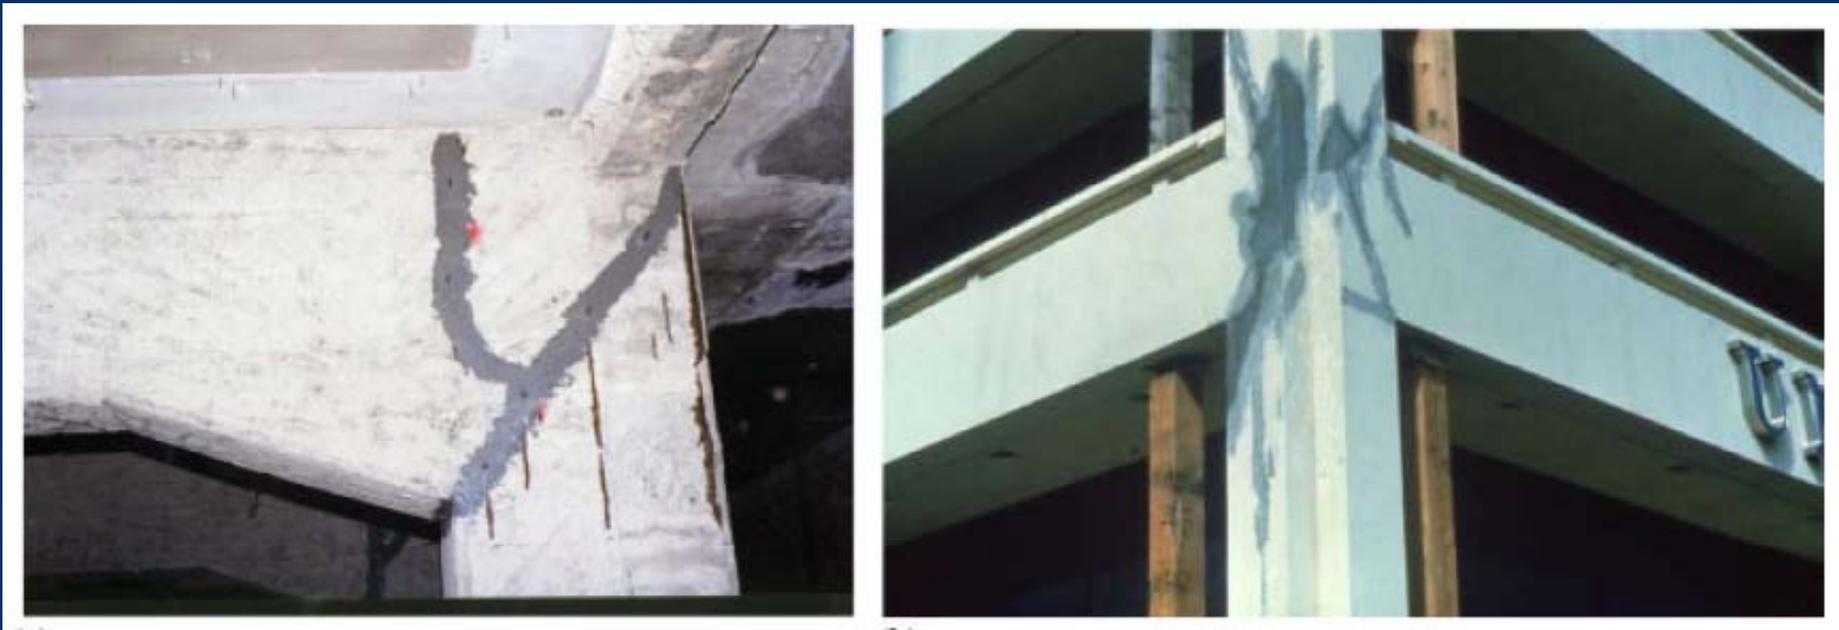
EPOXY RESIN & CEMENT GROUT INJECTION

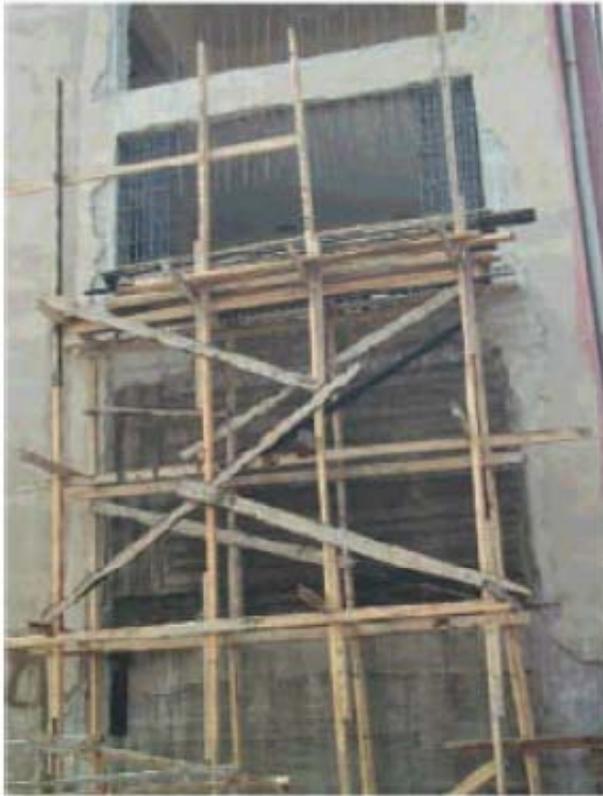
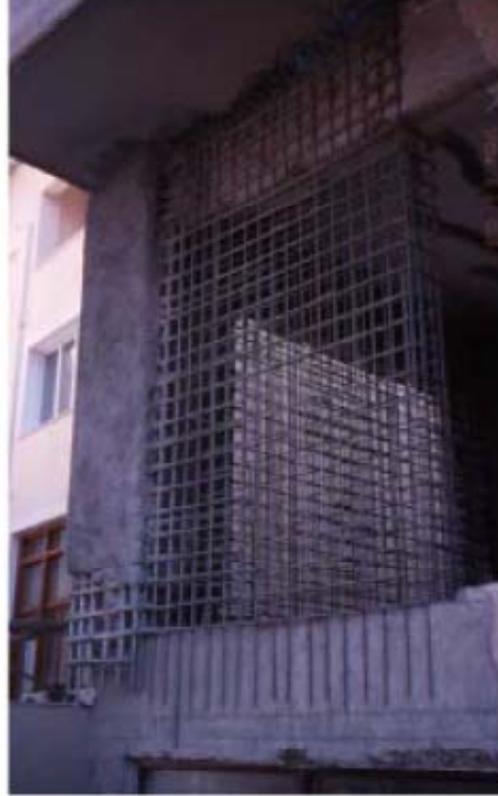
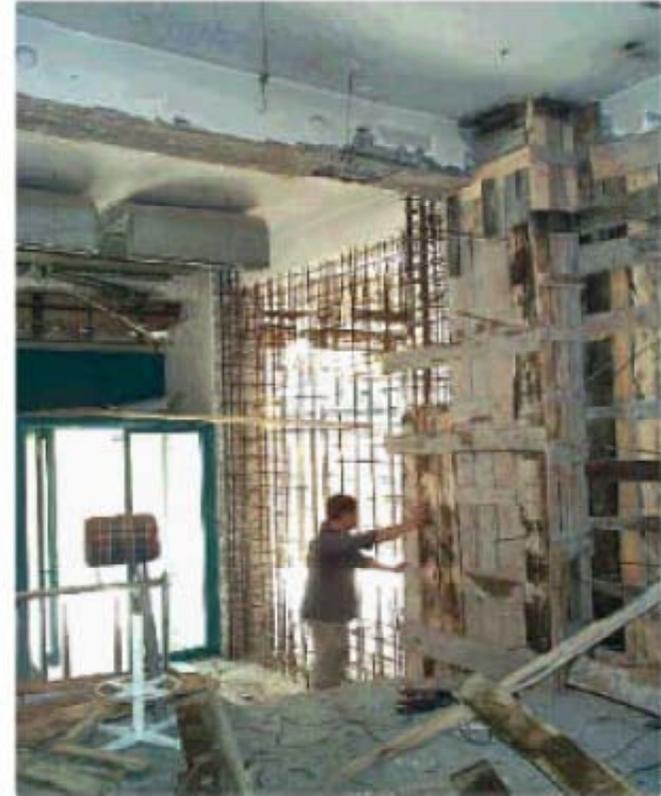
CAST-IN-PLACE INFILL WALLS

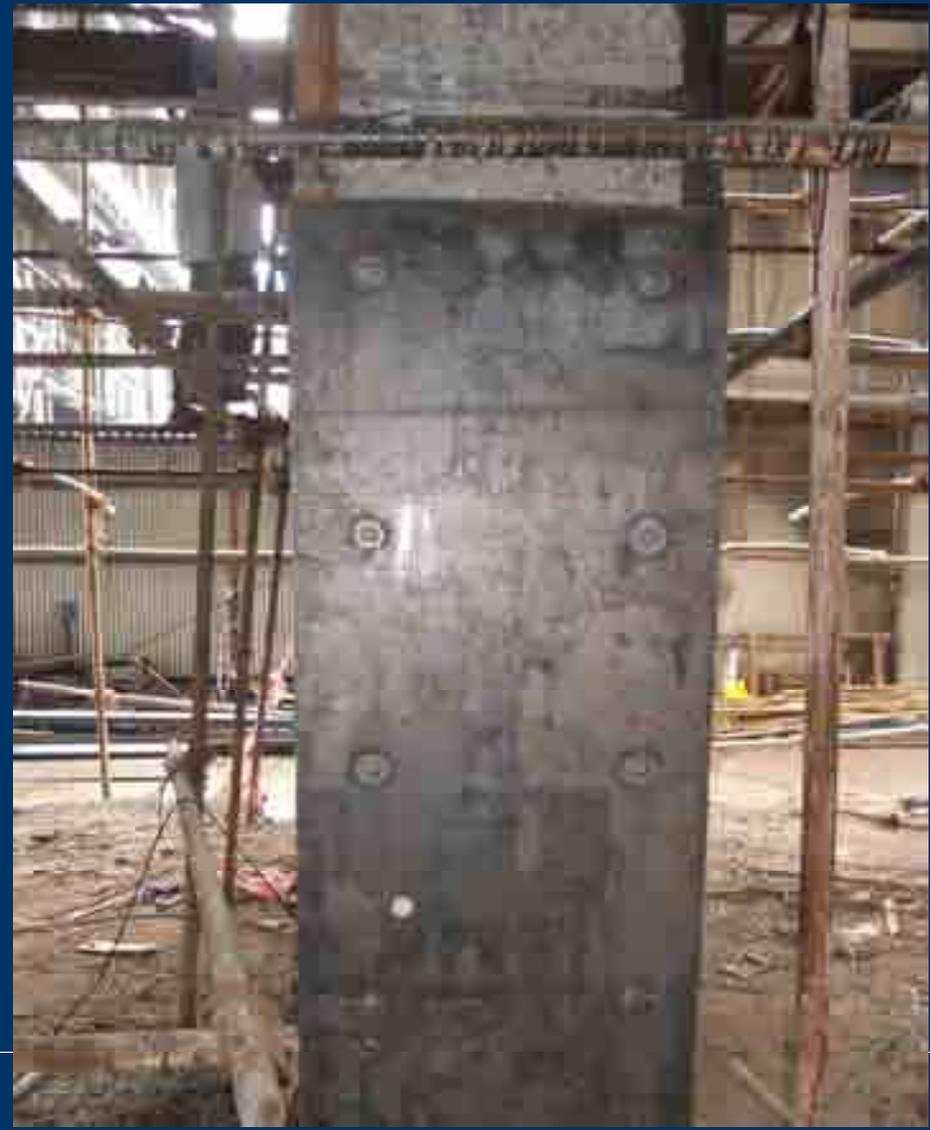
STEEL PLATE / ANGLE JACKETING

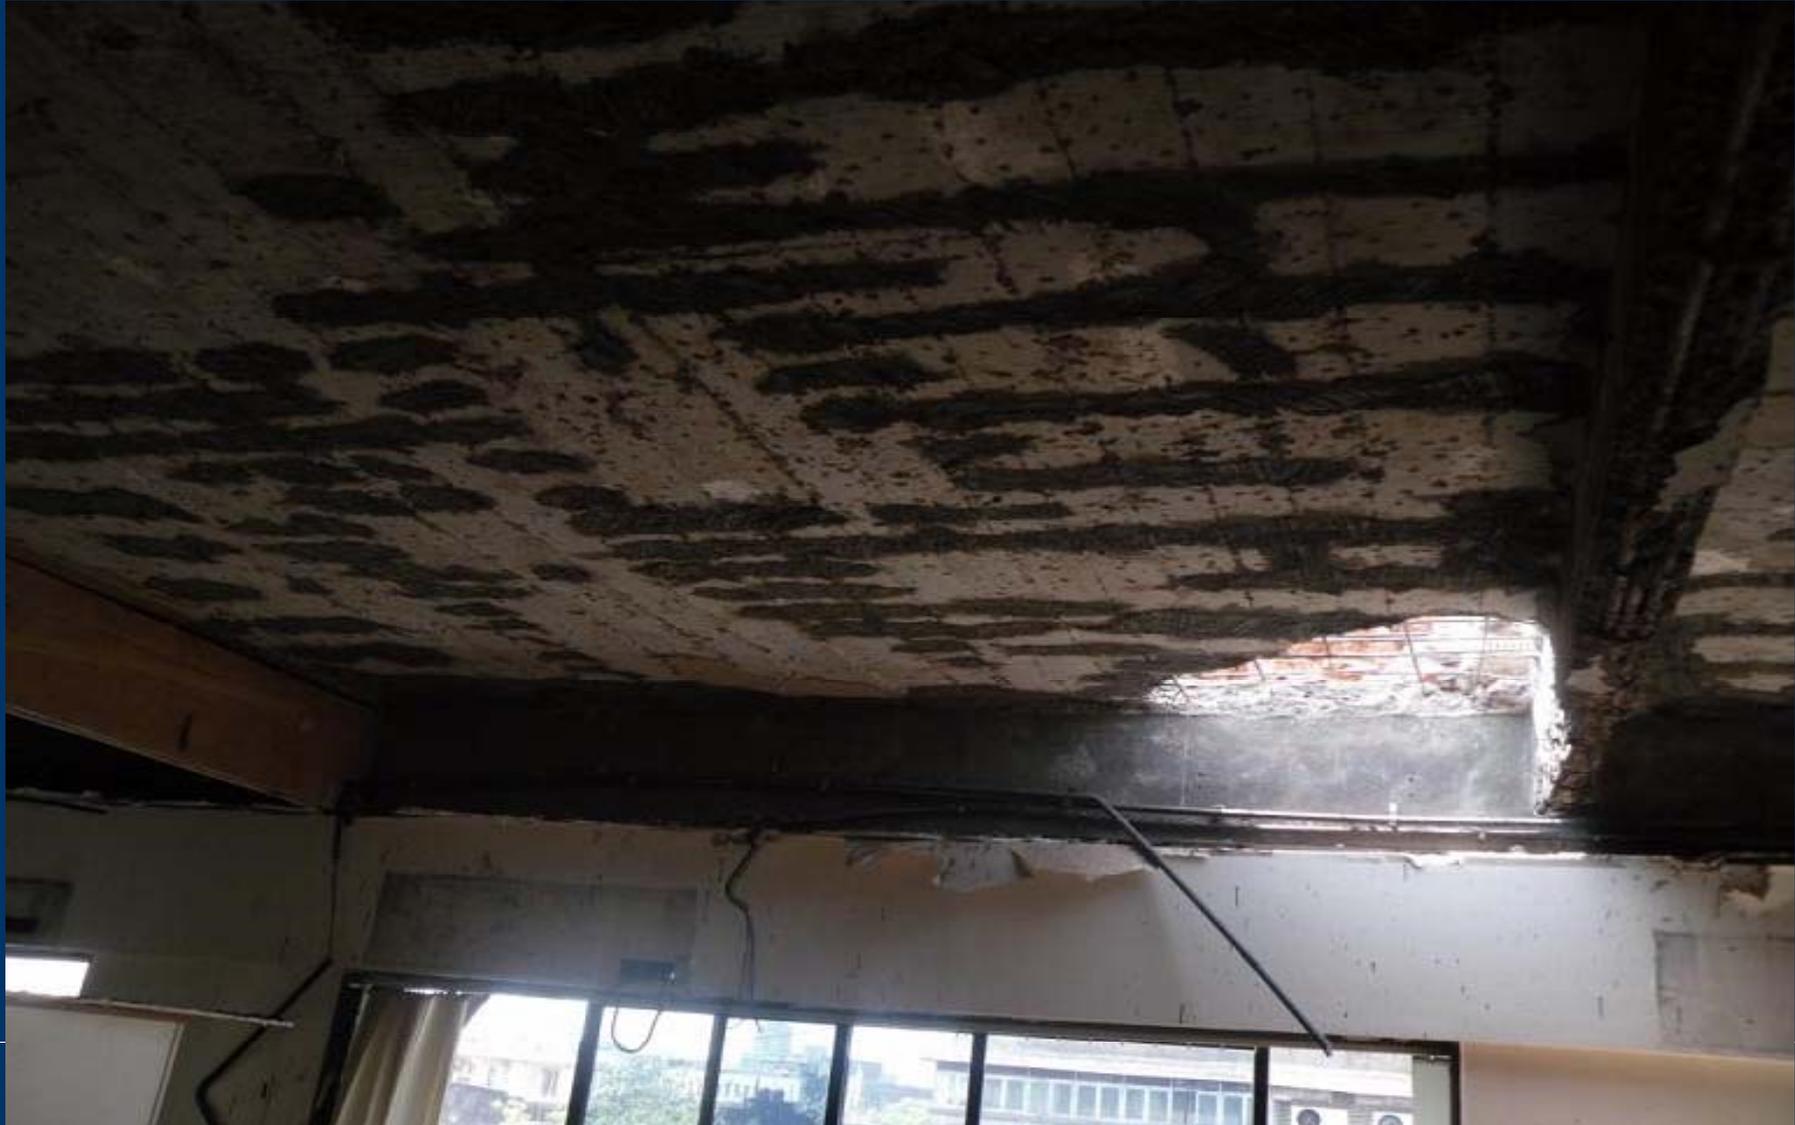
PARTLY COLLAPSED SLAB

- Certain portion of the slab had collapsed due to heavy corrosion.
- Heavy leakages were observed from the terrace slab.
- Beams and columns were also corroded.
- However this was limited to terrace slab only.

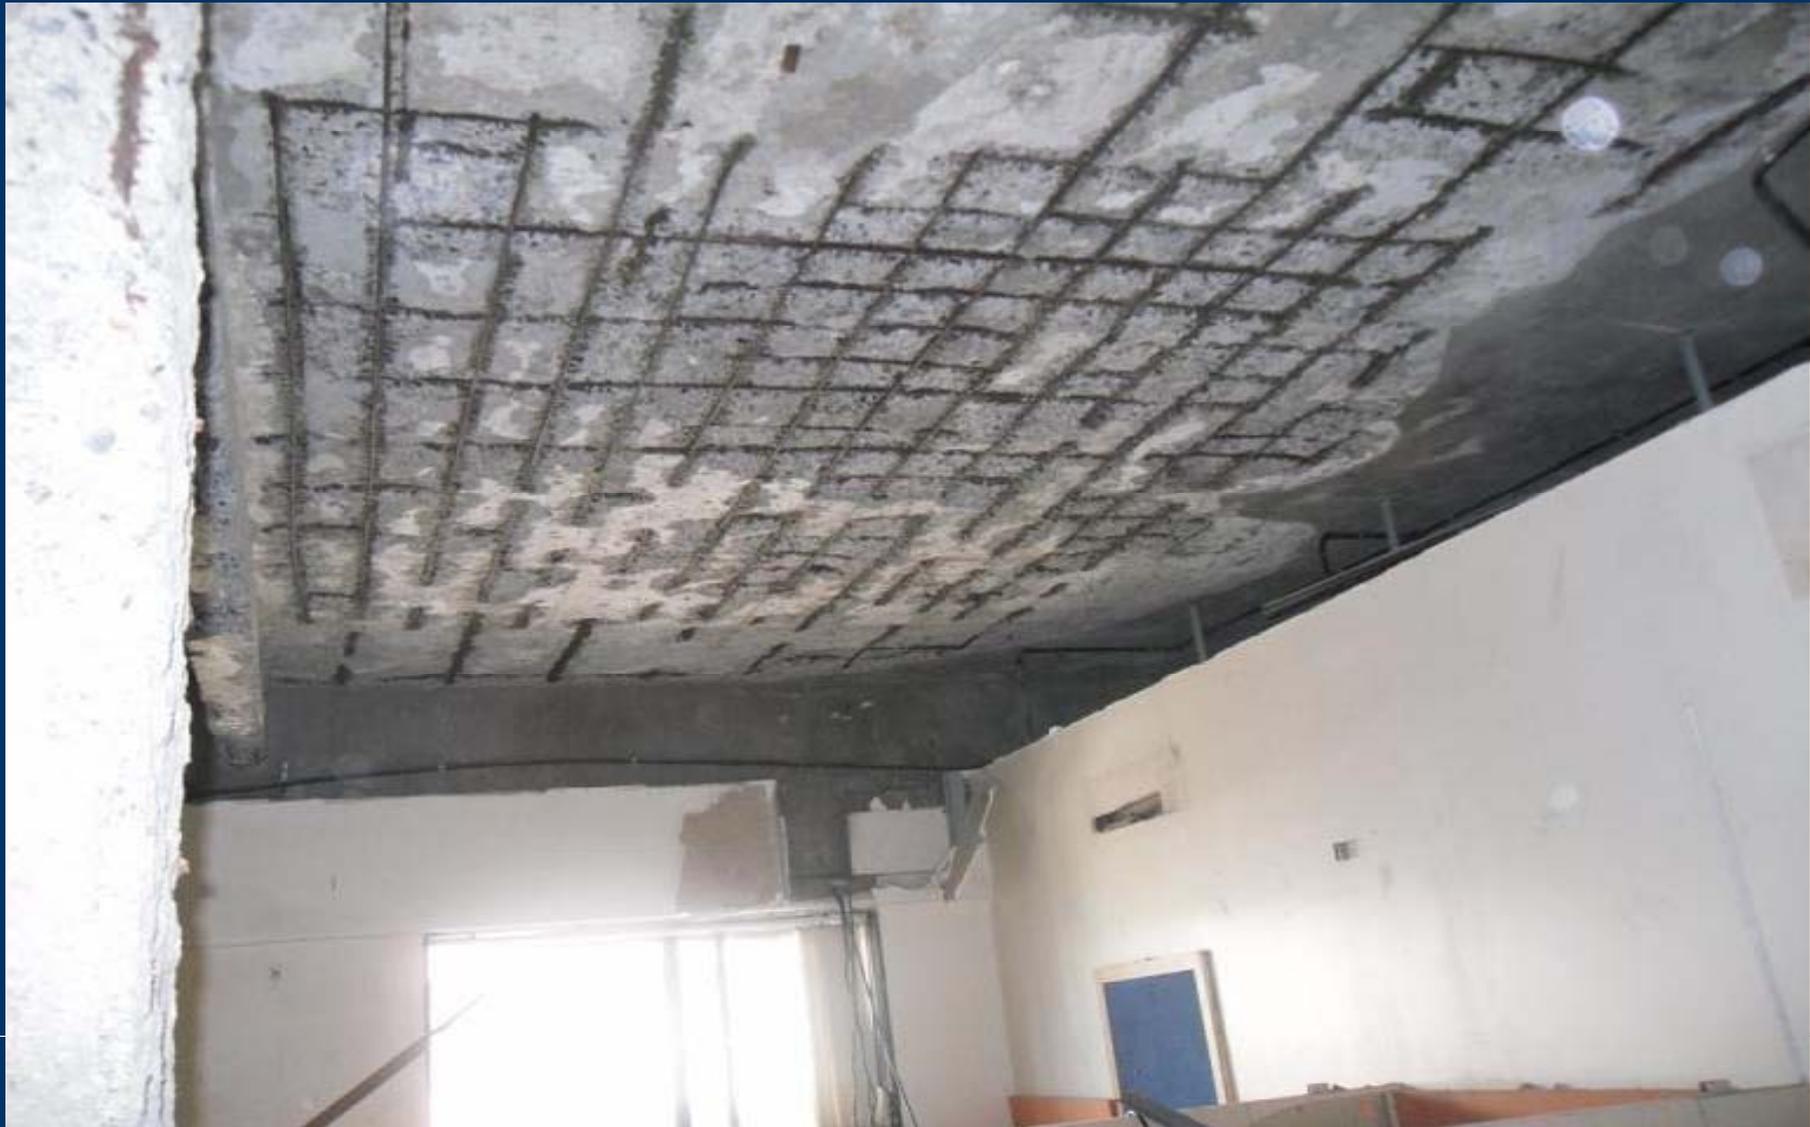
DAMAGED SLAB

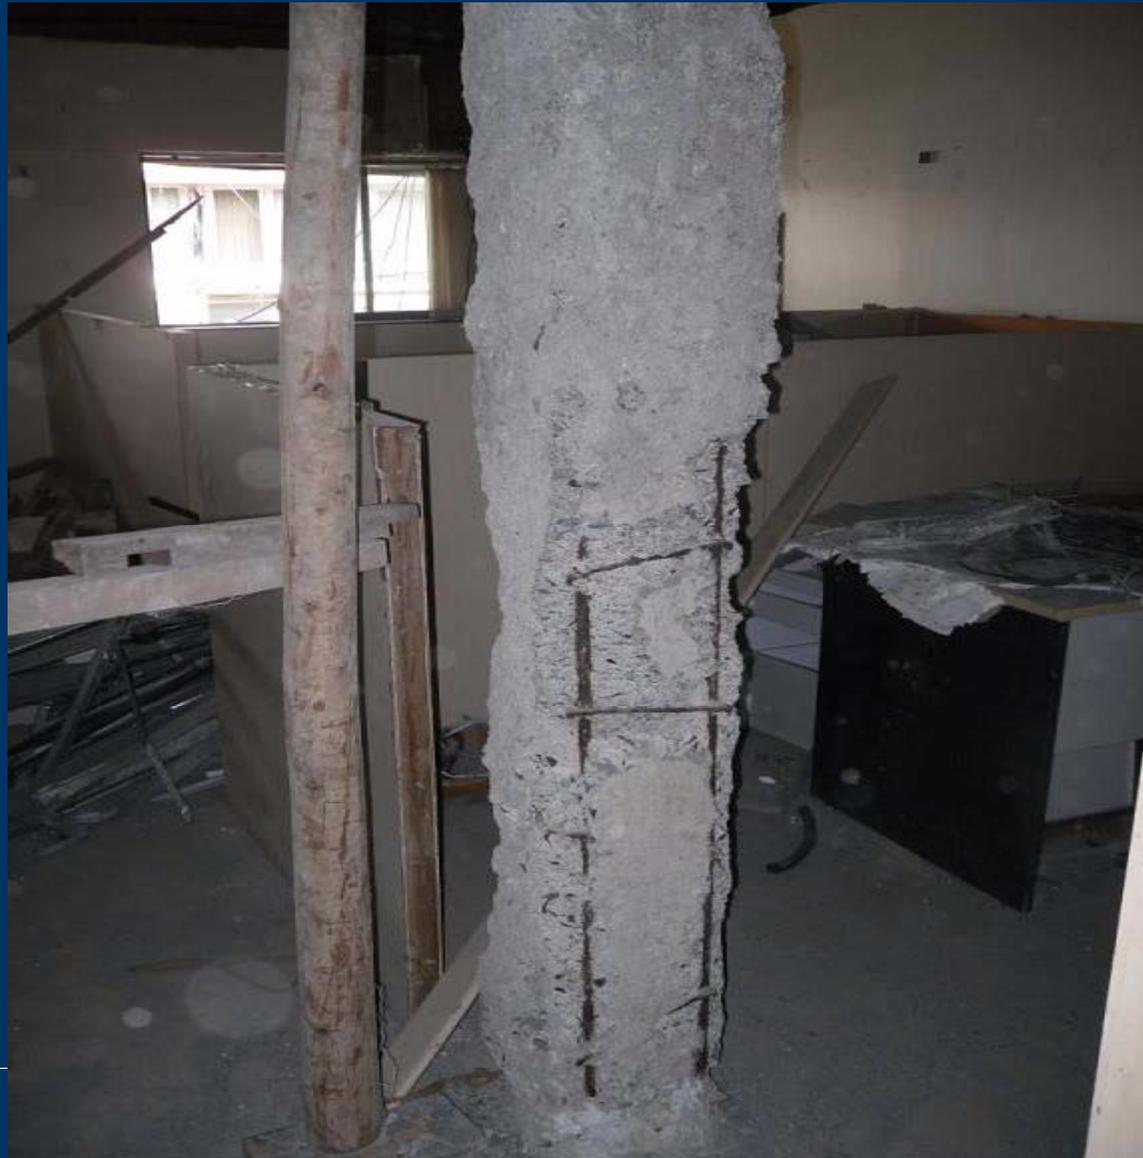
DAMAGED COLUMN

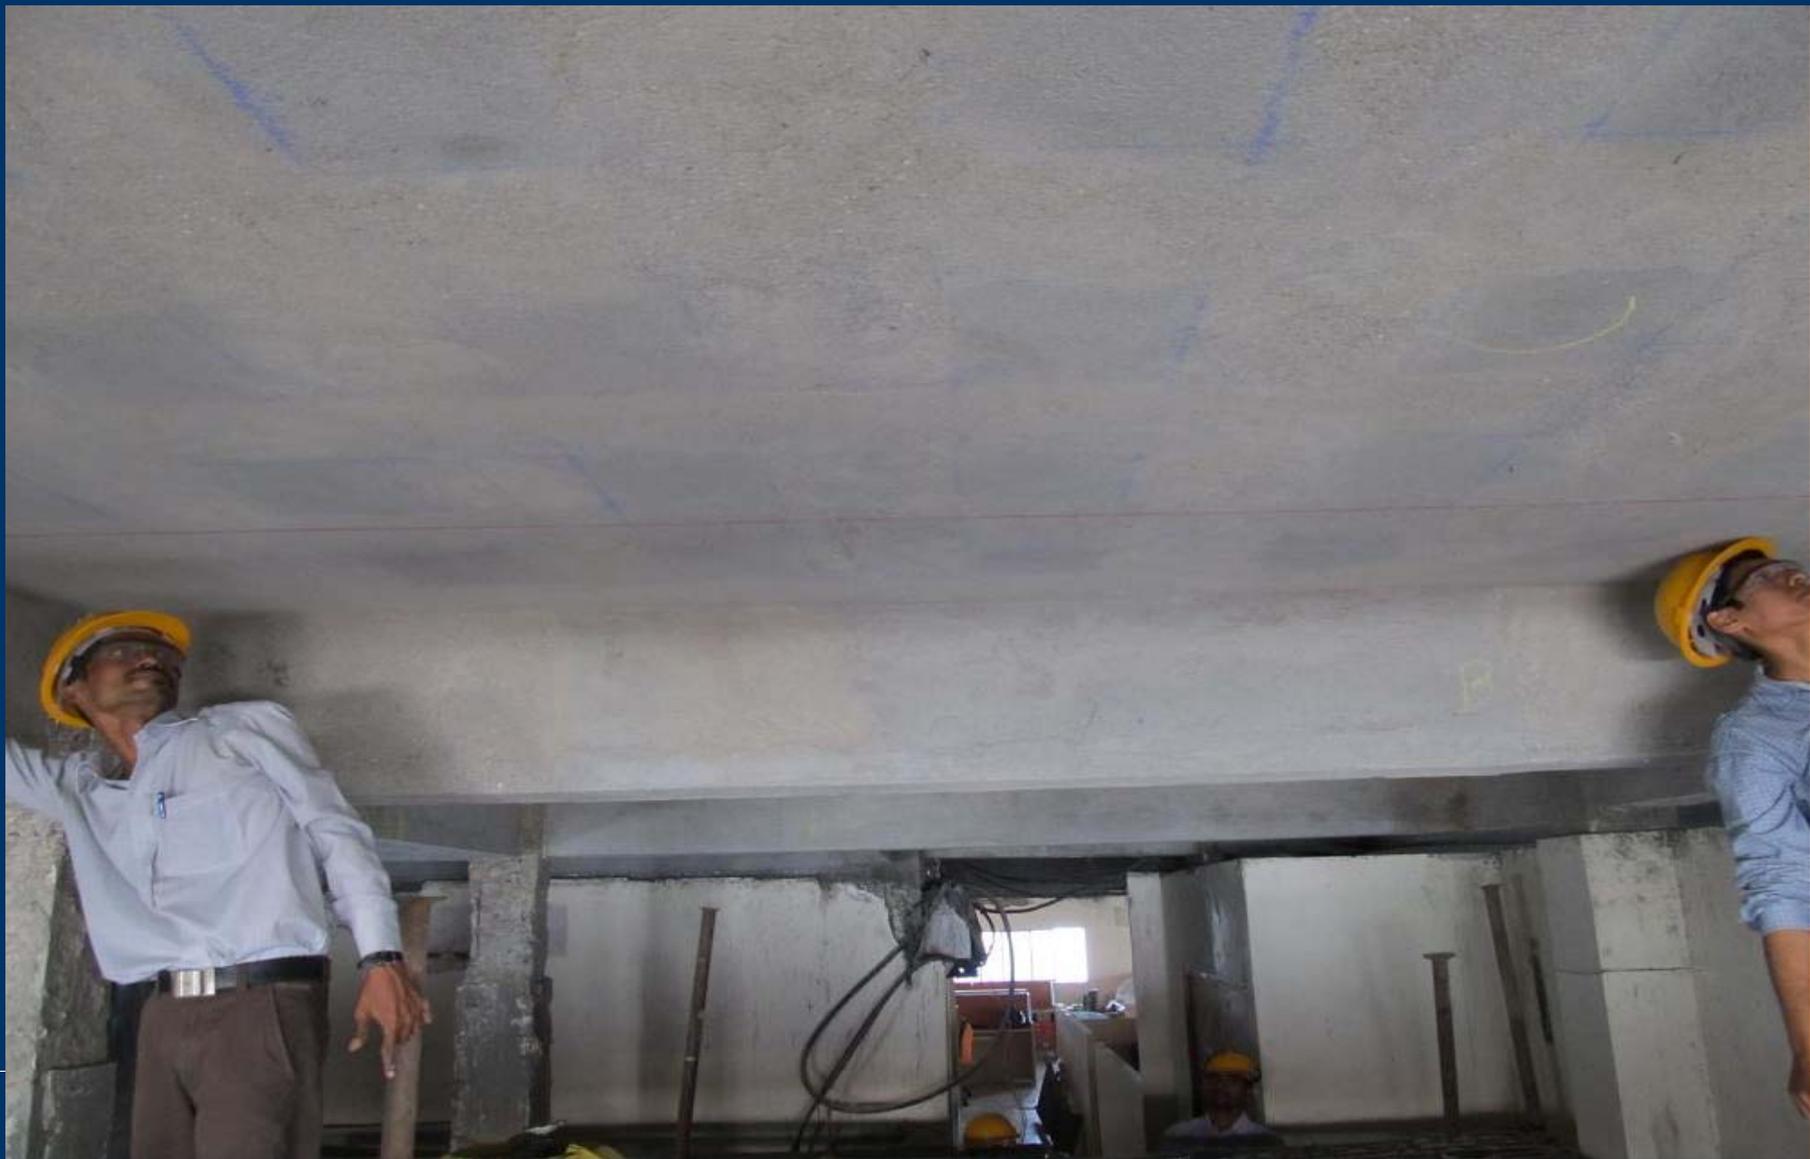
SLAB AFTER REPAIR

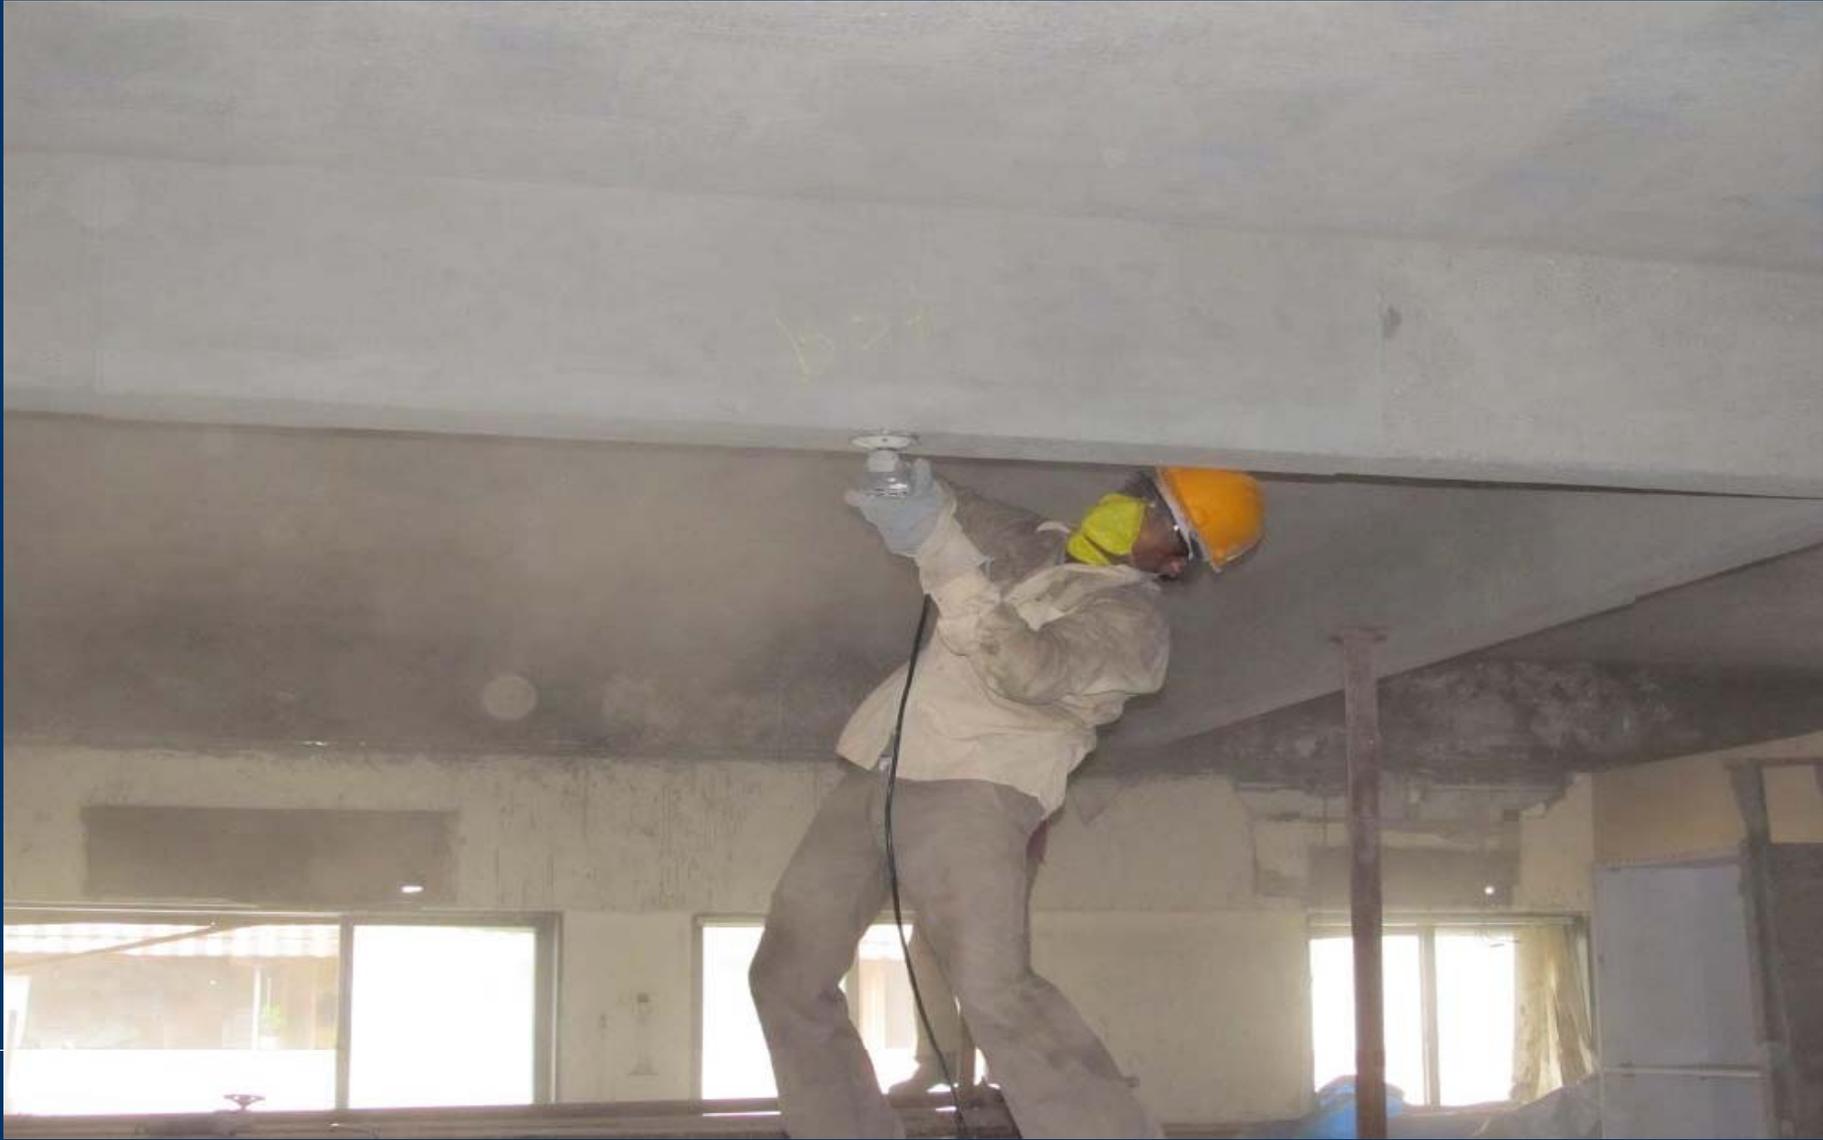
GRIDING FOR FIBRE WRAPPING IN PROGRESS

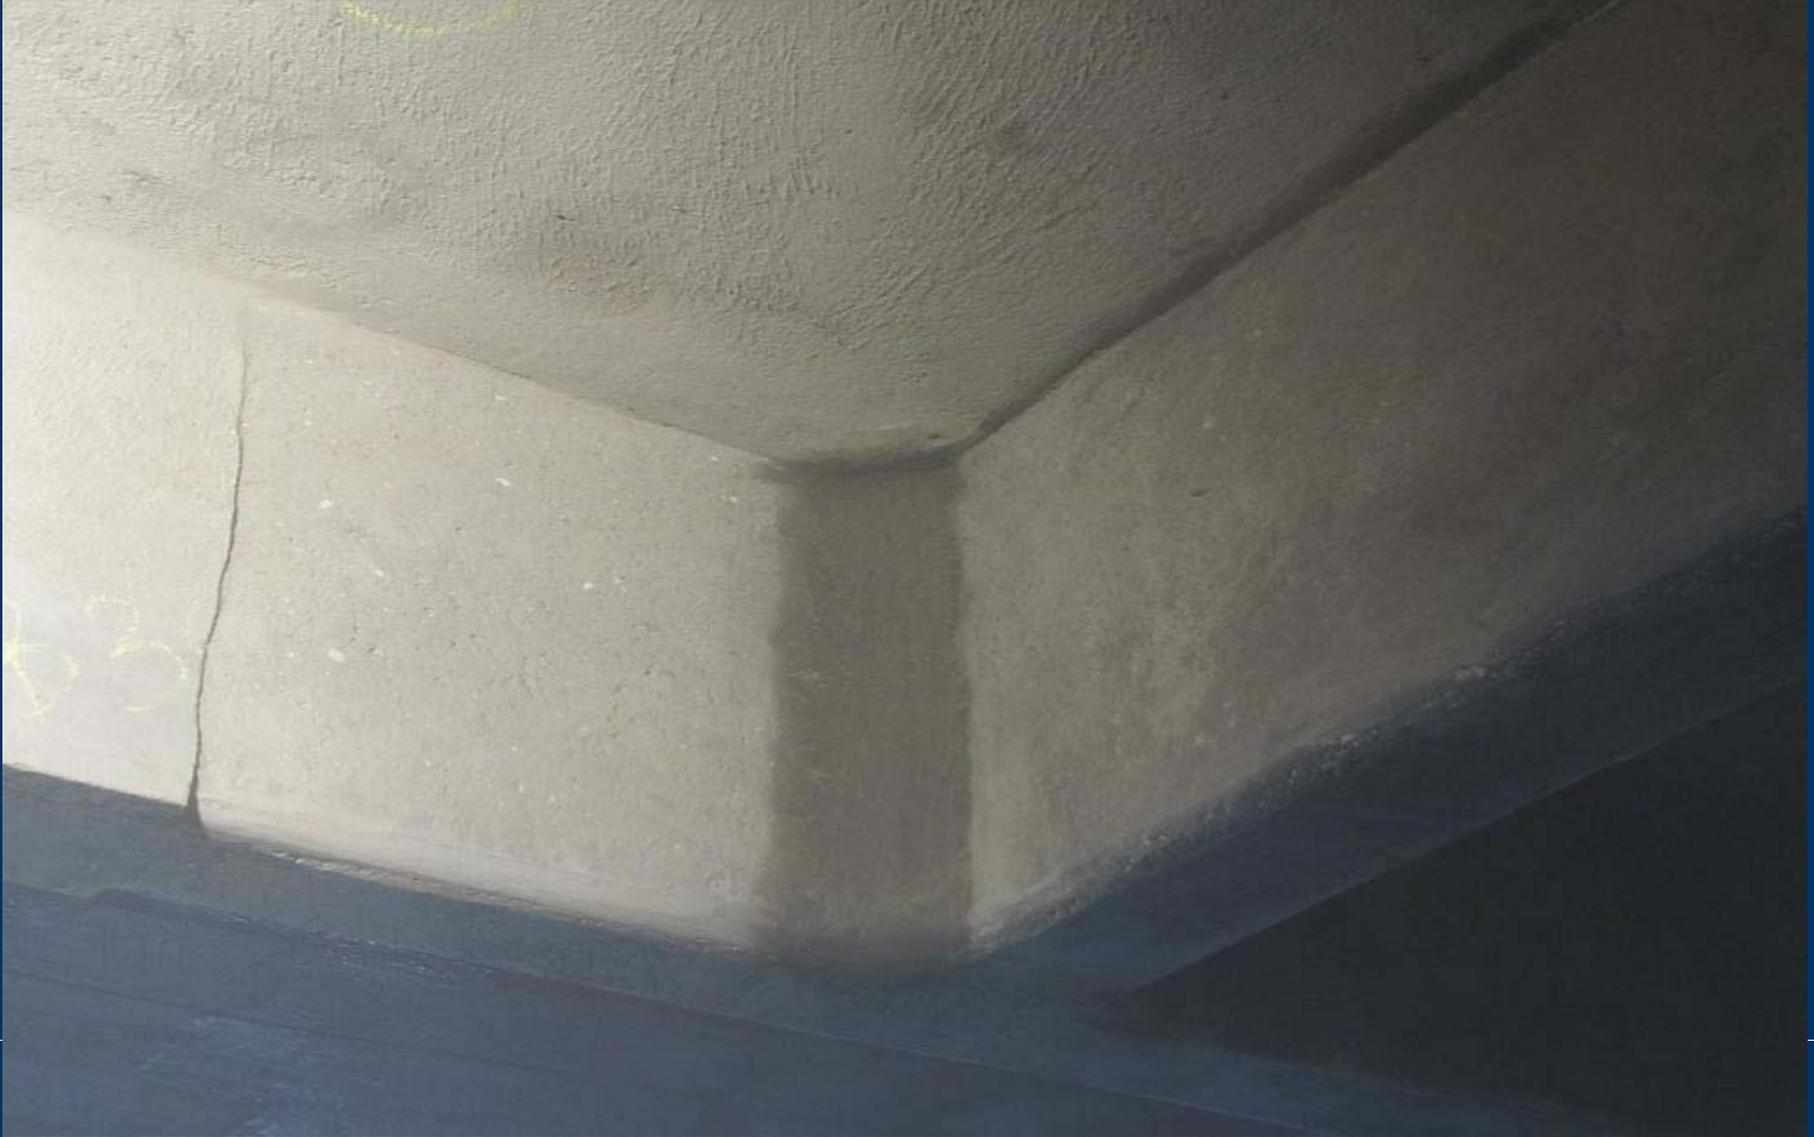
ROUNDING OF BOND-CRITICAL JUNCTIONS

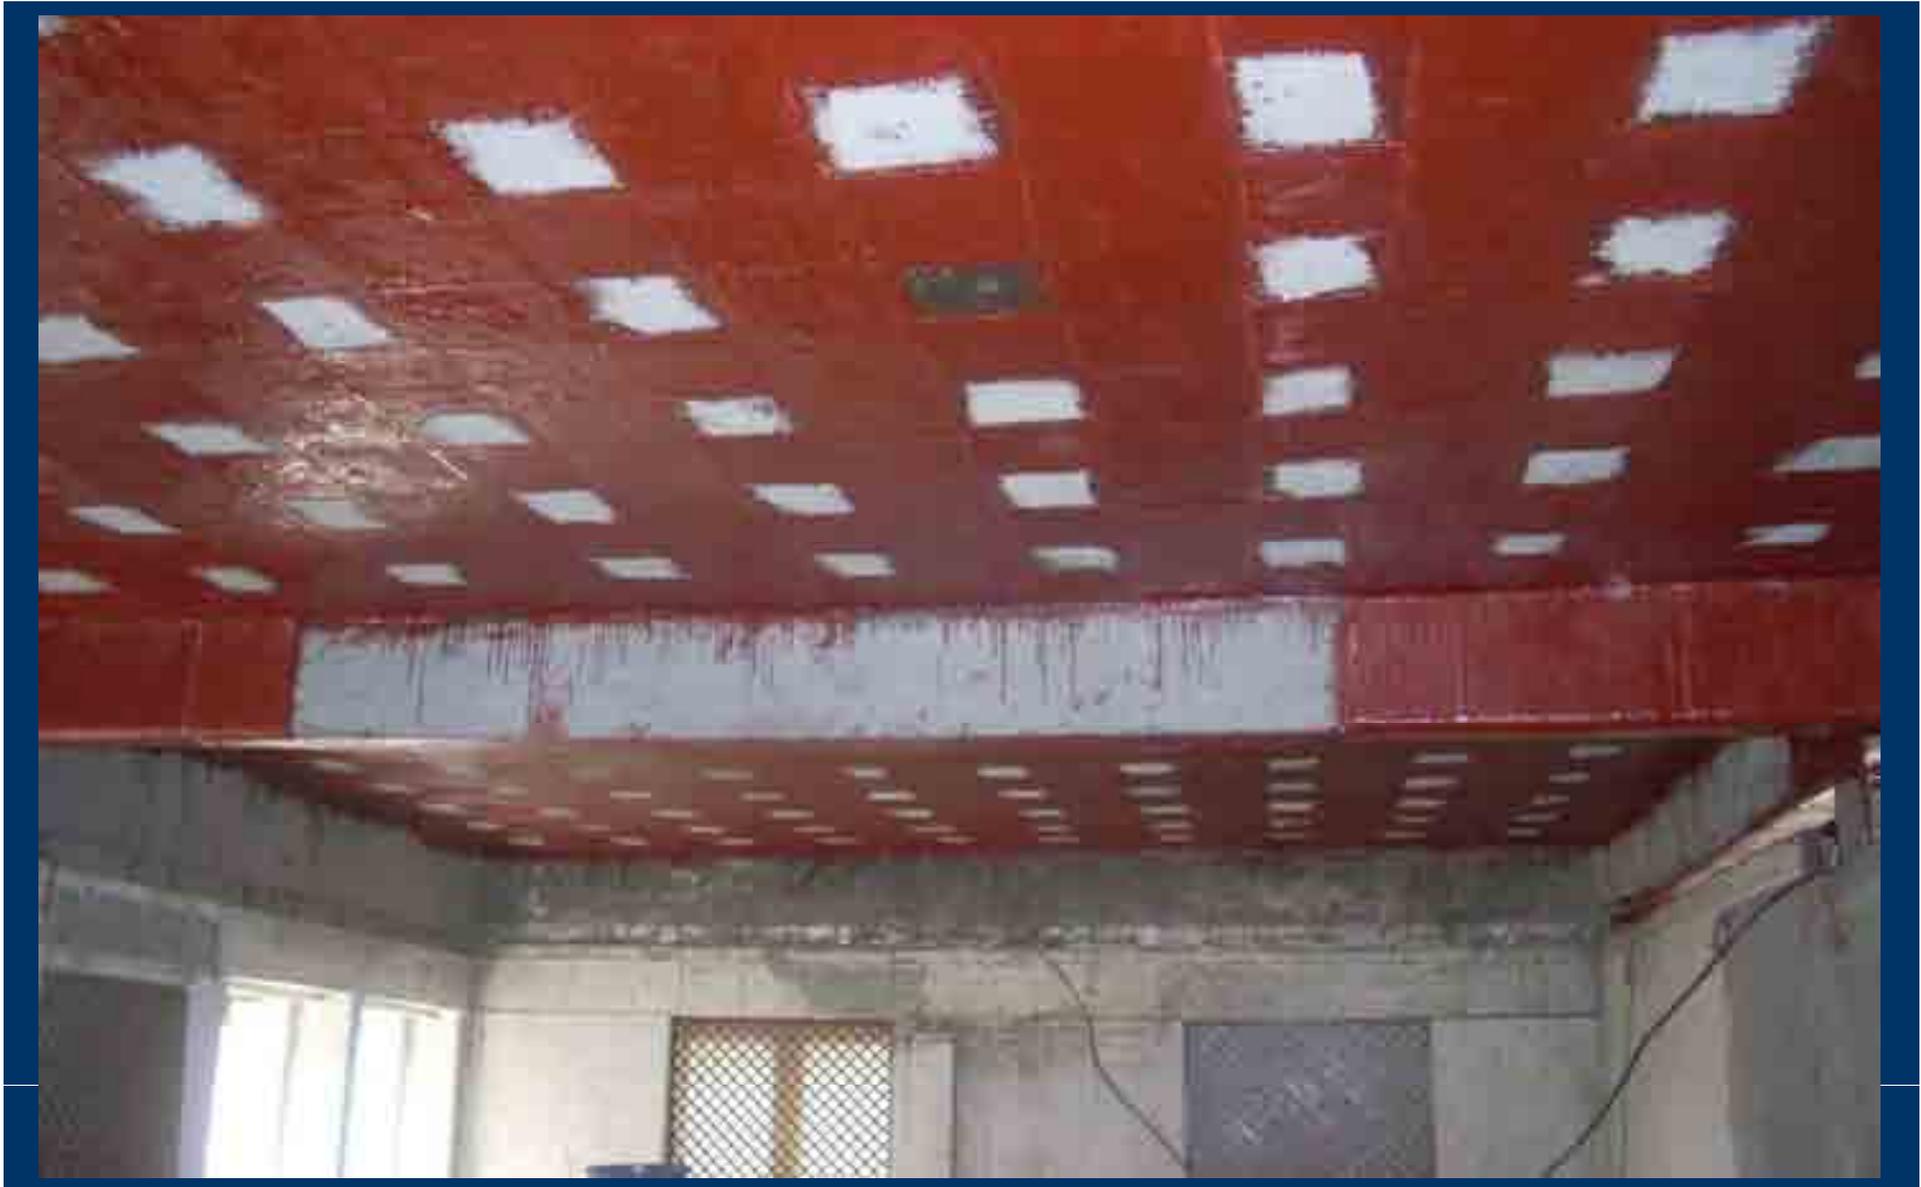
SLAB & BEAMS AFTER STRENGTHENING

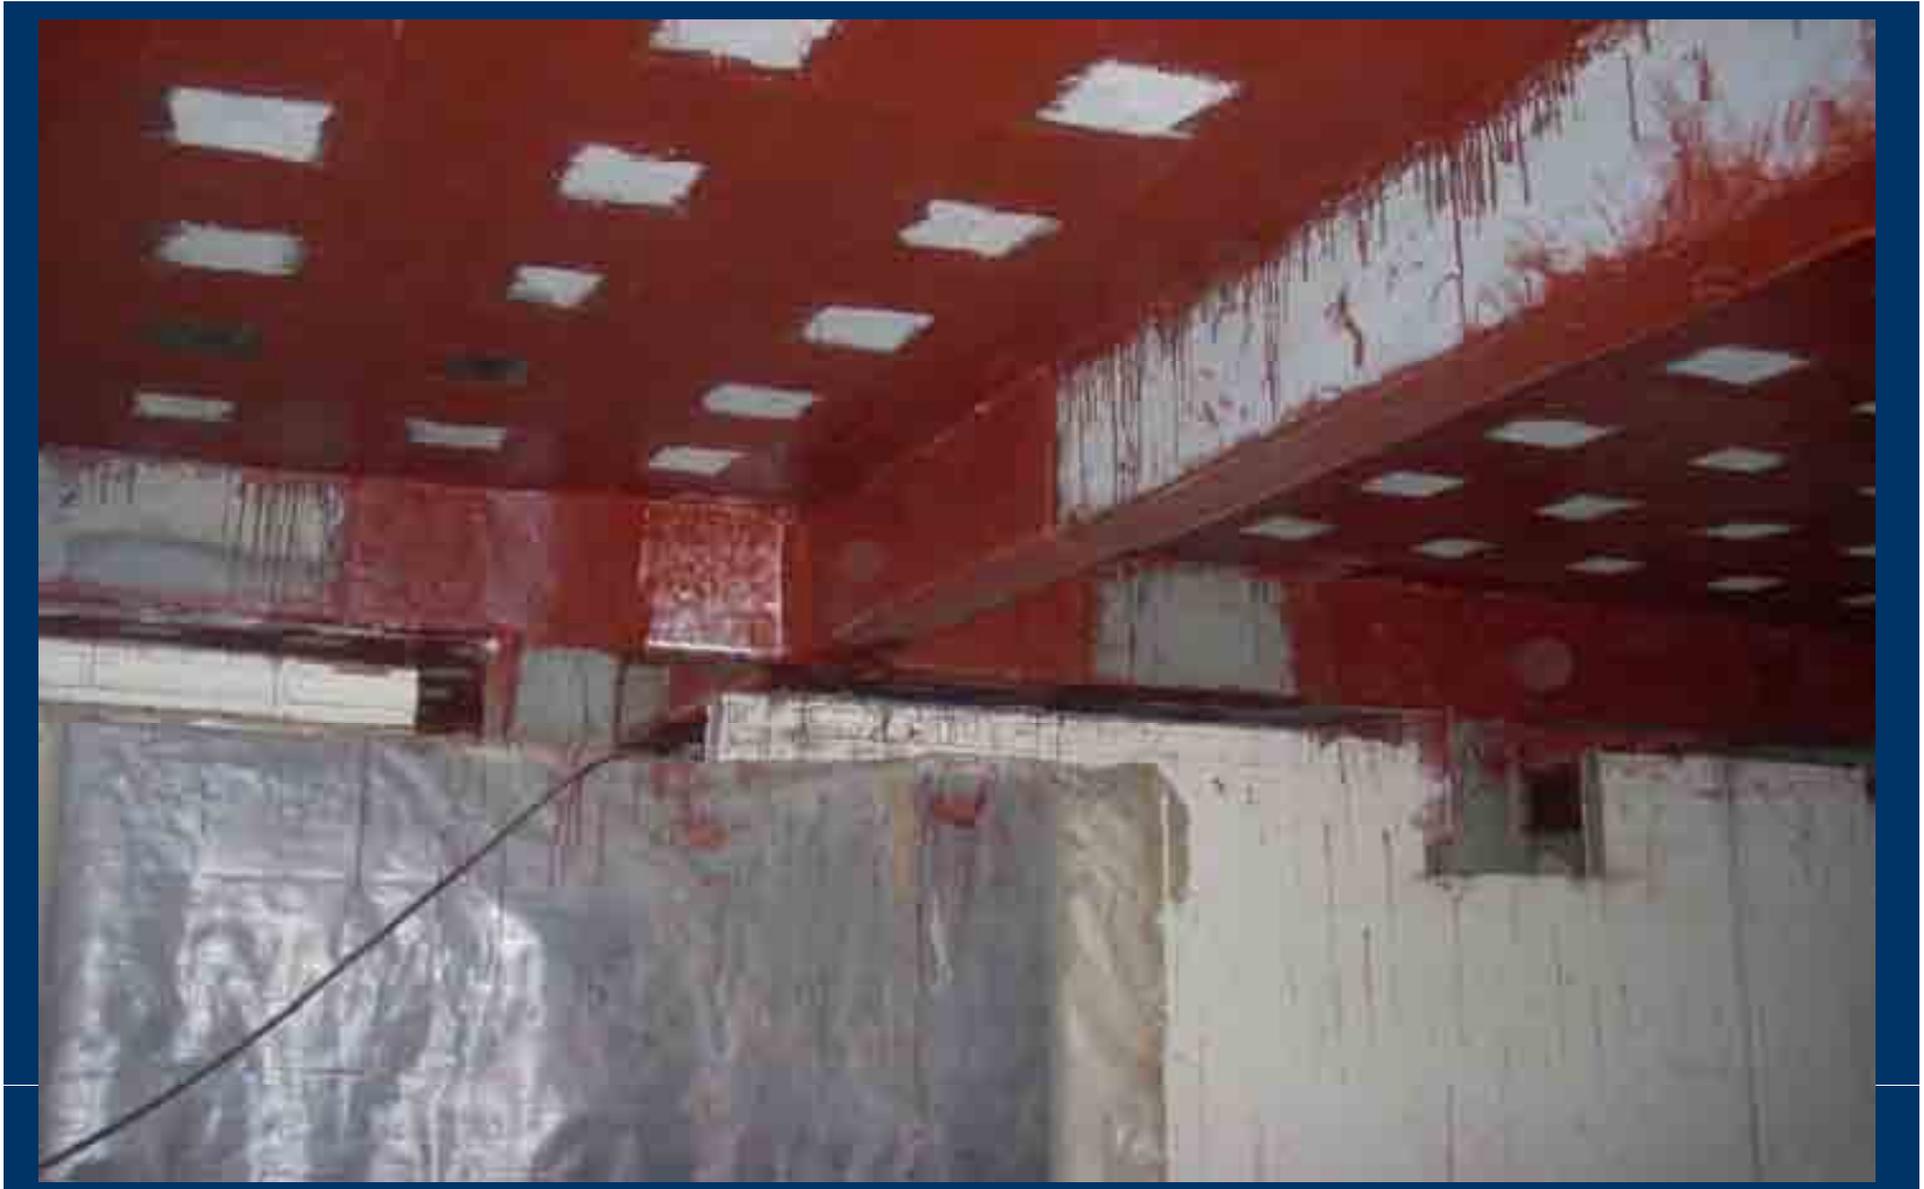
SLAB & BEAMS AFTER STRENGTHENING

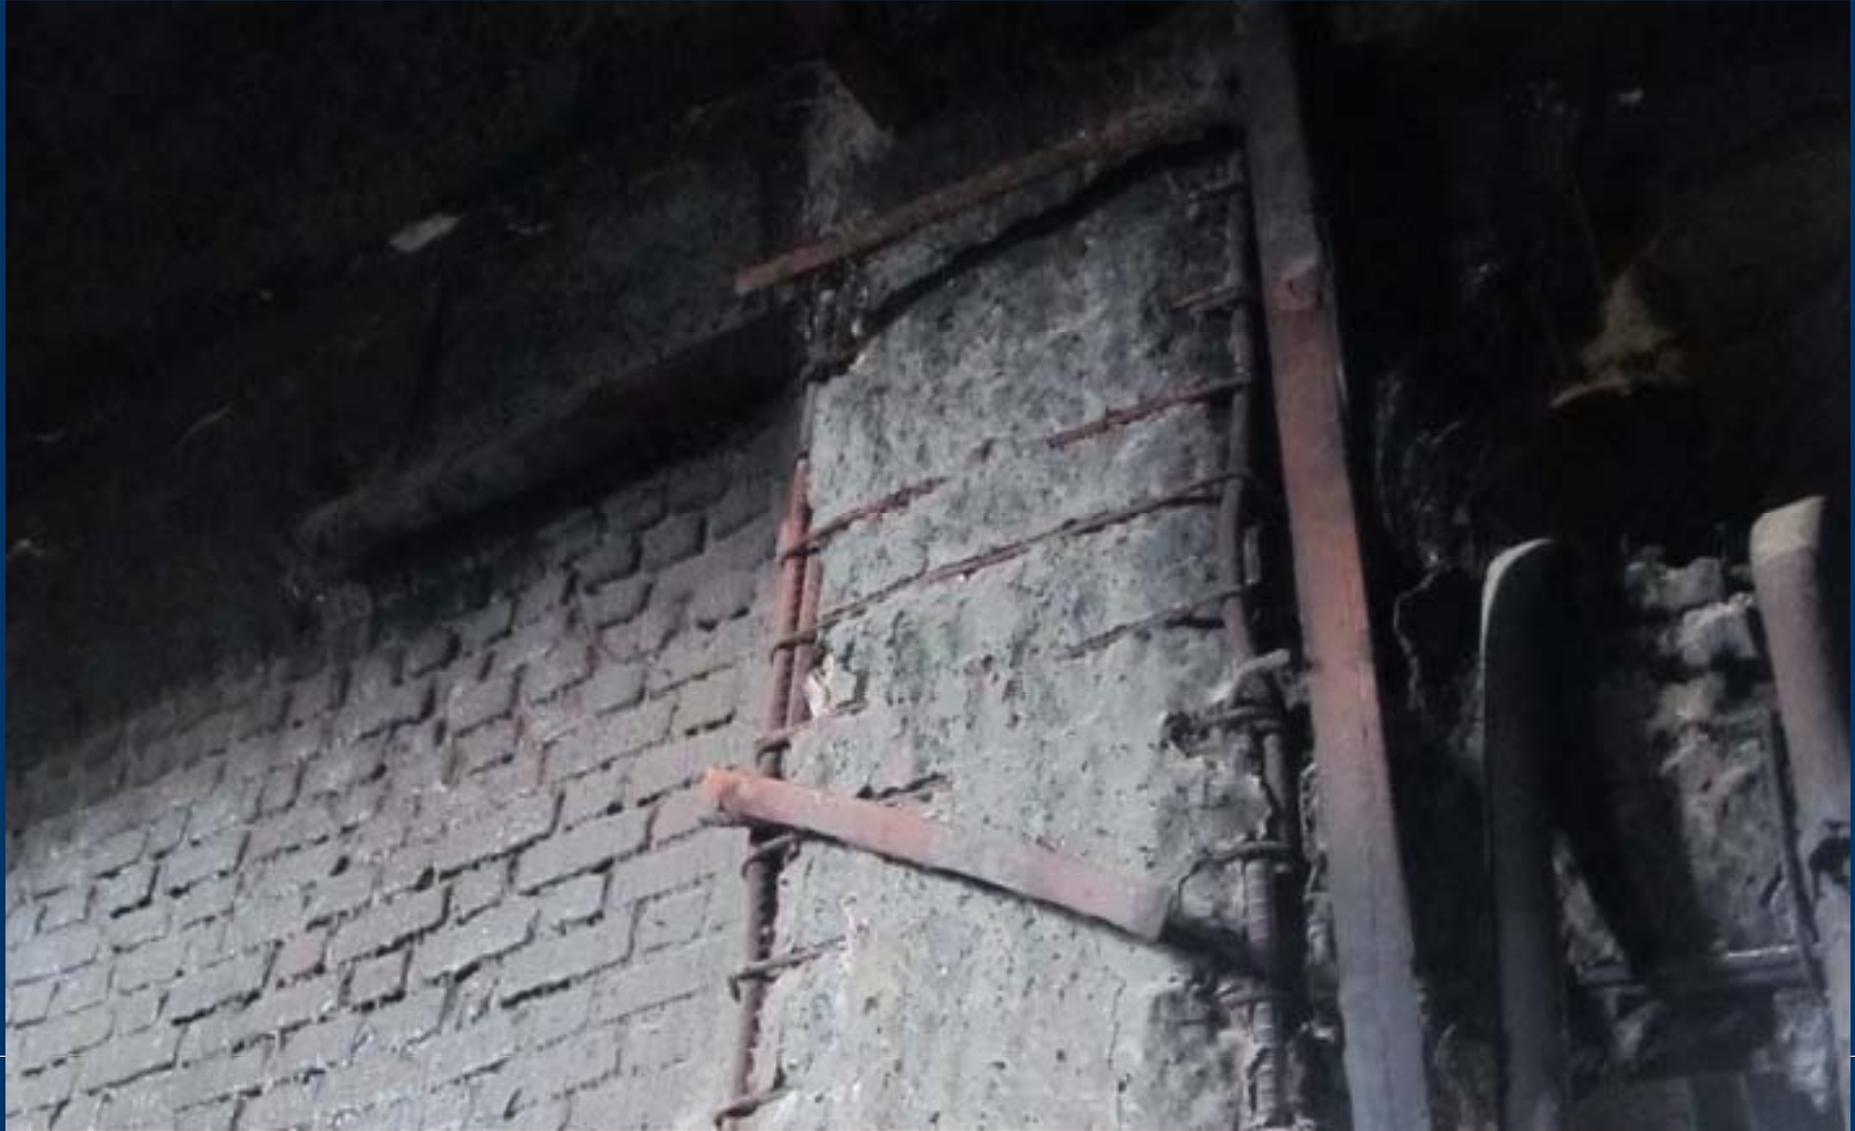
DAMAGED RCC COLUMN
