SDMC Training Programme

Retrofitting Techniques of Existing Buildings

Reinforced Concrete Structures

CSIR-Central Building Research Institute, Roorkee (India)

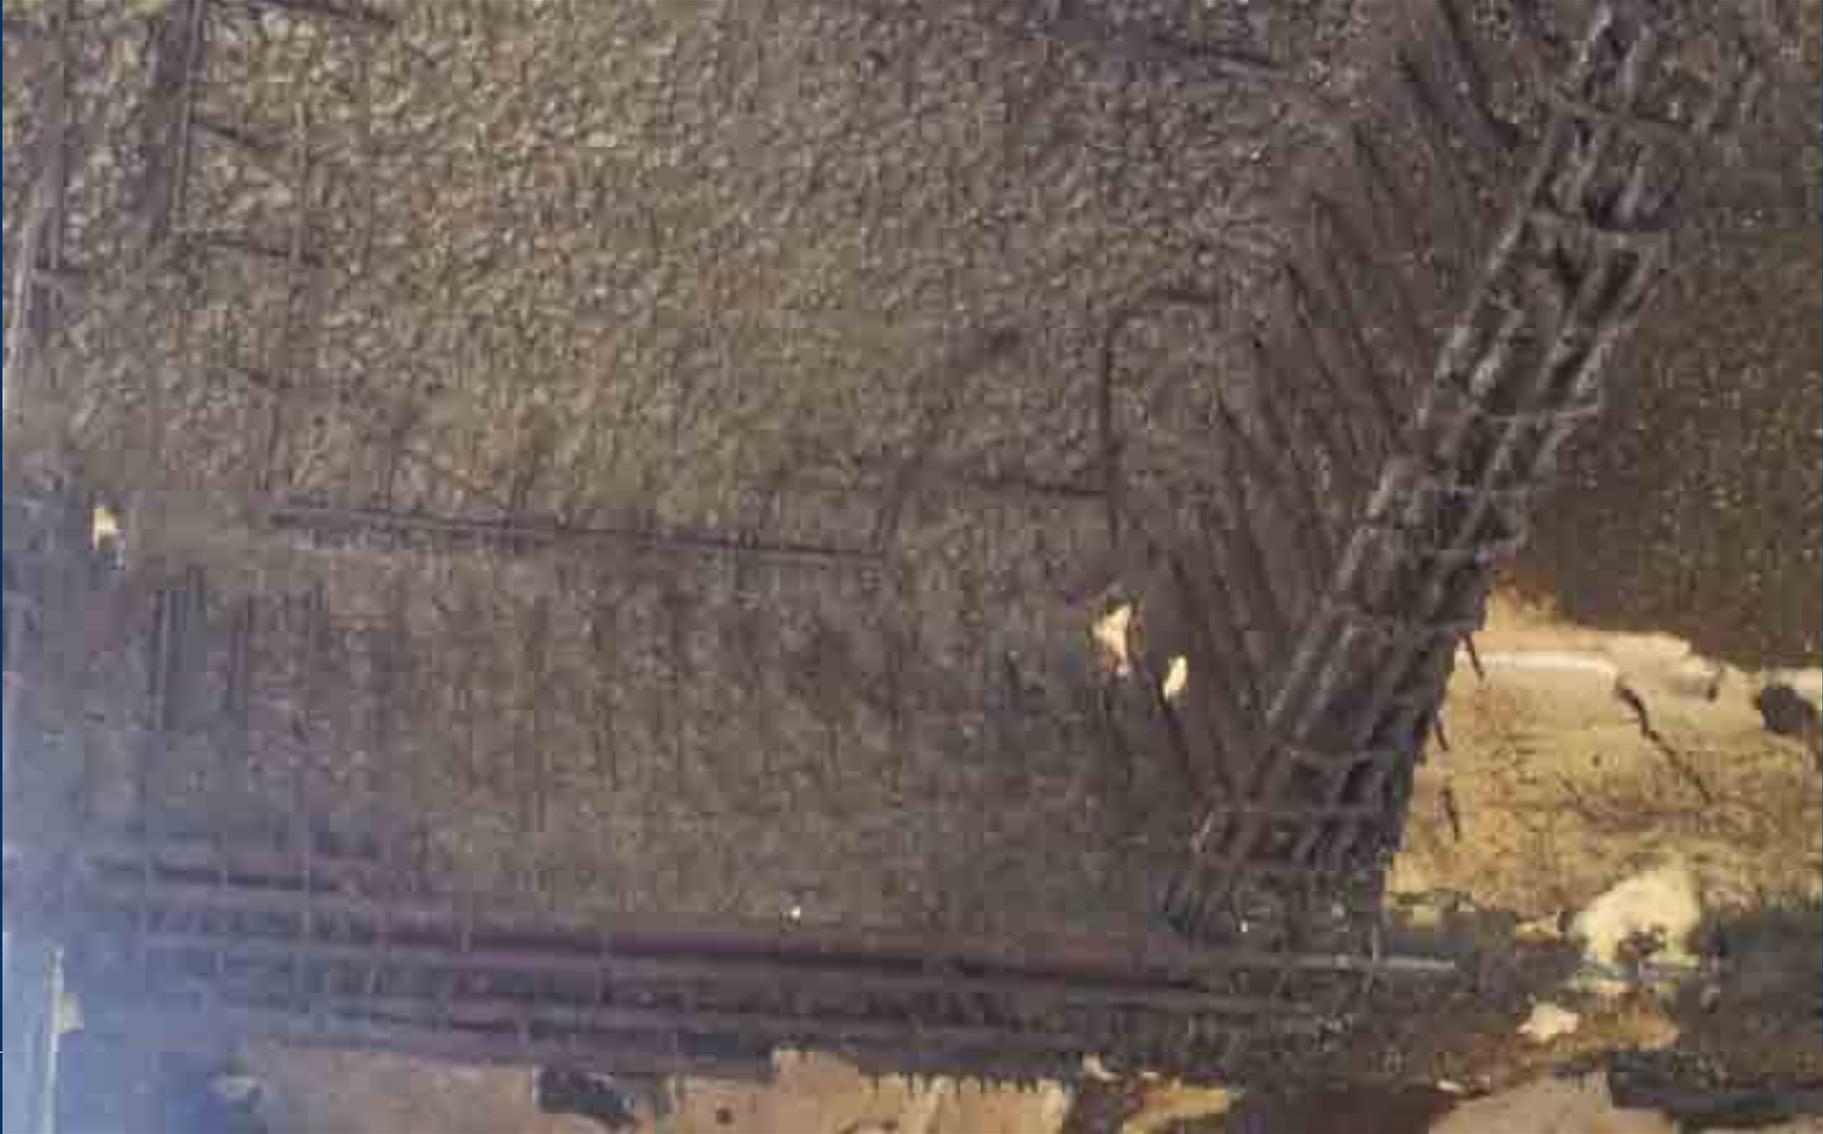
DAMAGED R C C BEAM AND SLAB

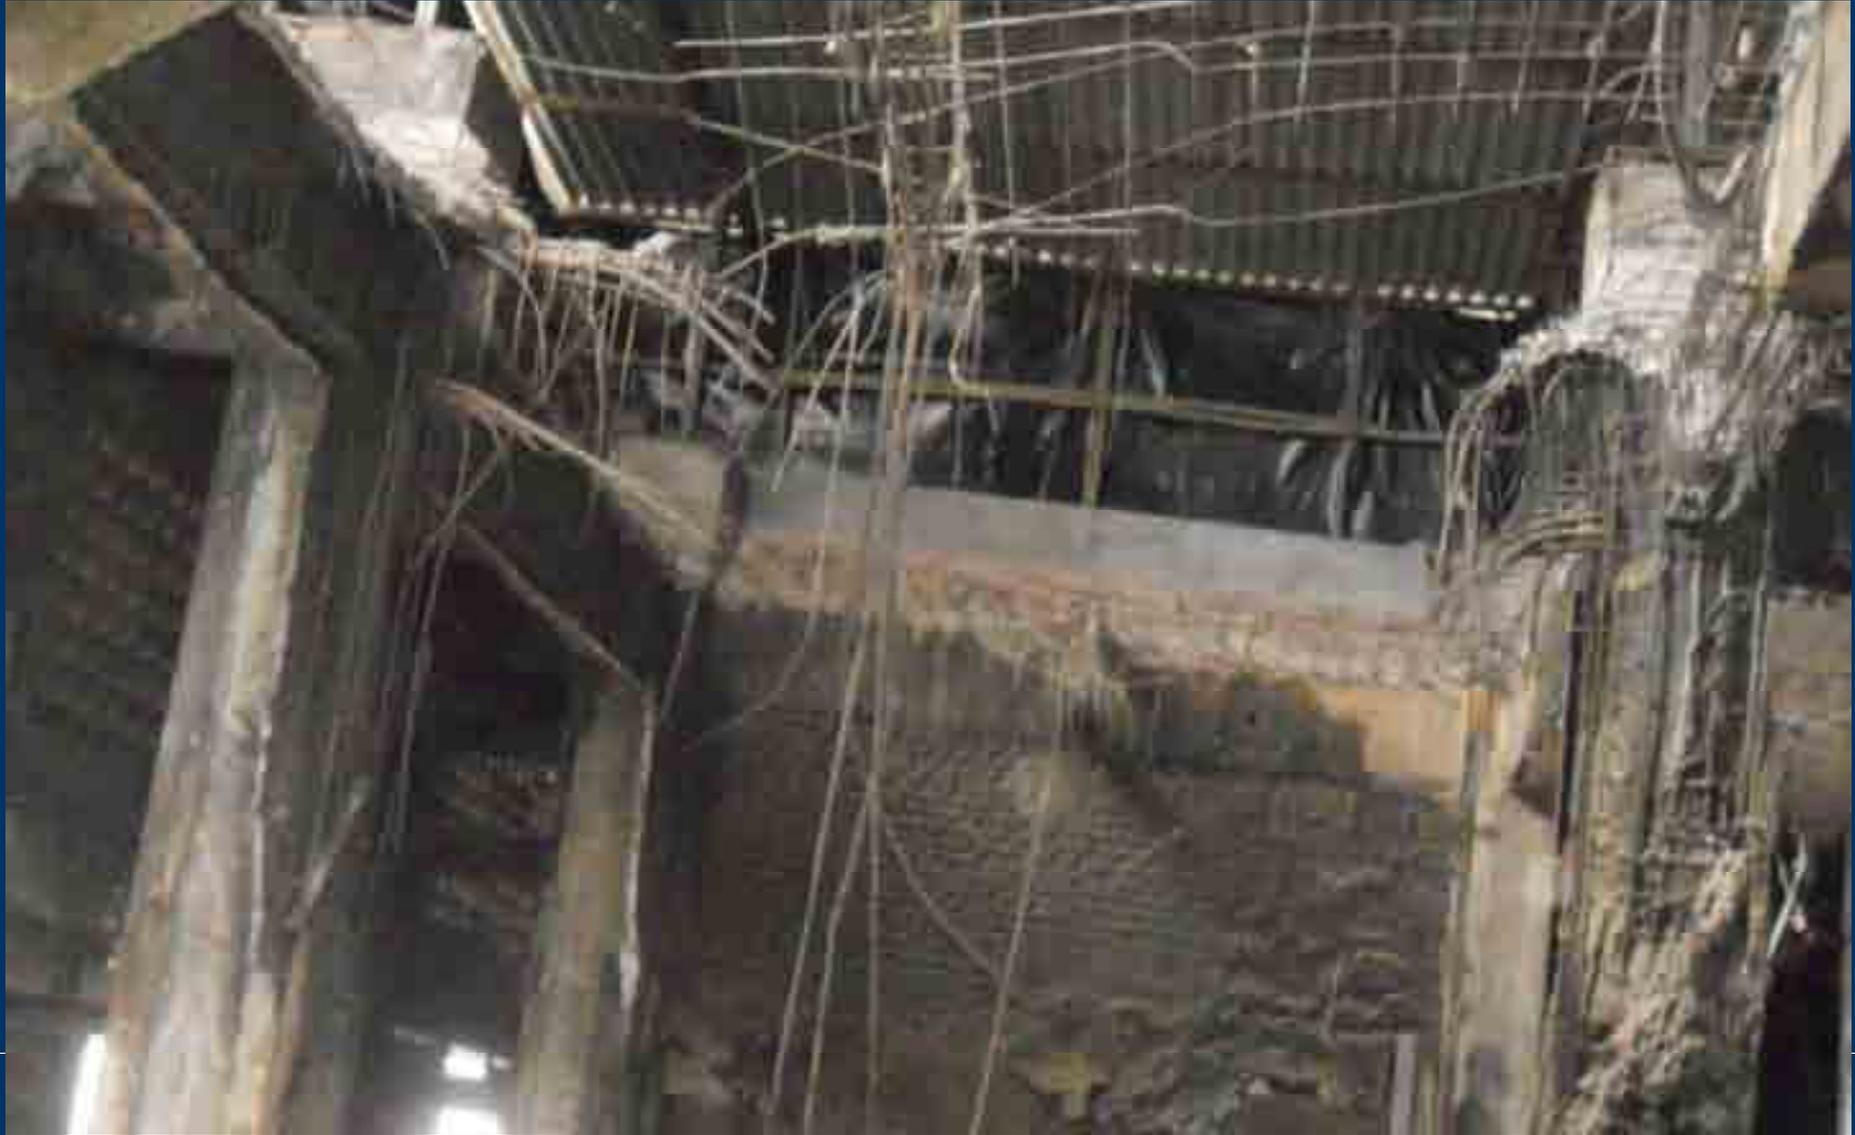
PARTLY COLLAPSED STRUCTURE

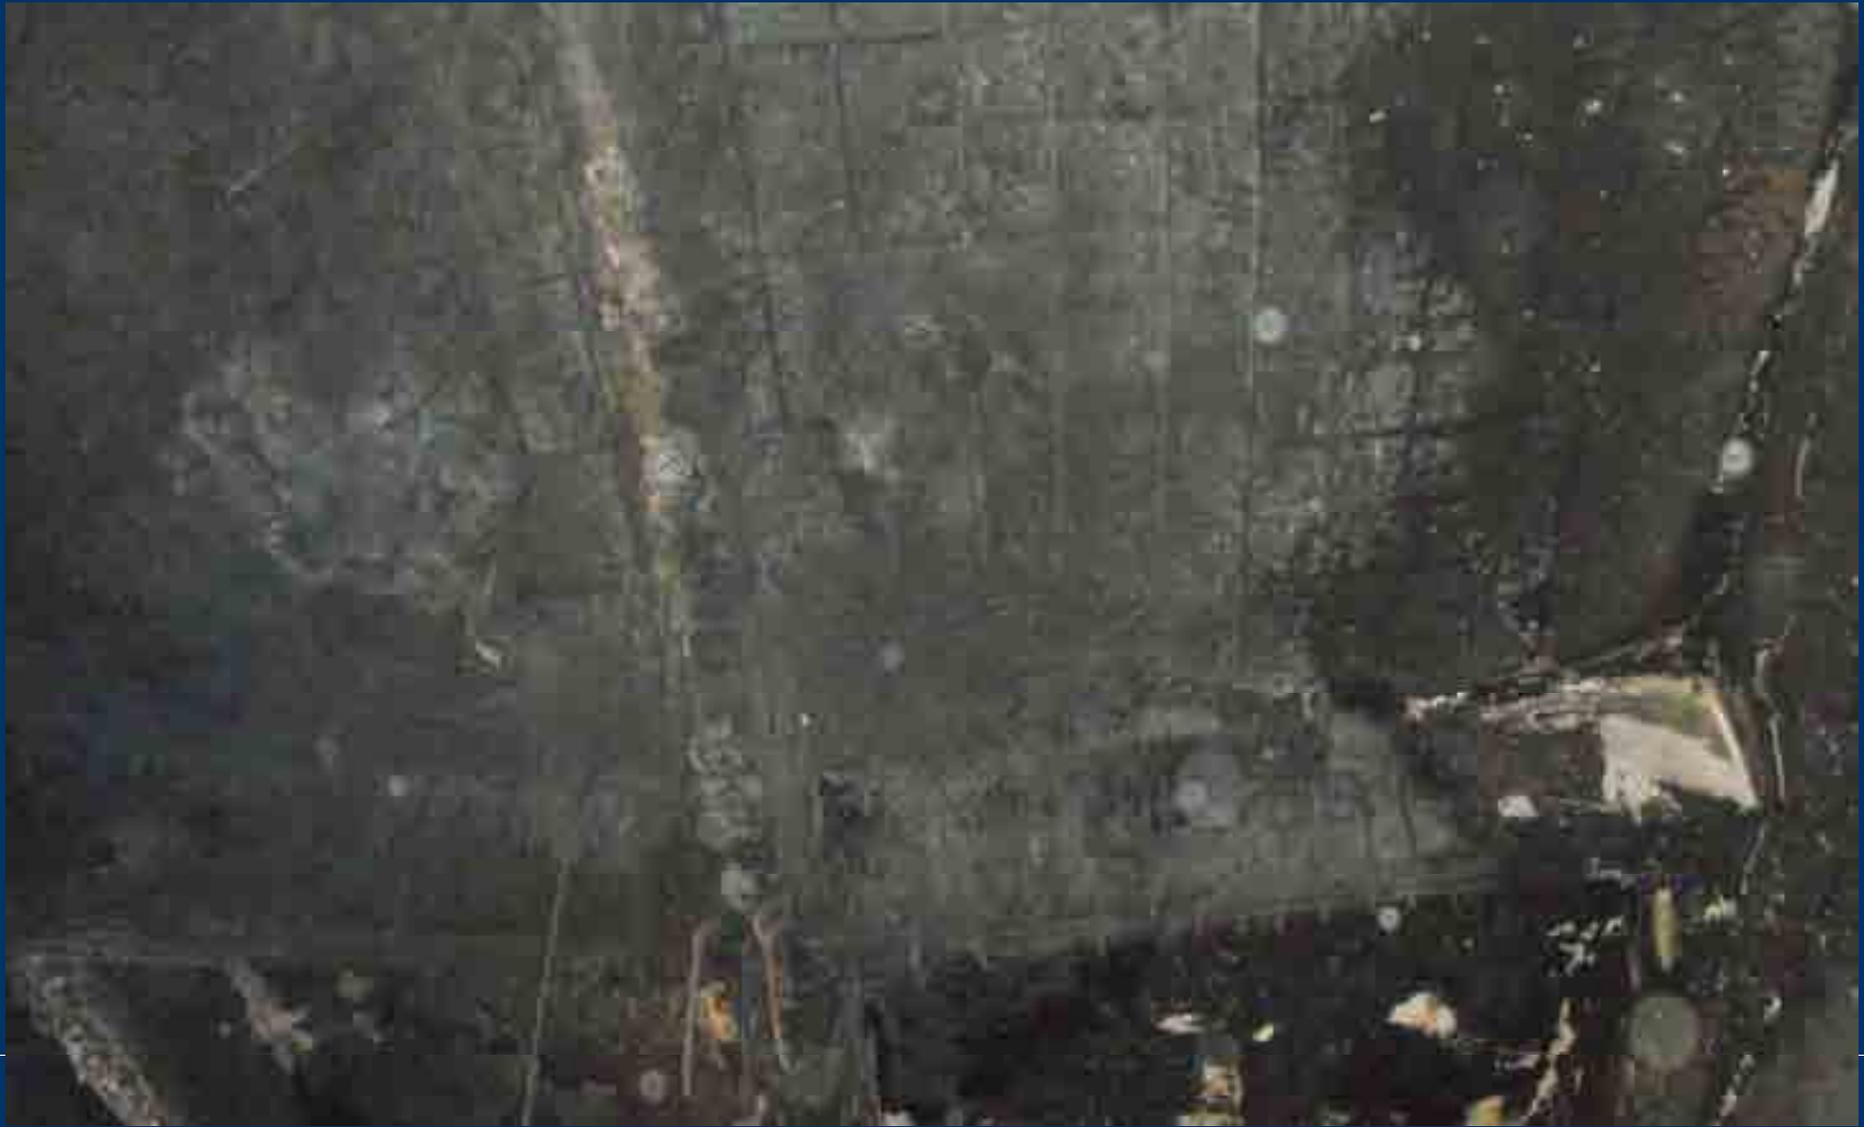
DEFORMED SLAB AND BEAMS

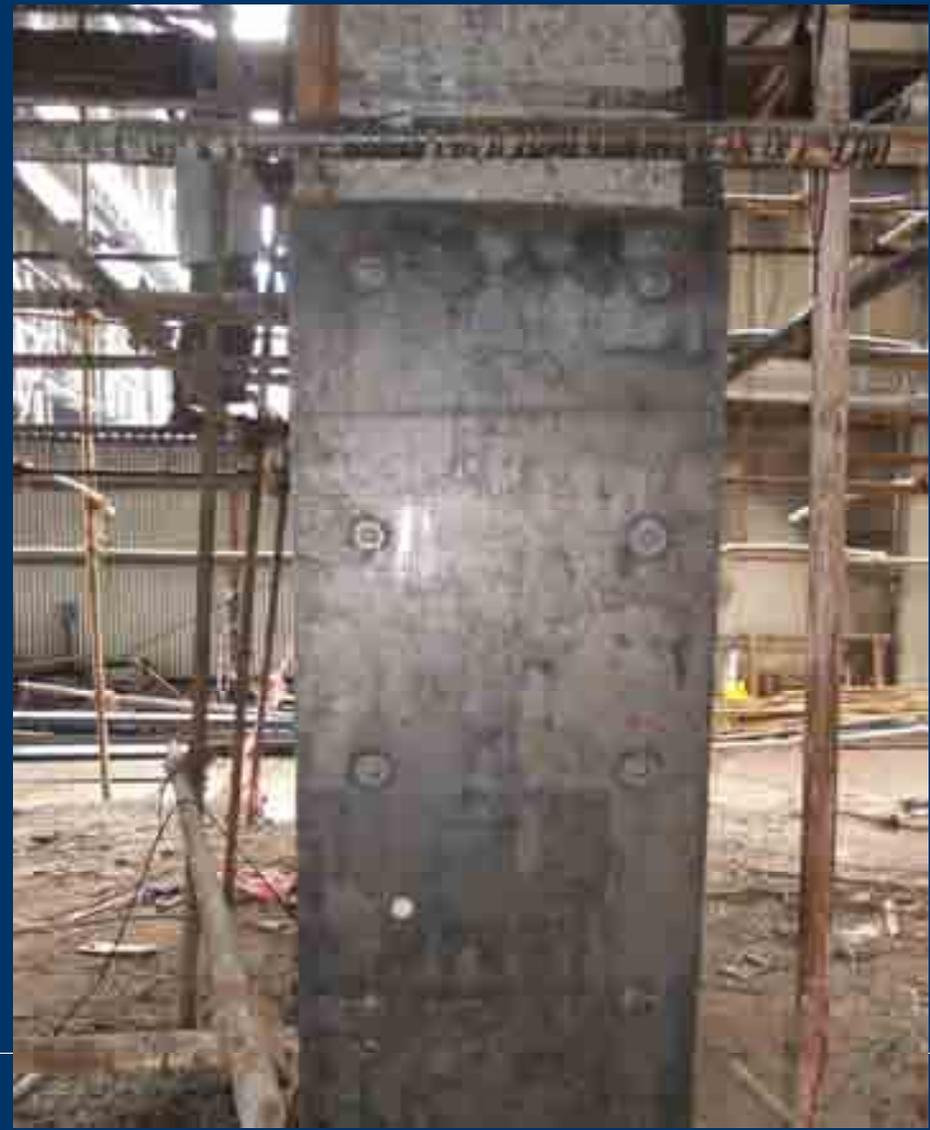
COLUMN JACKETING IN PROGRESS

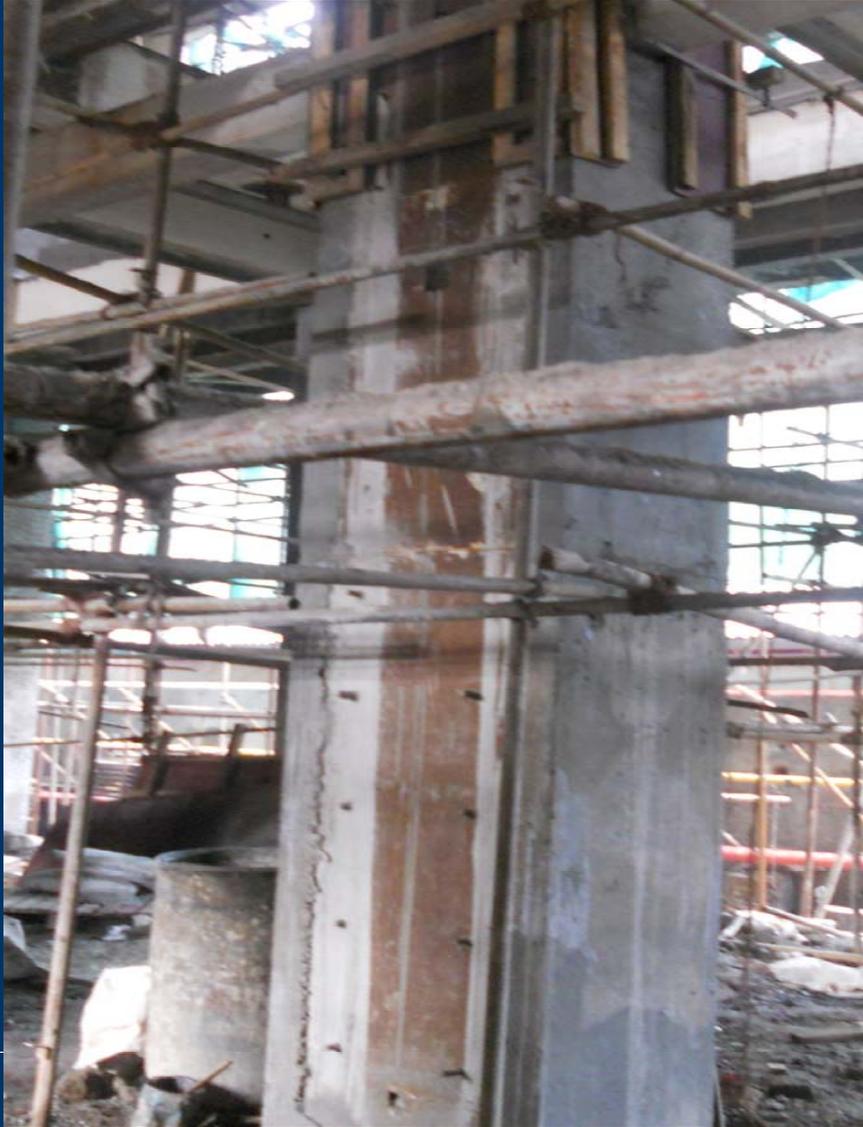
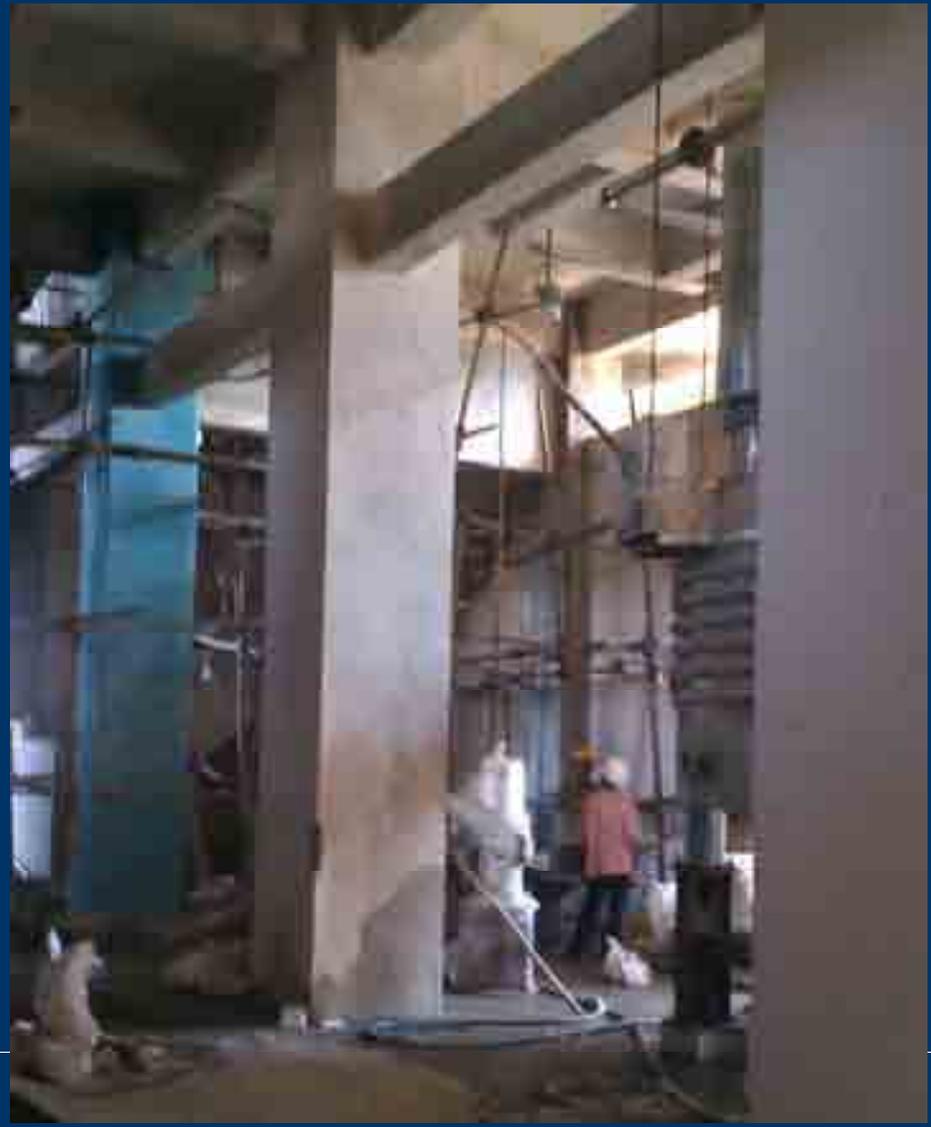
COLUMN AFTER JACKETING

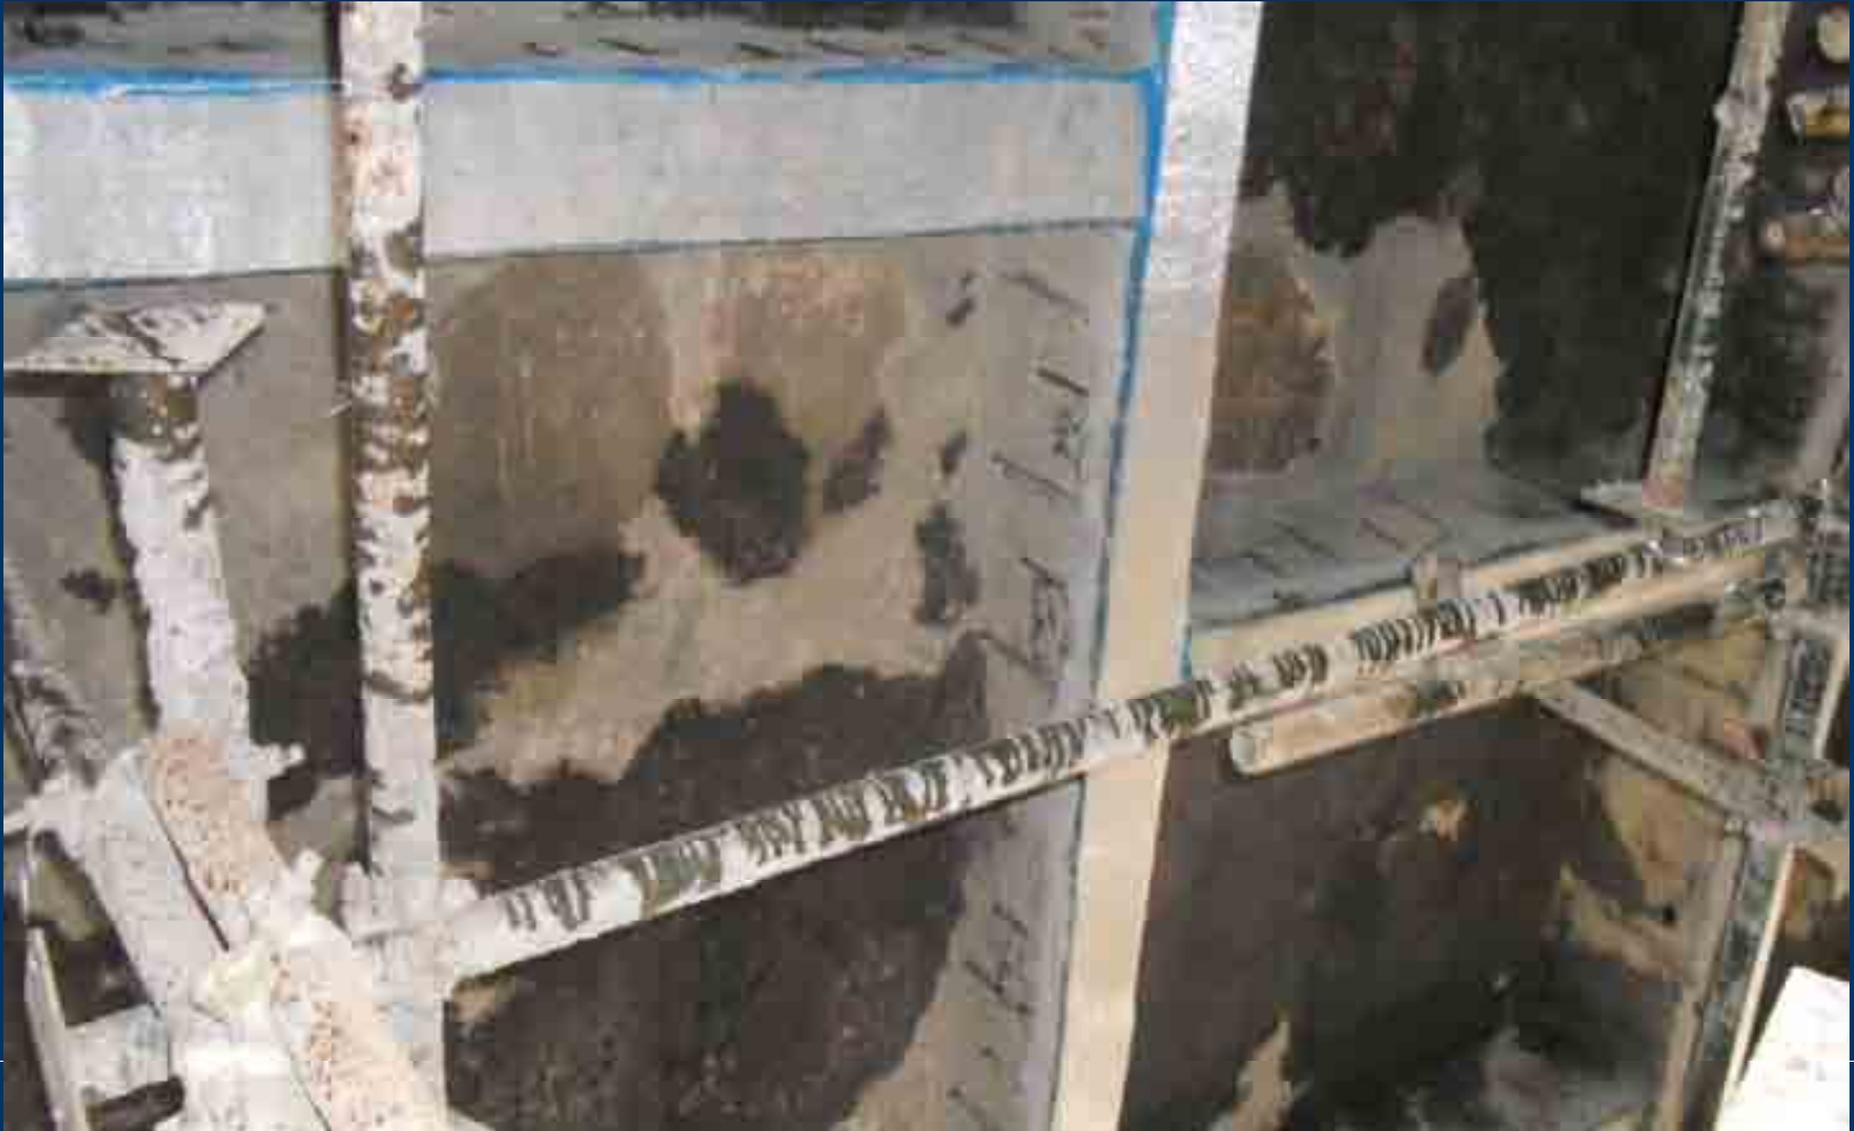
STRENGTHENING OF BEAM IN PROGRESS

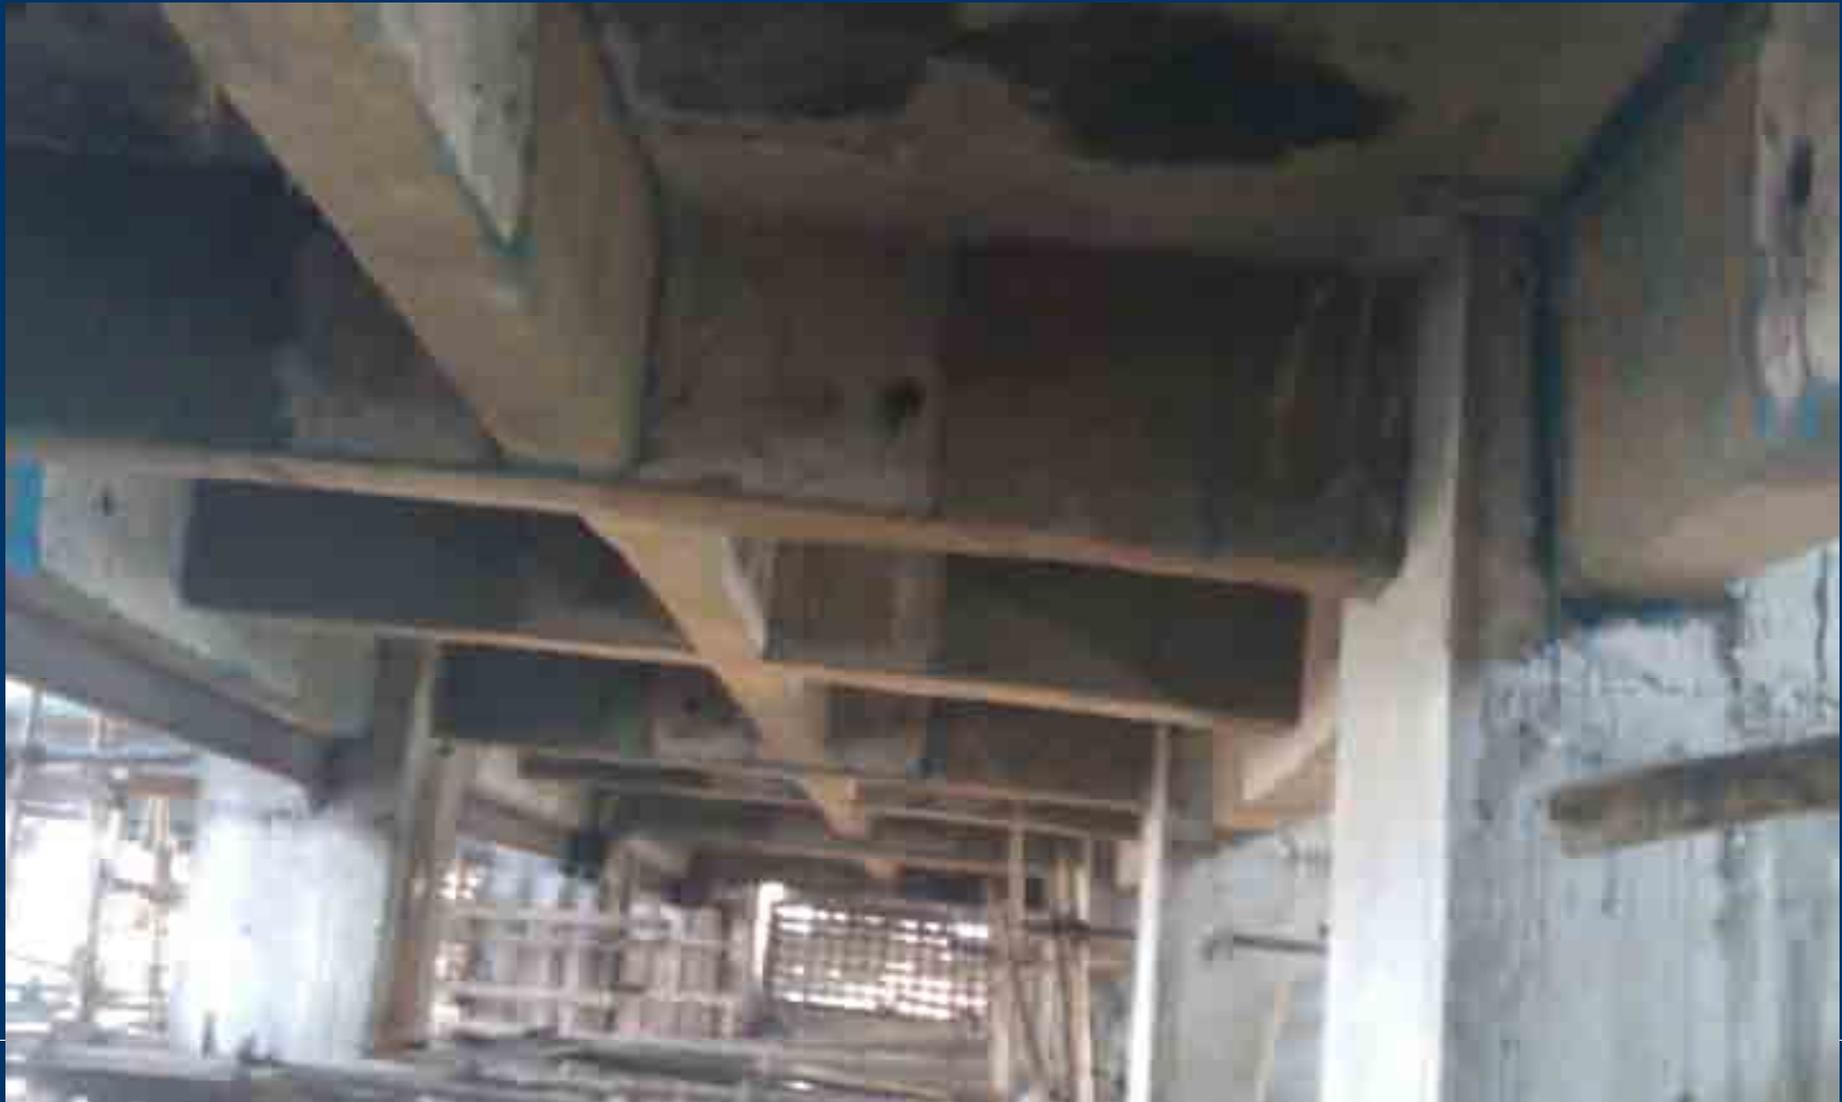
BEAMS – AFTER FIBRE WRAPPING

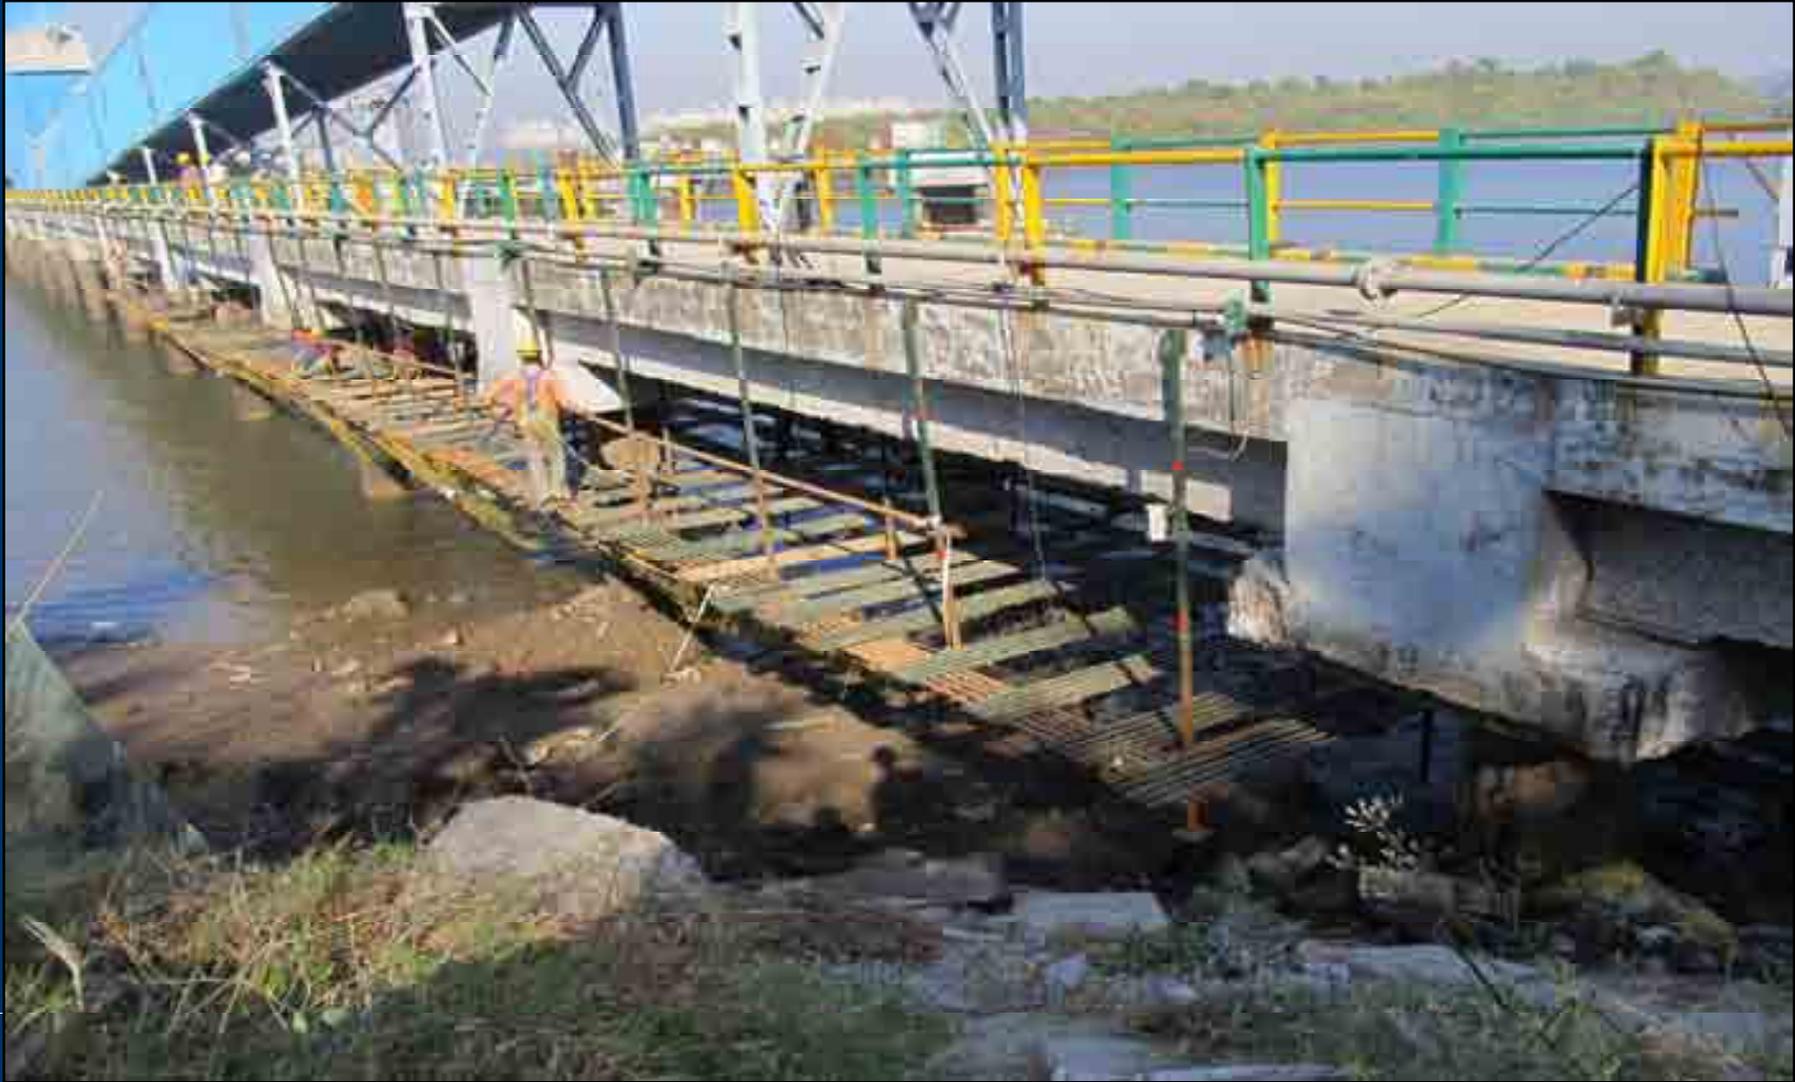
SCAFFOLDING SUSPENDED FROM DECK SLAB

- Due to tidal variation, the maximum duration of dry period available for work was 6 hours at a stretch. As a result all the materials were modified to set within that period and were also insensitive to moisture
- The scaffolding provided had to be suspended from the deck with anchors
- Work had to be carried out round the clock

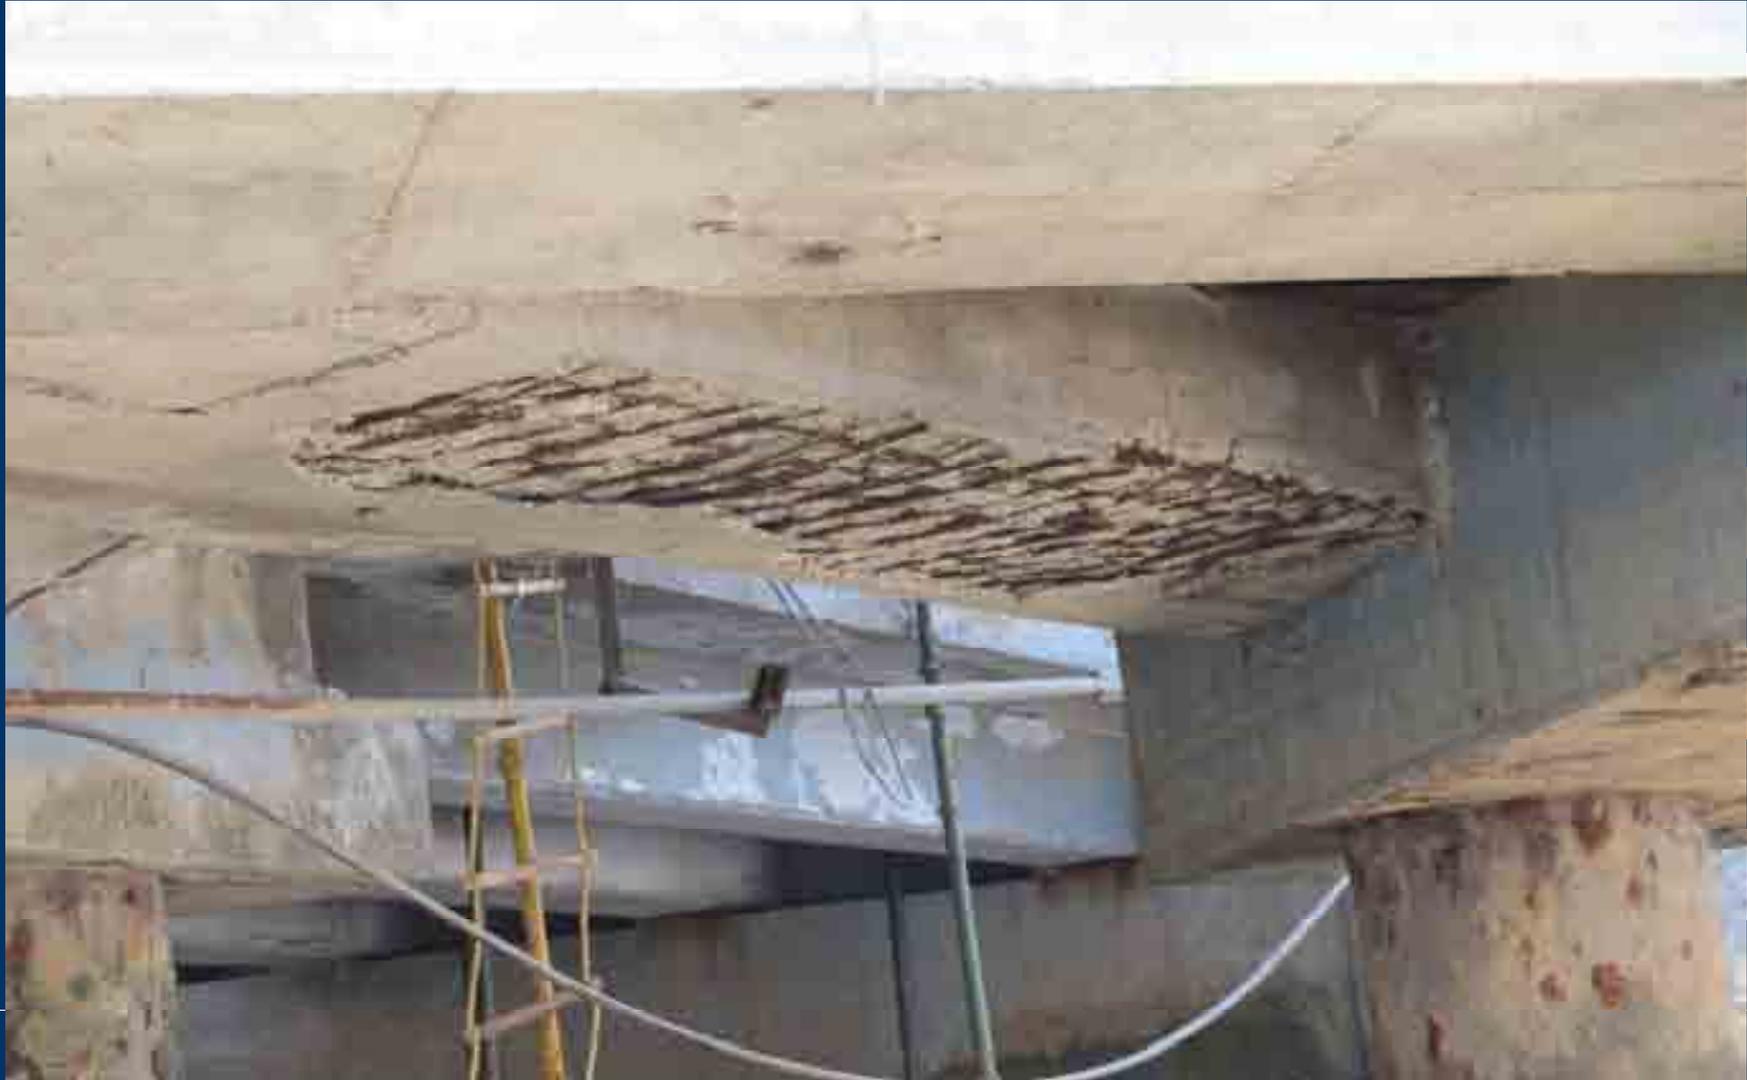
DAMAGED JUNCTURE BEAM

- Chloride induced corrosion of steel, resulting in de-lamination of concrete and reduction in reinforcement size.

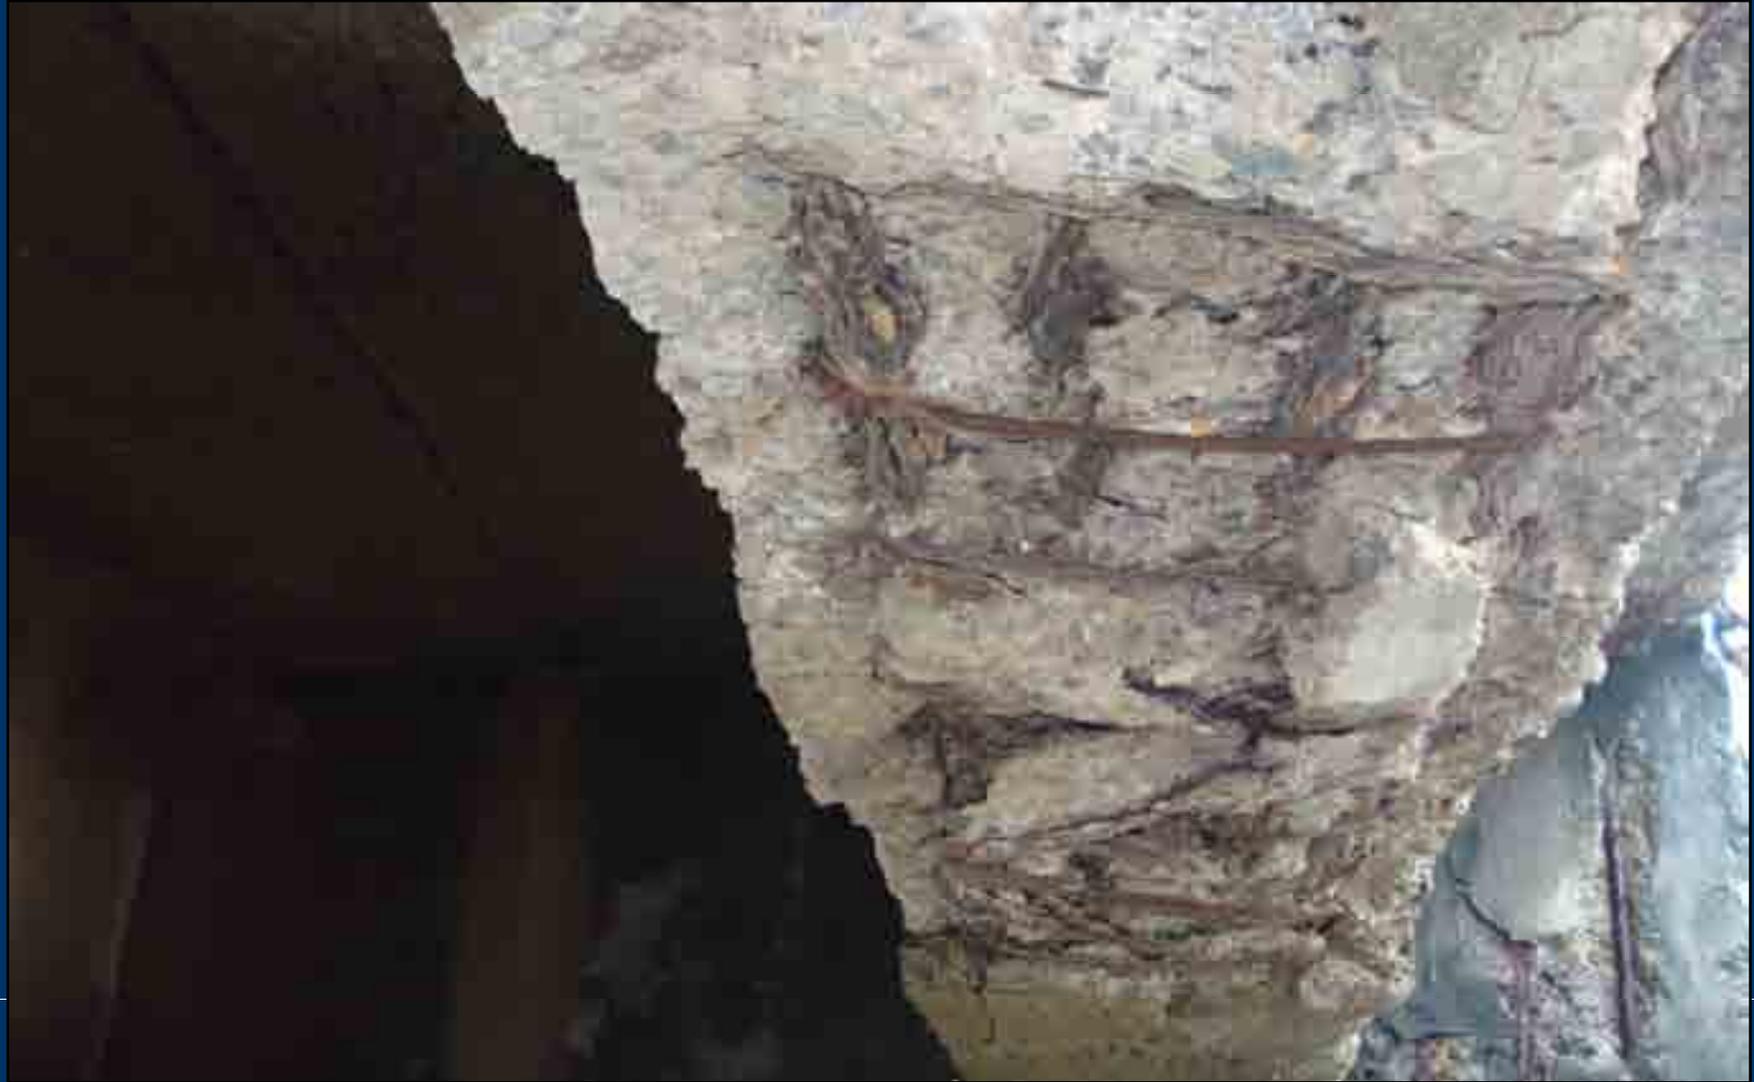
DAMAGED T-BEAM

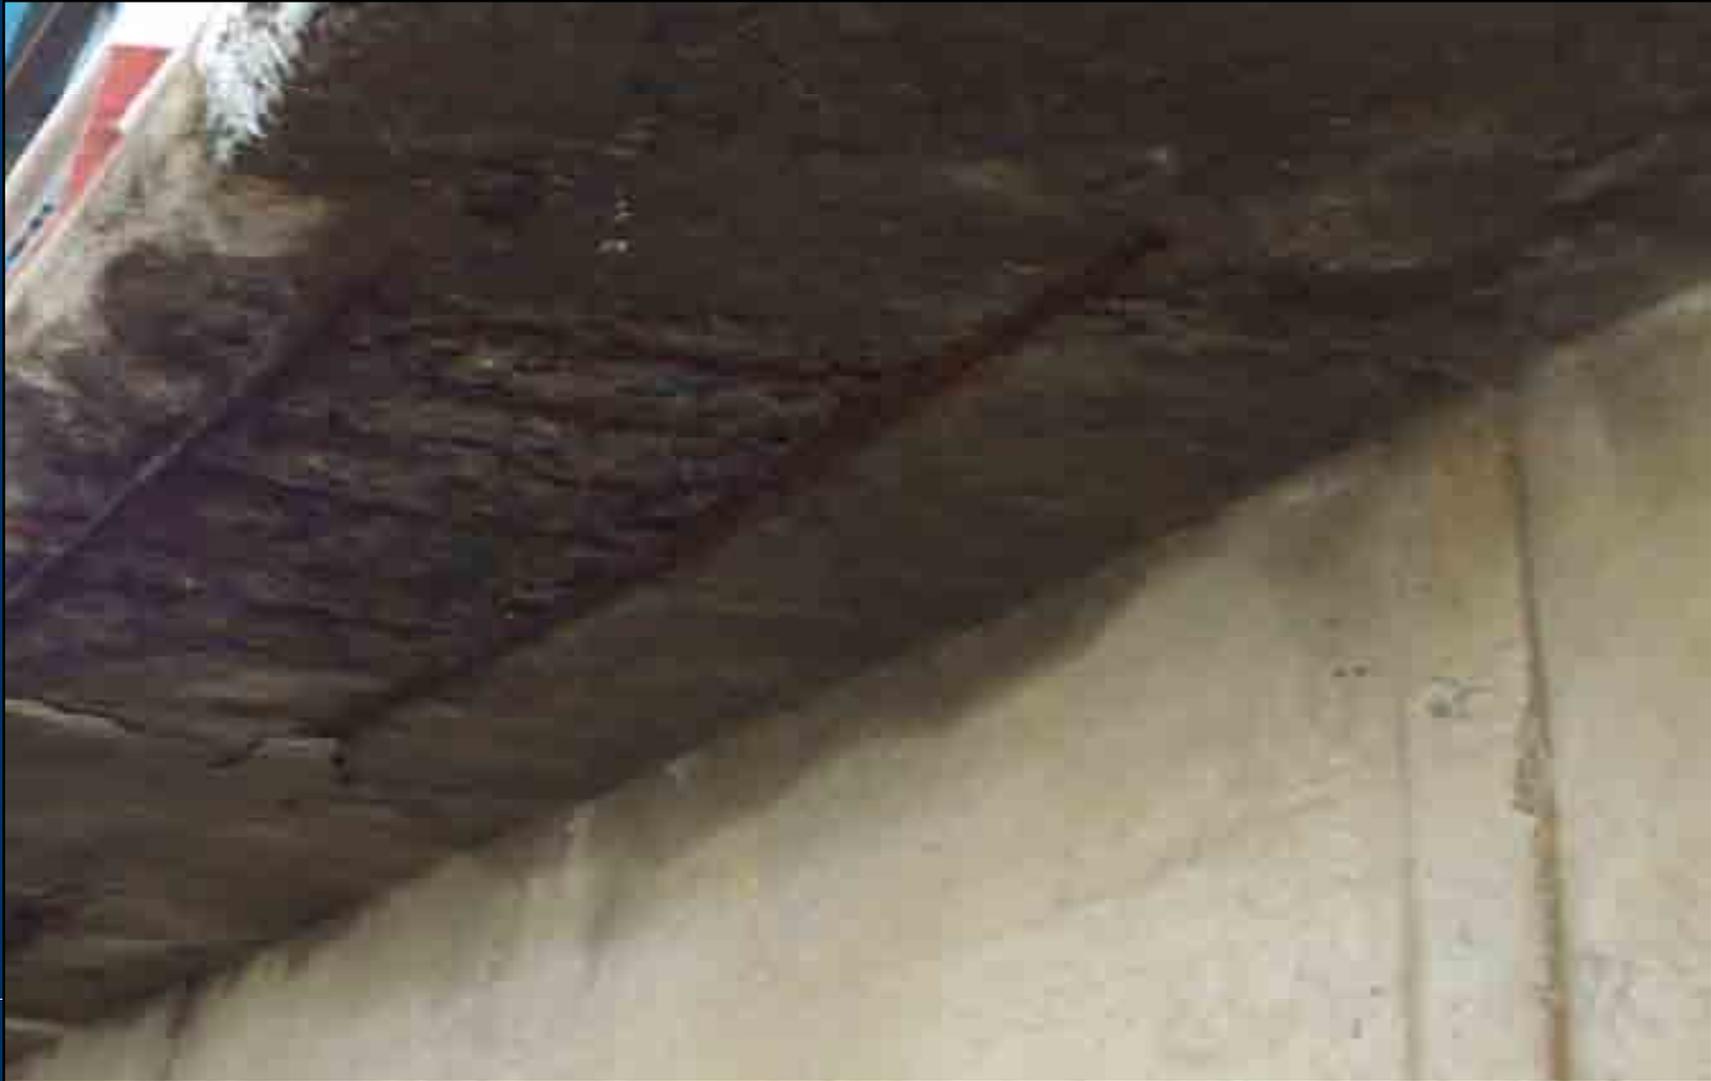
DAMAGED CANTILEVER SLAB

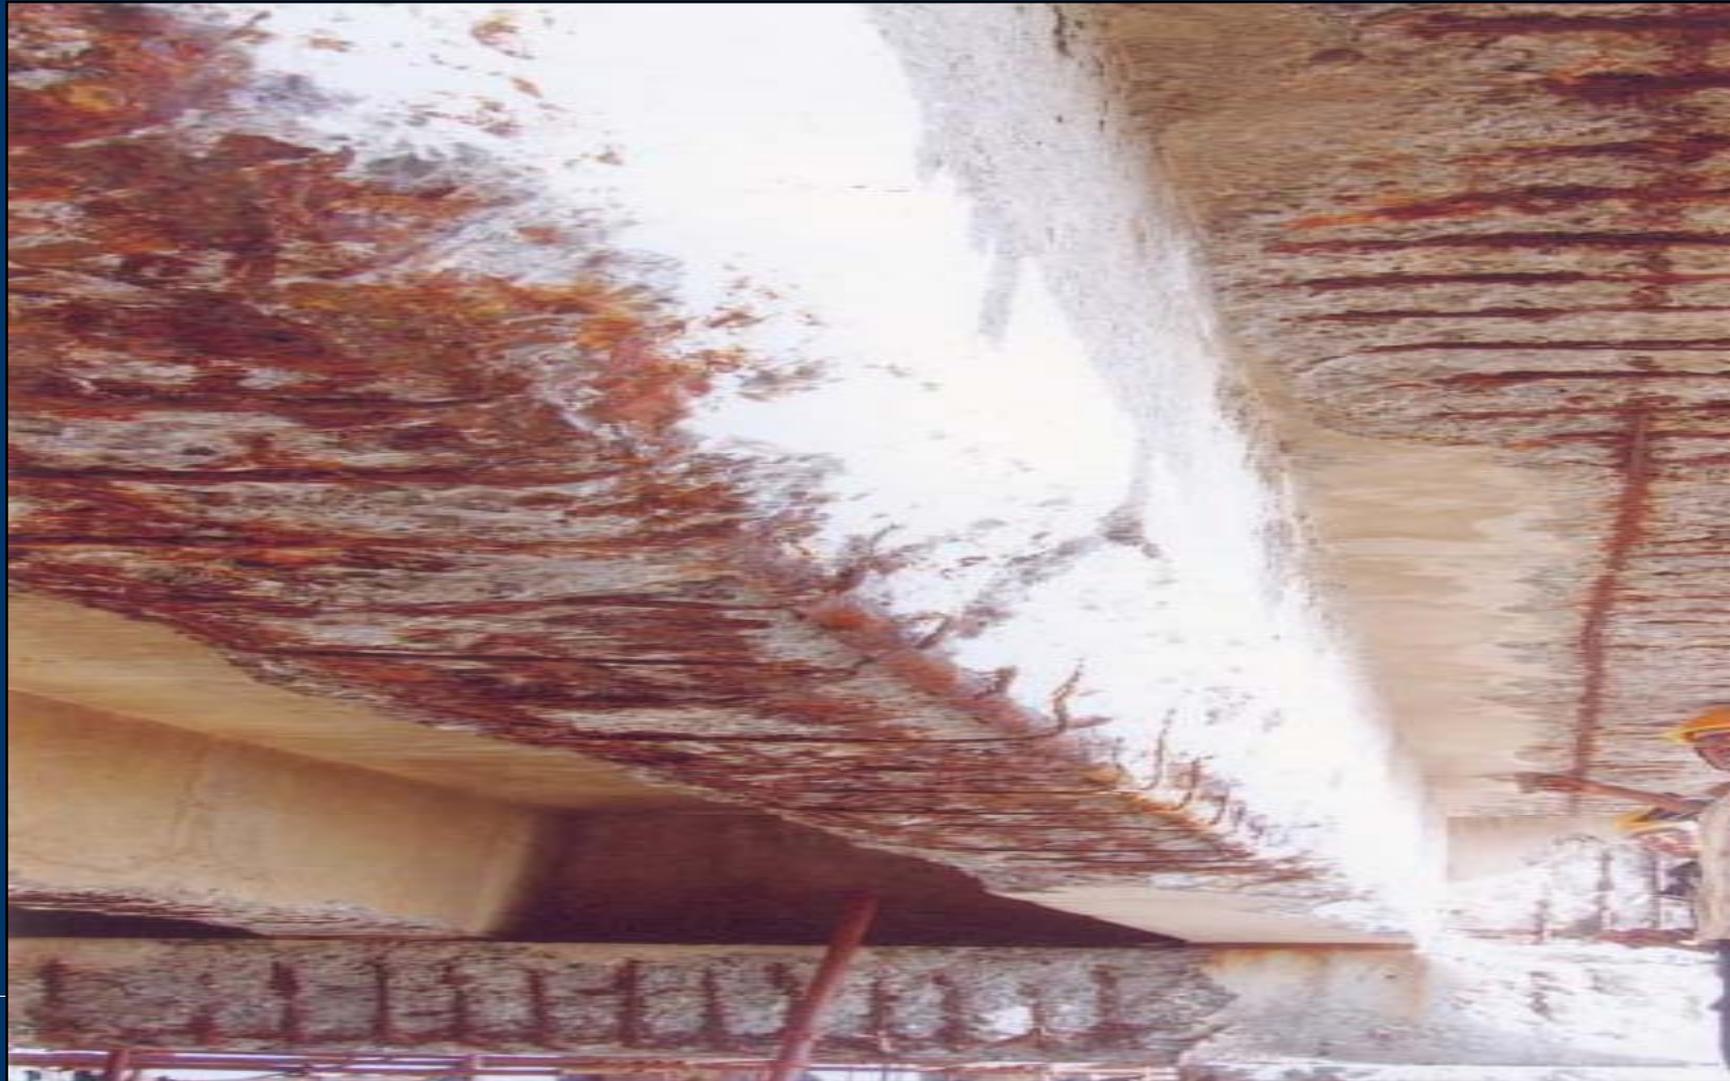
DAMAGED BEAM, SLAB AND PILE CAPS
