SDMC Training Programme

Retrofitting Techniques of Existing Buildings

Reinforced Concrete Structures

CSIR-Central Building Research Institute, Roorkee (India)

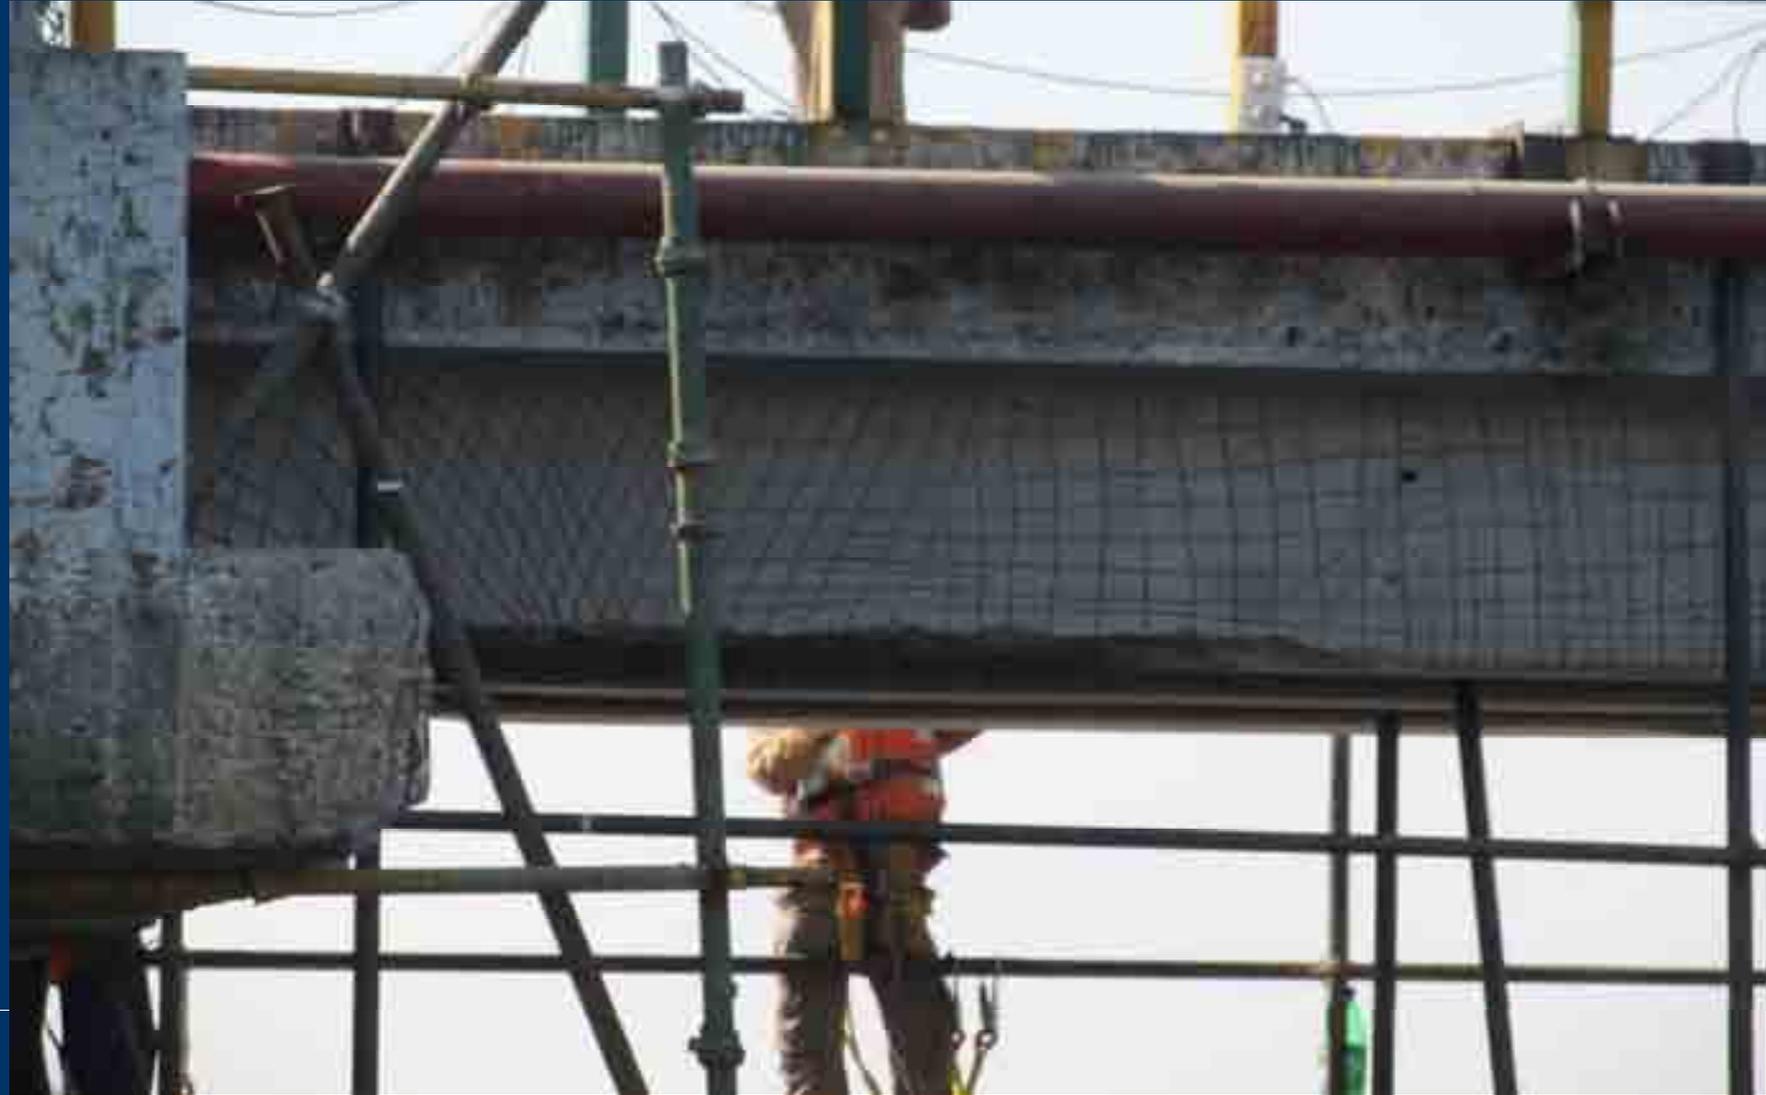
GROOVING OF COVER CONCRETE

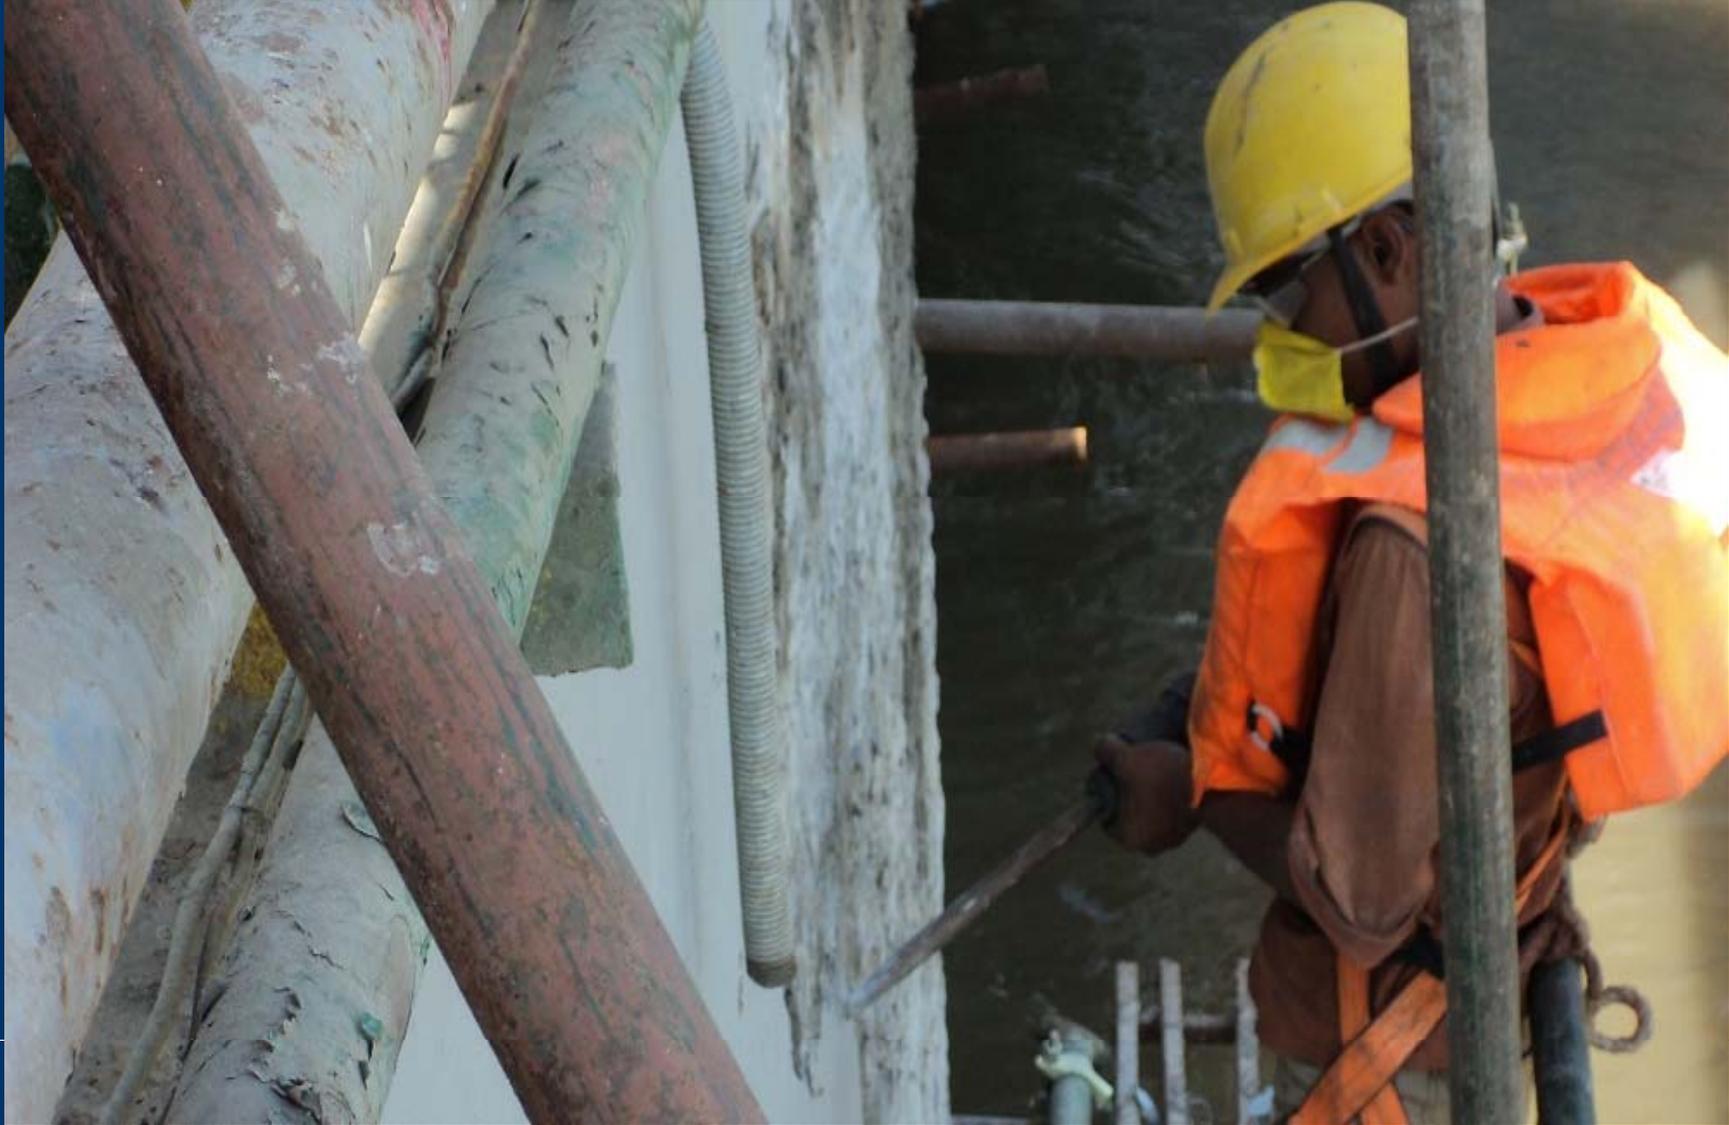
CHIPPING OF DAMAGED CONCREEE SECTION

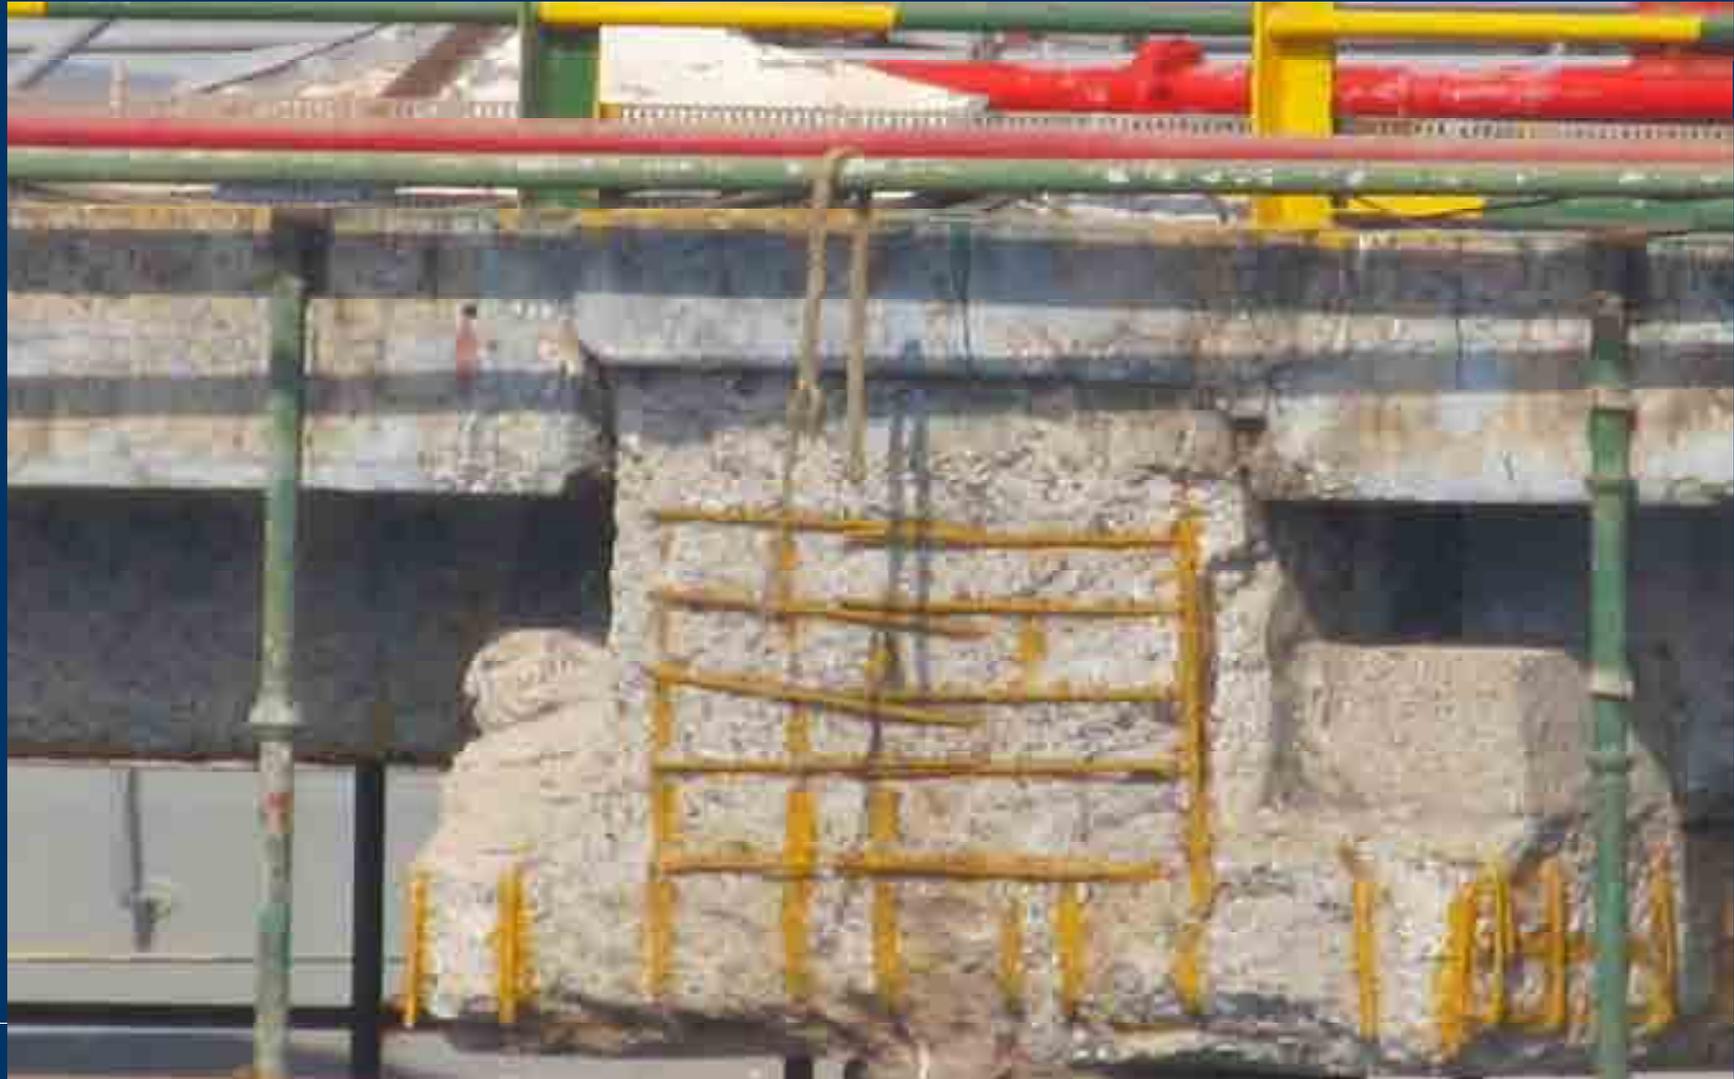
STEEL PROTECTIVE COATING OVER EXPOSED REINFORCEMENT

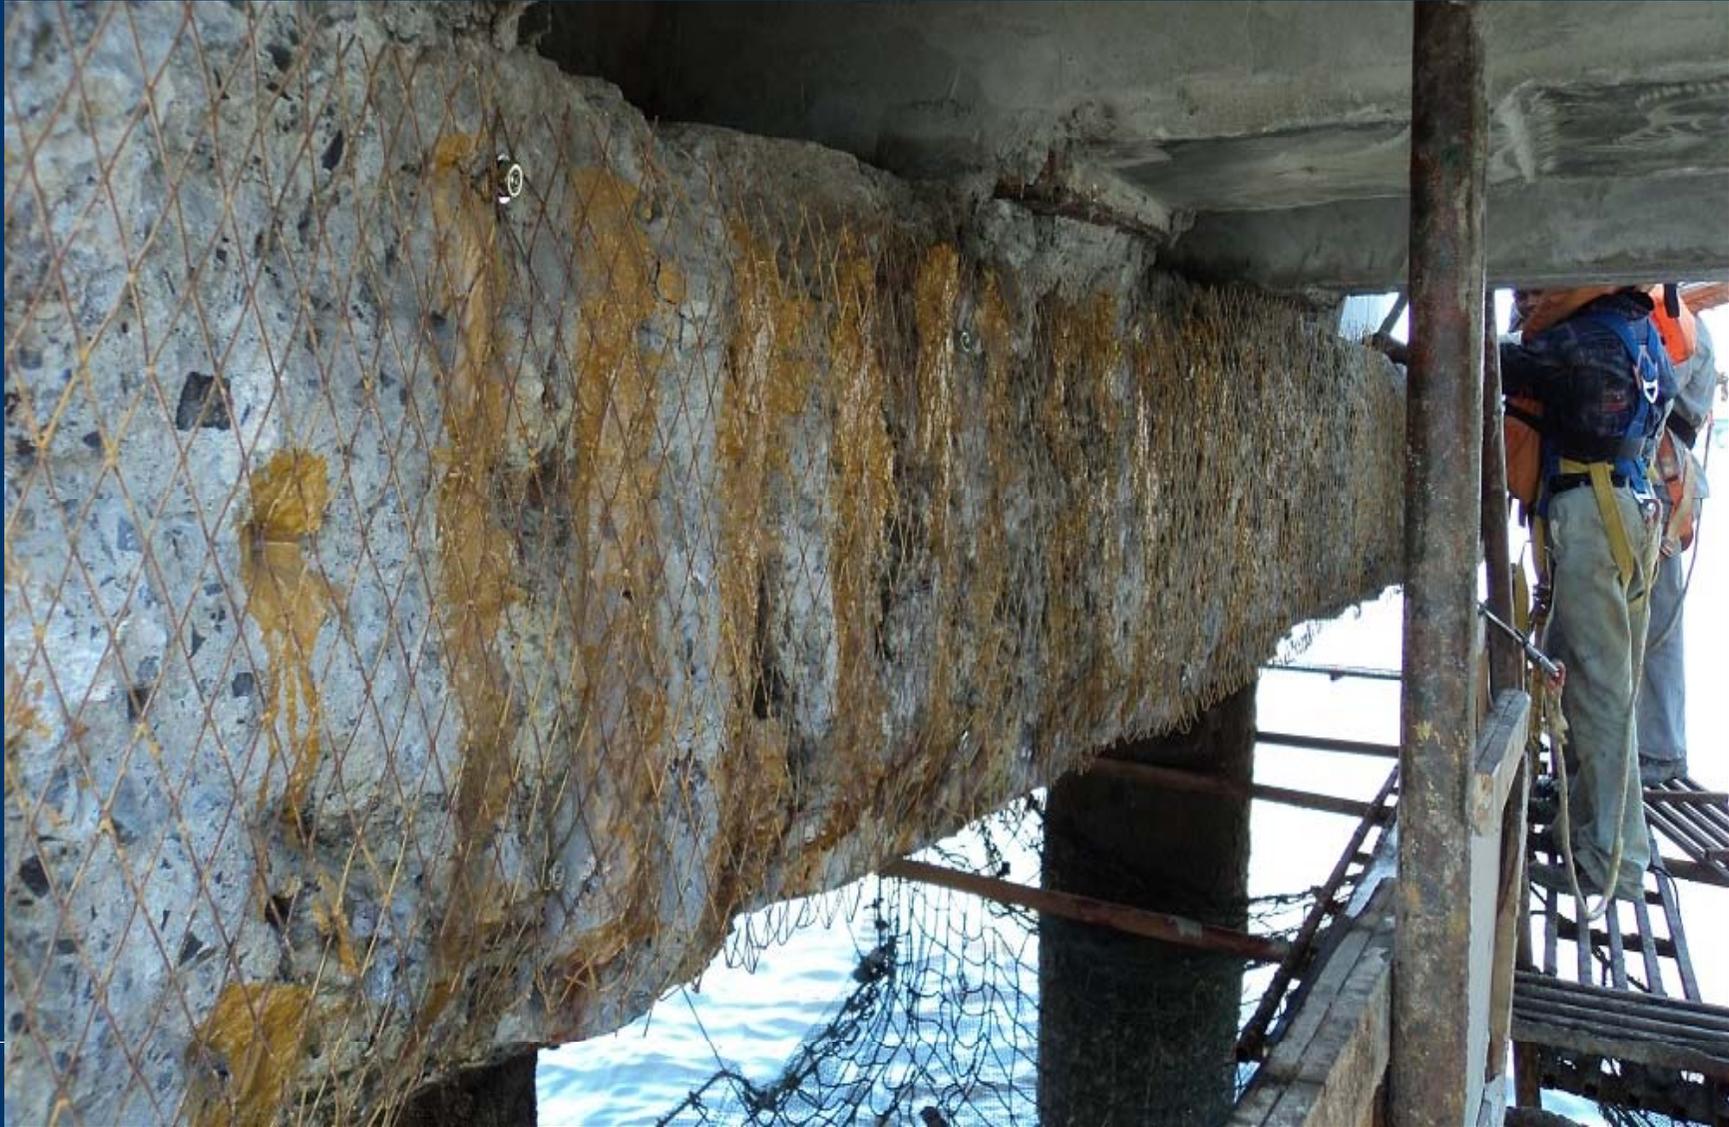
THERMAL REINFORCEMENT IN FORM OF MESH

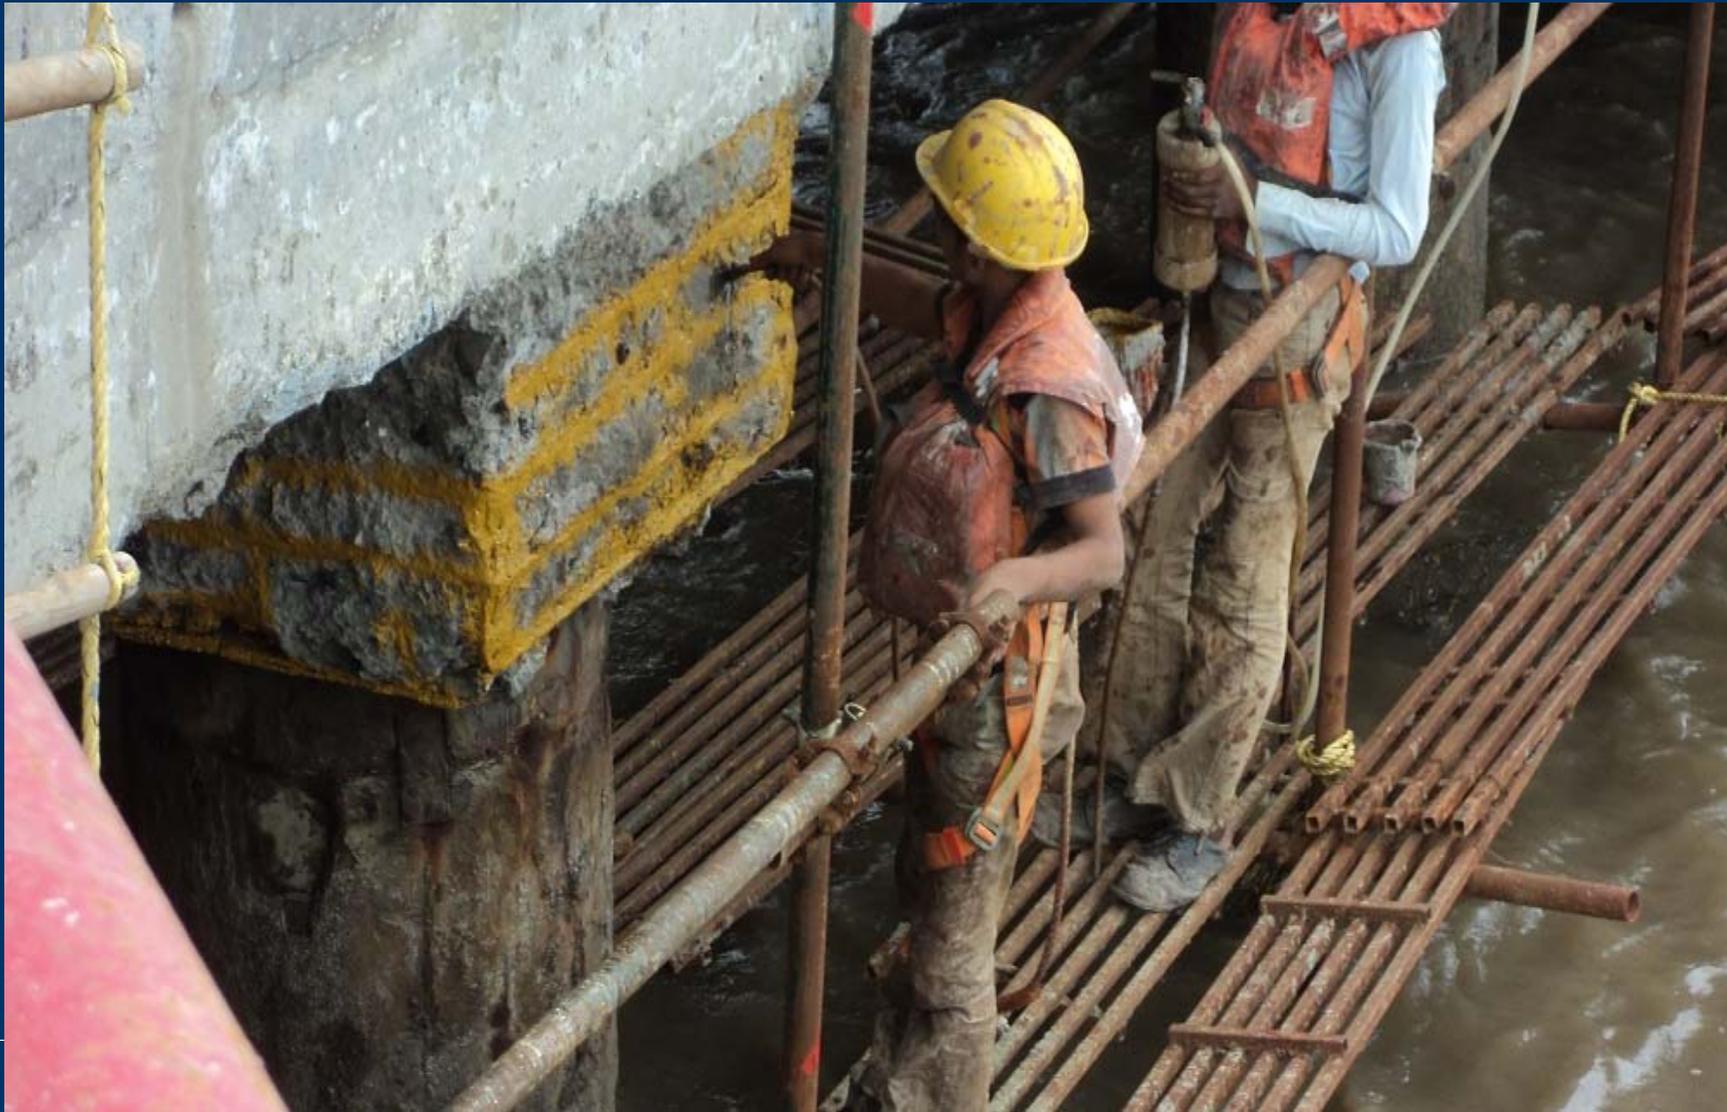
GROUTING WITH CORROSION INHIBITORS AND MMA GROUT

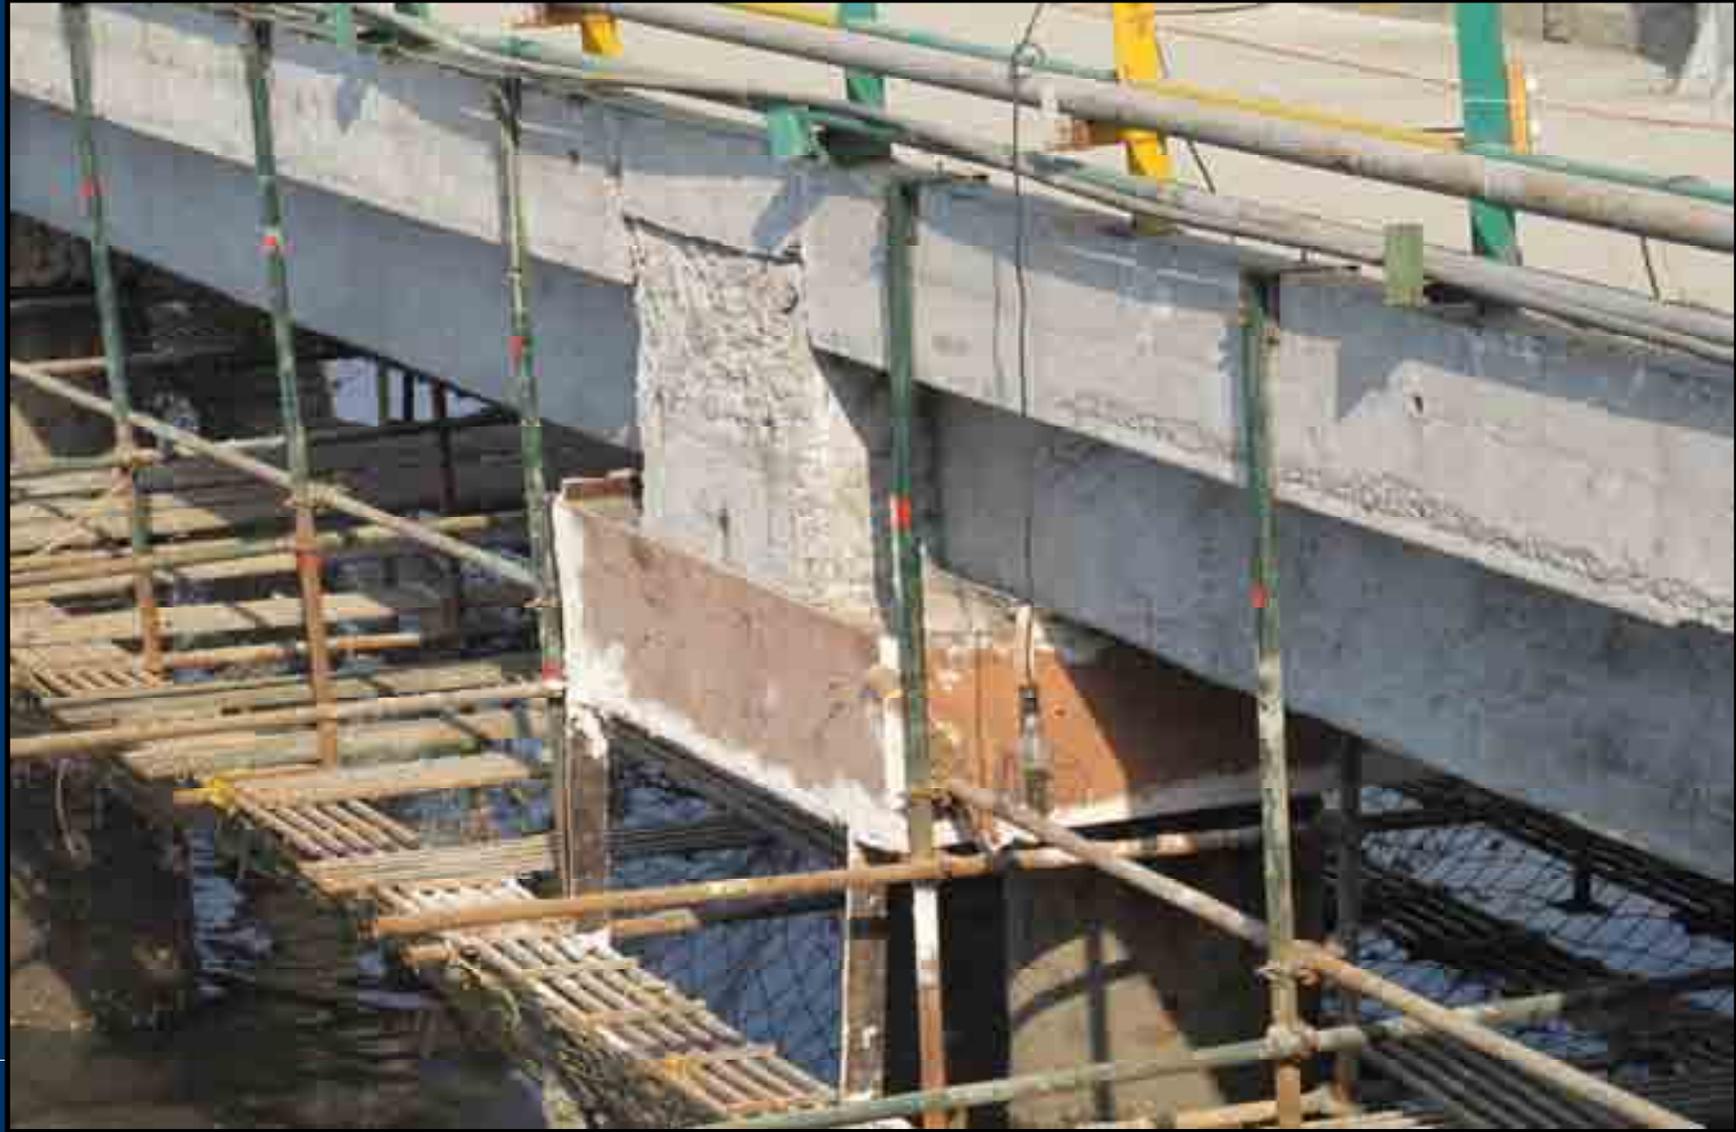
BUILDING UP DAMAGED CONCRETE SECTION WITH MICROCONCRETE

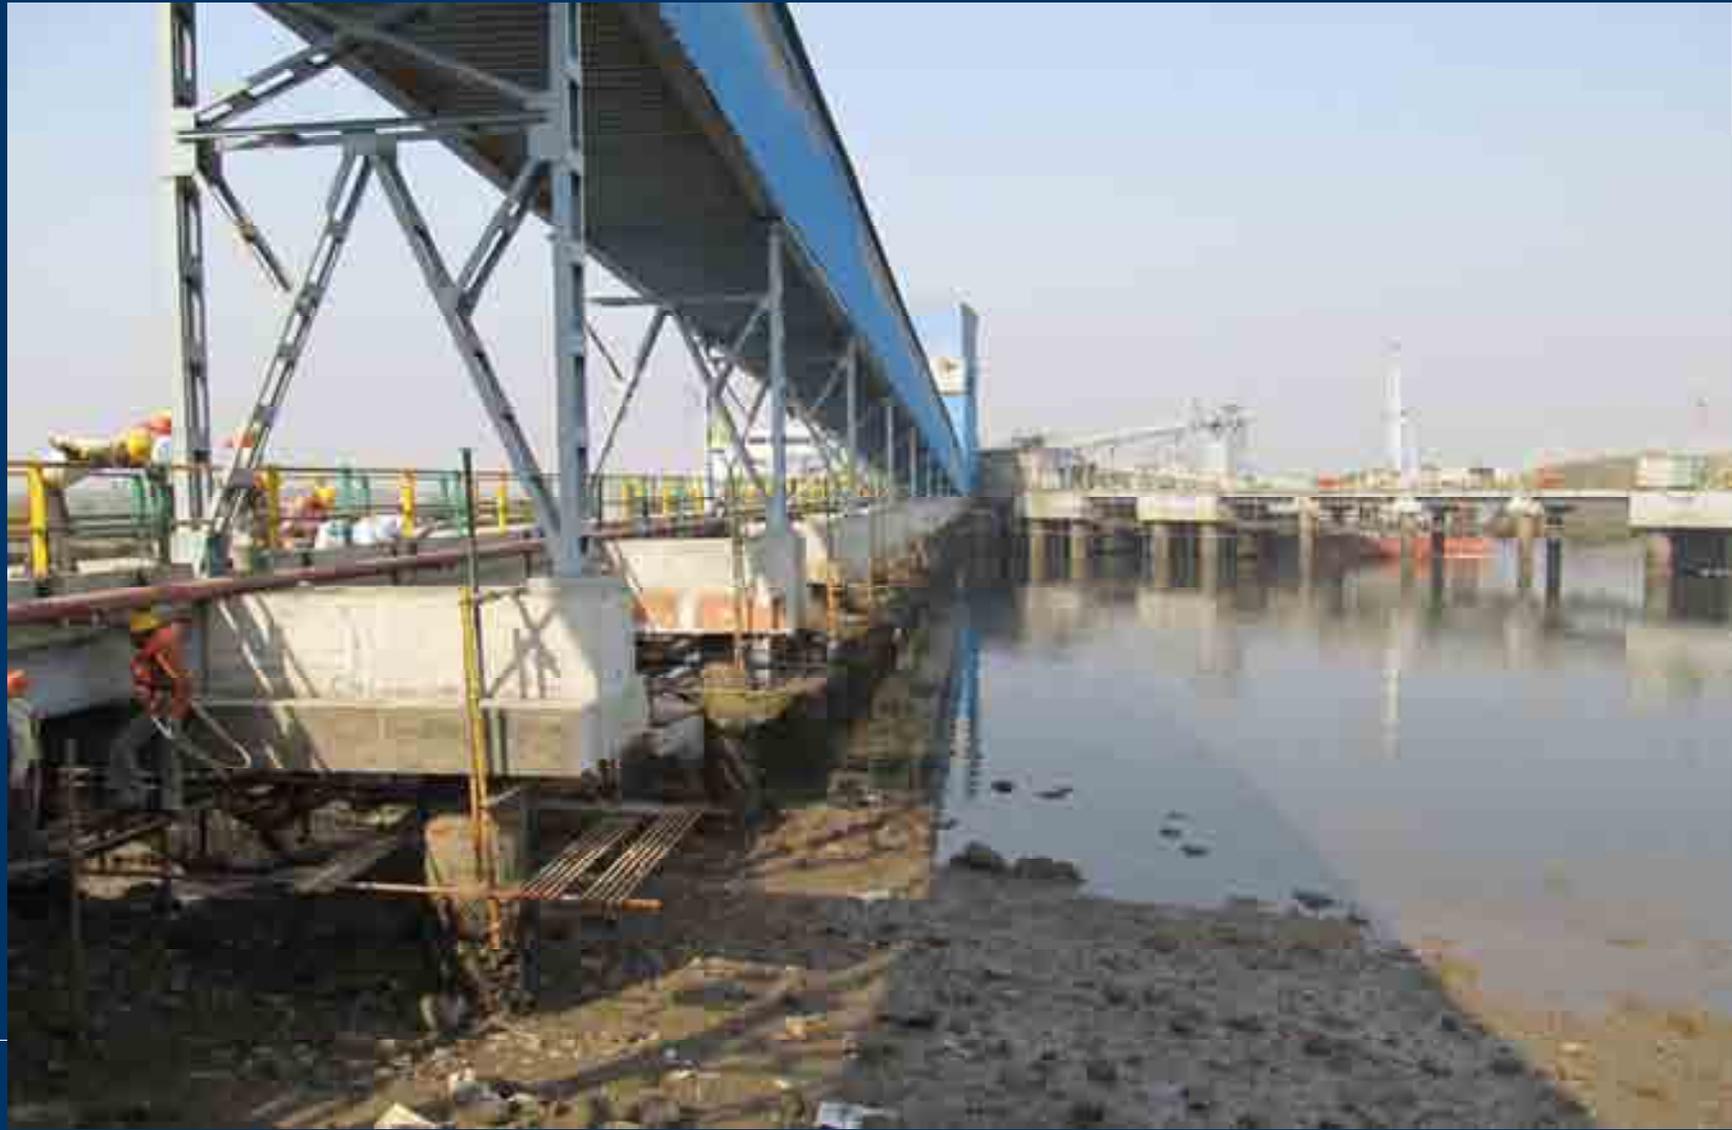
REPAIRED SECTION

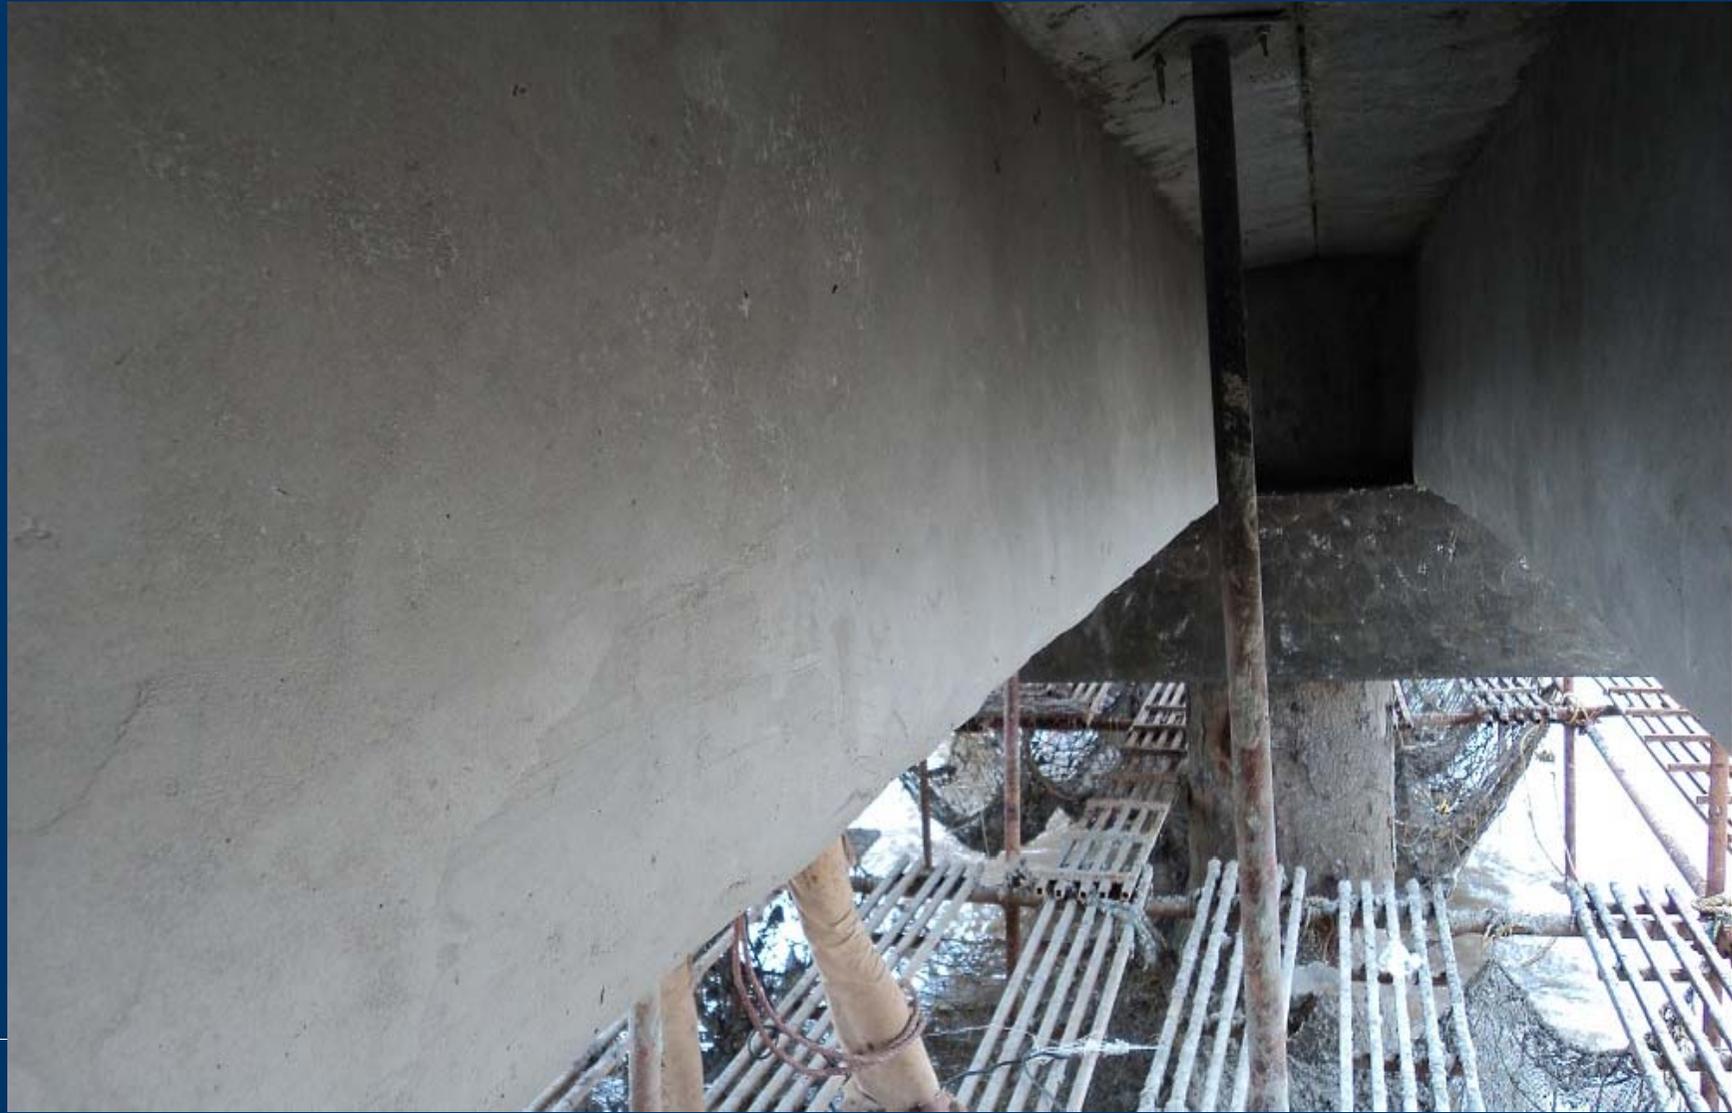
PATCHUP OF DAMAGED CONCRETE SECTION WITH STRUCTURAL GRADE MORTAR

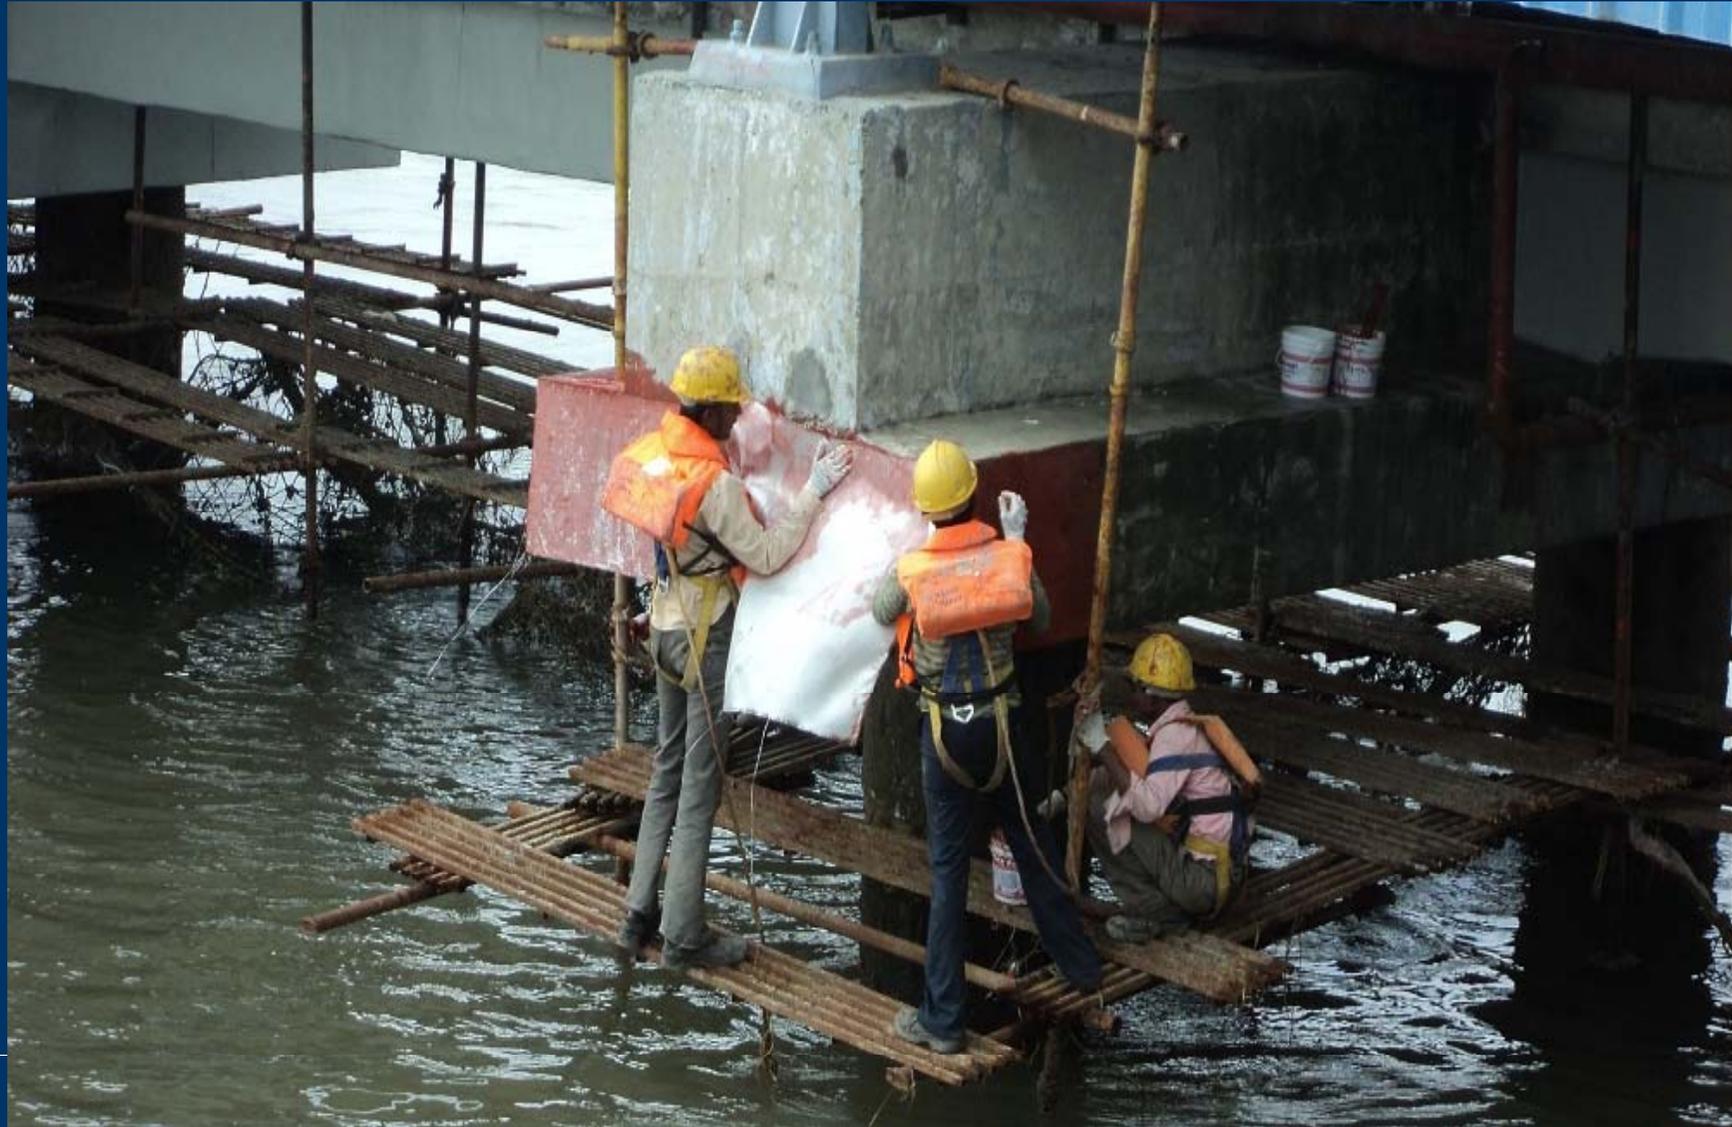
REINFORCING THE PILE BEAM WITH E-GLASS FIBRE WRAPPING

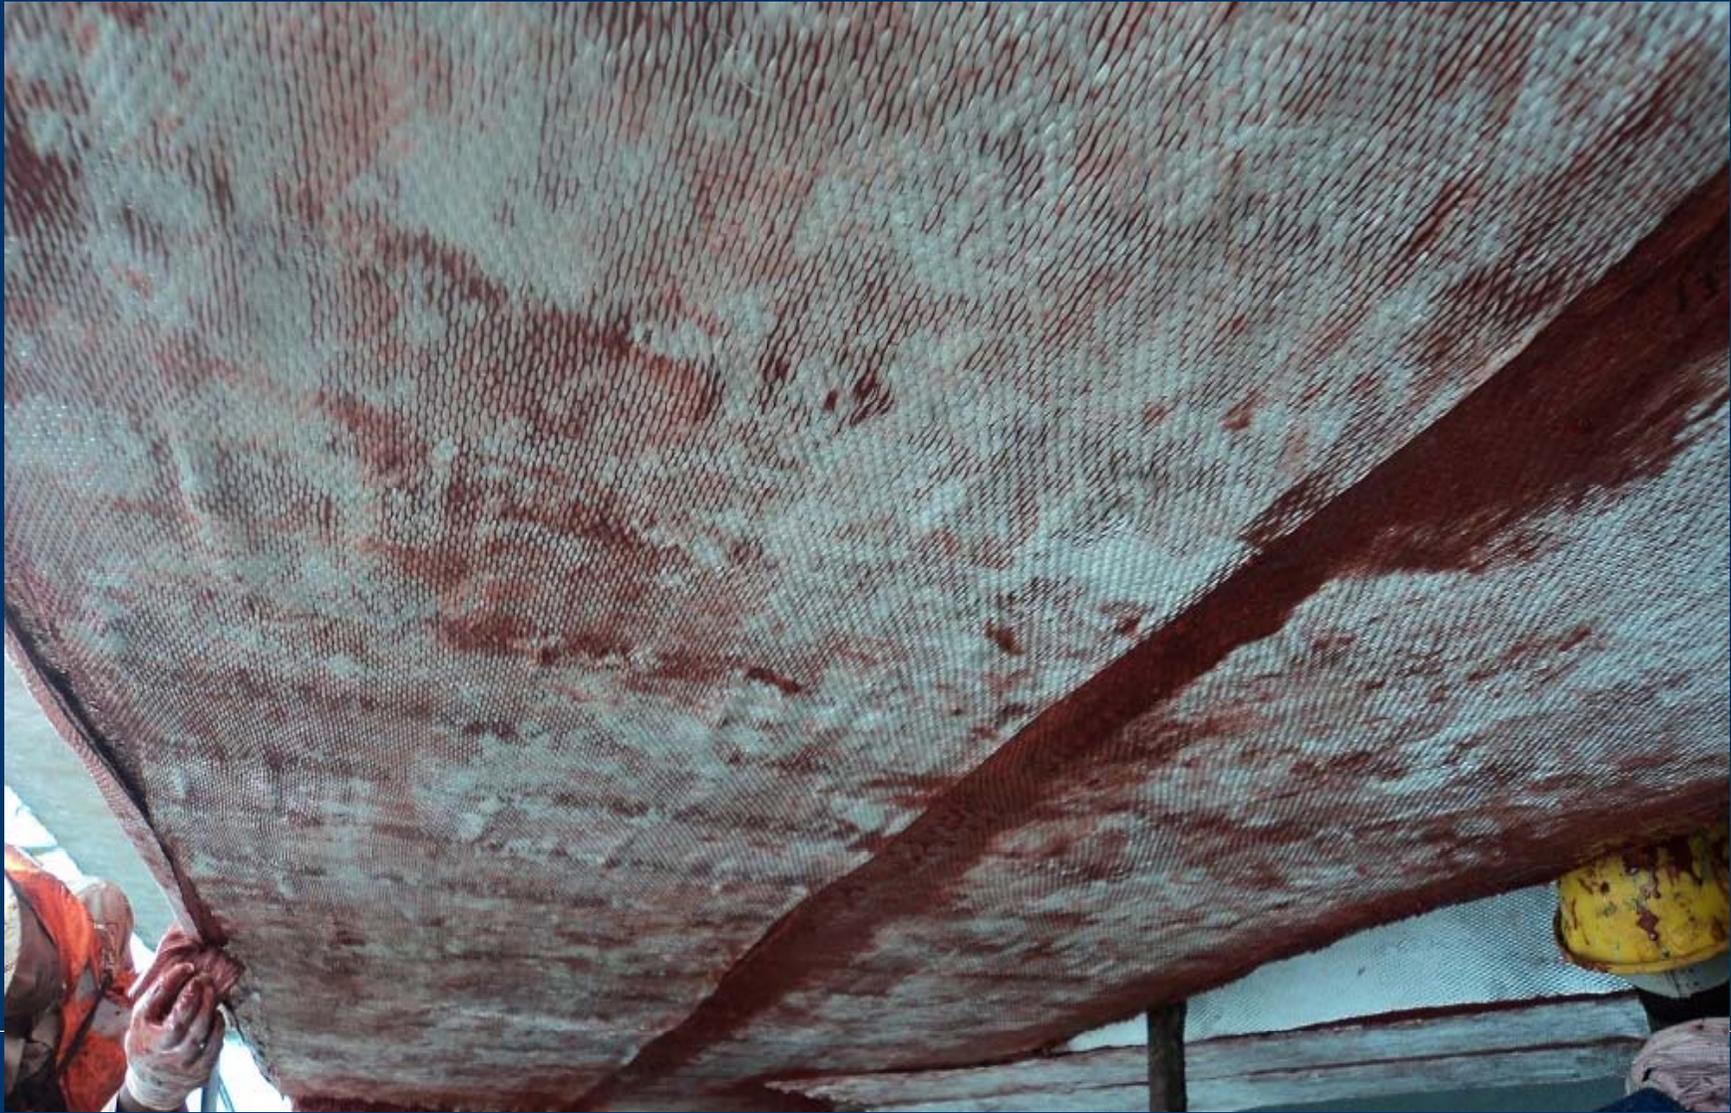
STRENGTHENING IN FLEXURE

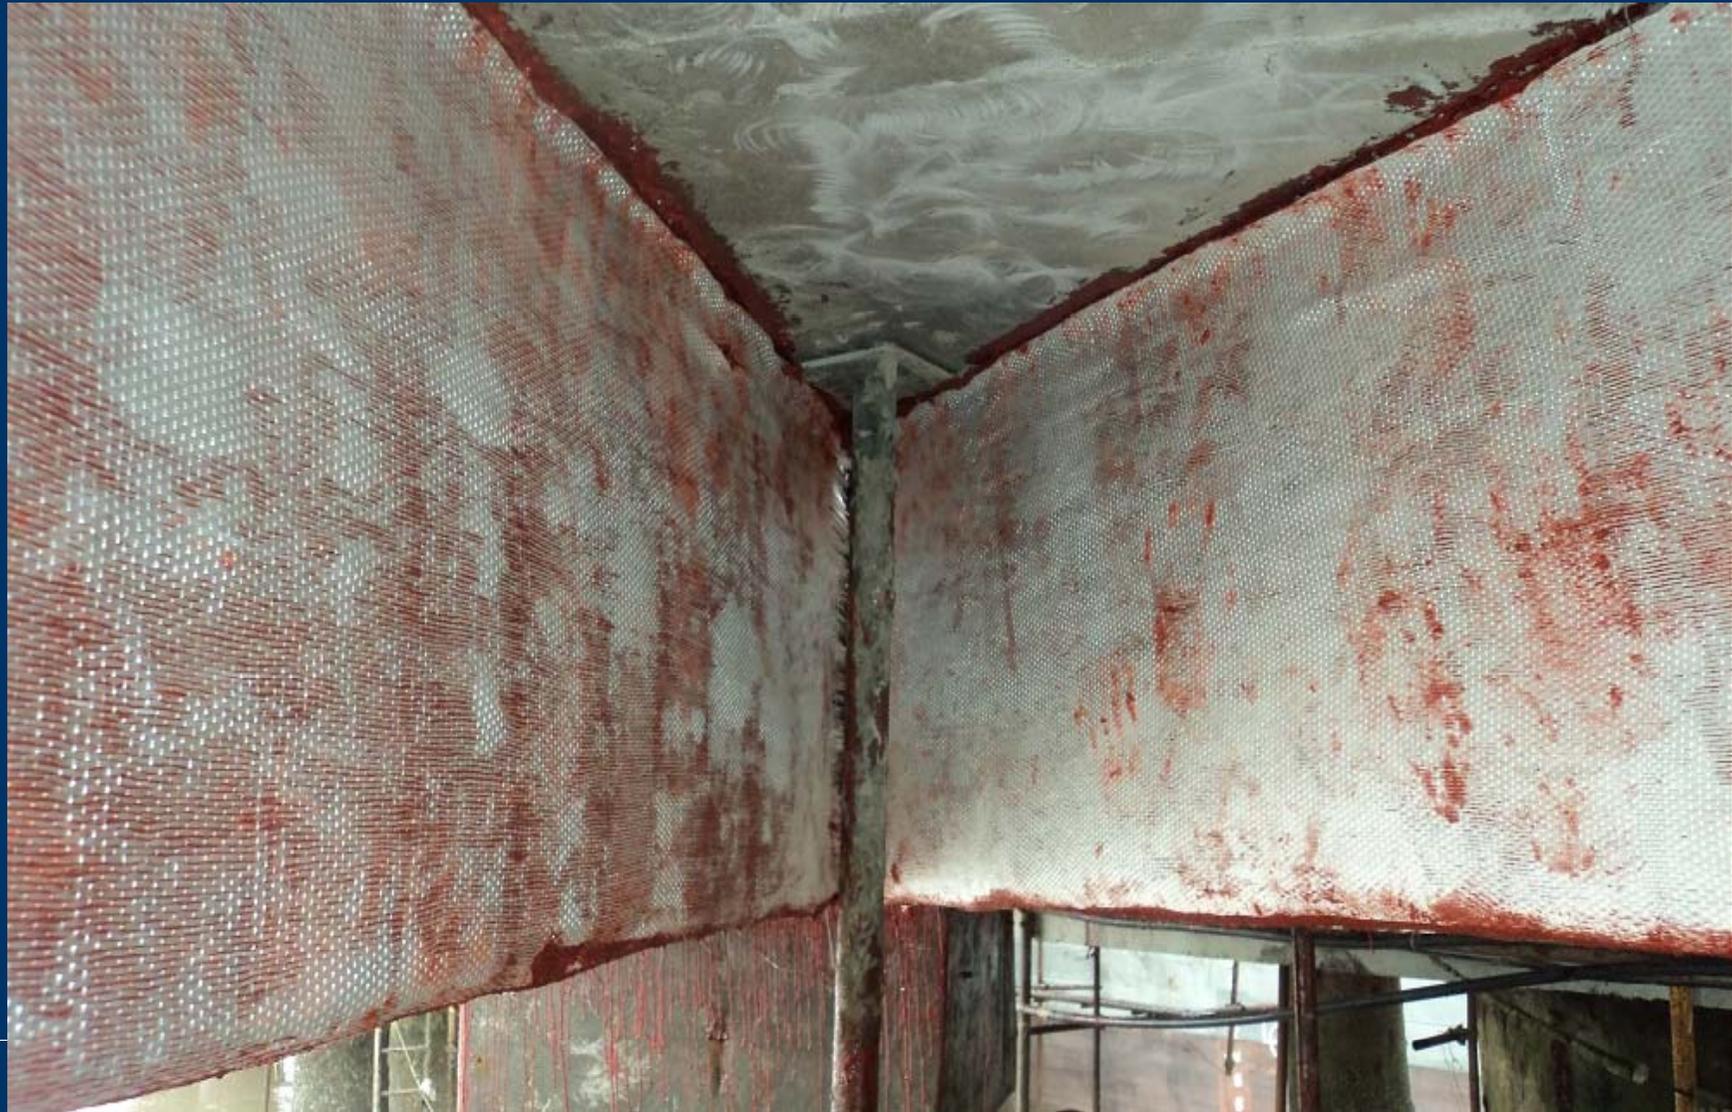
STRENGTHENING IN SHEAR

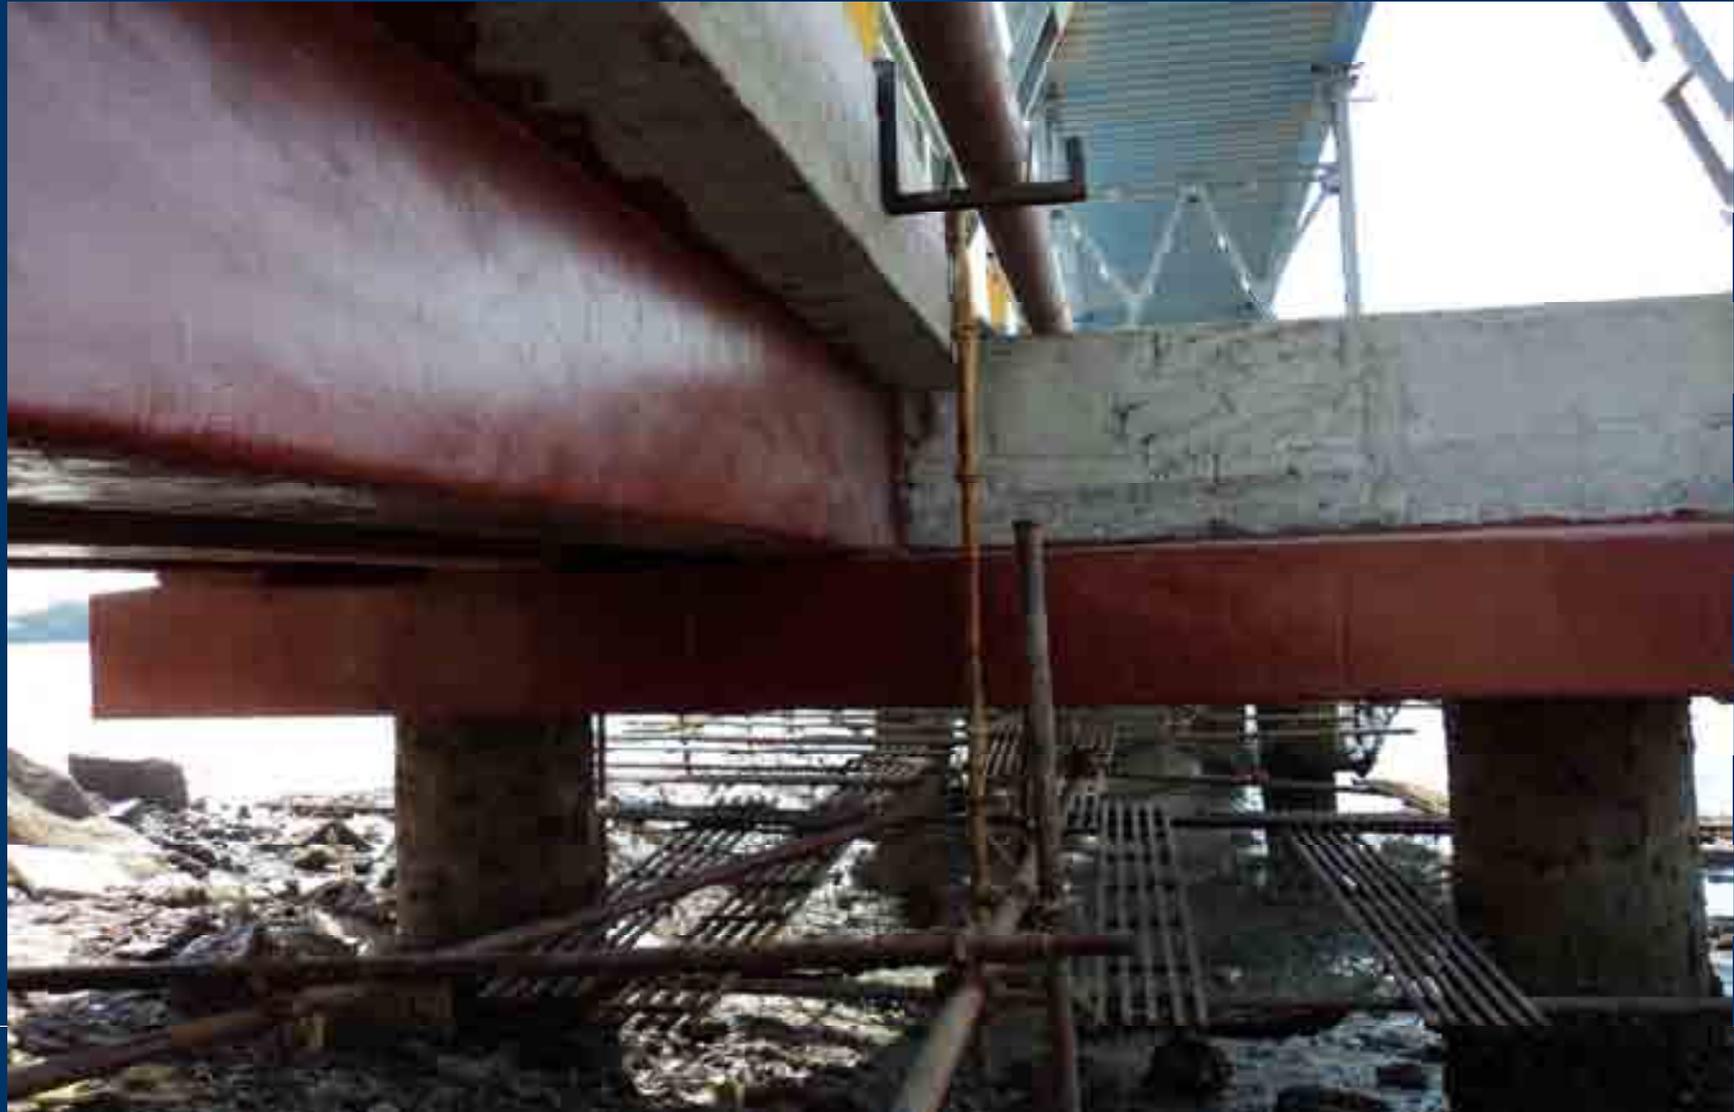
STRENGTHENED SLAB, T-BEAM, PILE BEAM & PILE CAP
