SDMC Training Programme

Retrofitting Techniques of Existing Buildings

Reinforced Concrete Structures

CSIR-Central Building Research Institute, Roorkee (India)

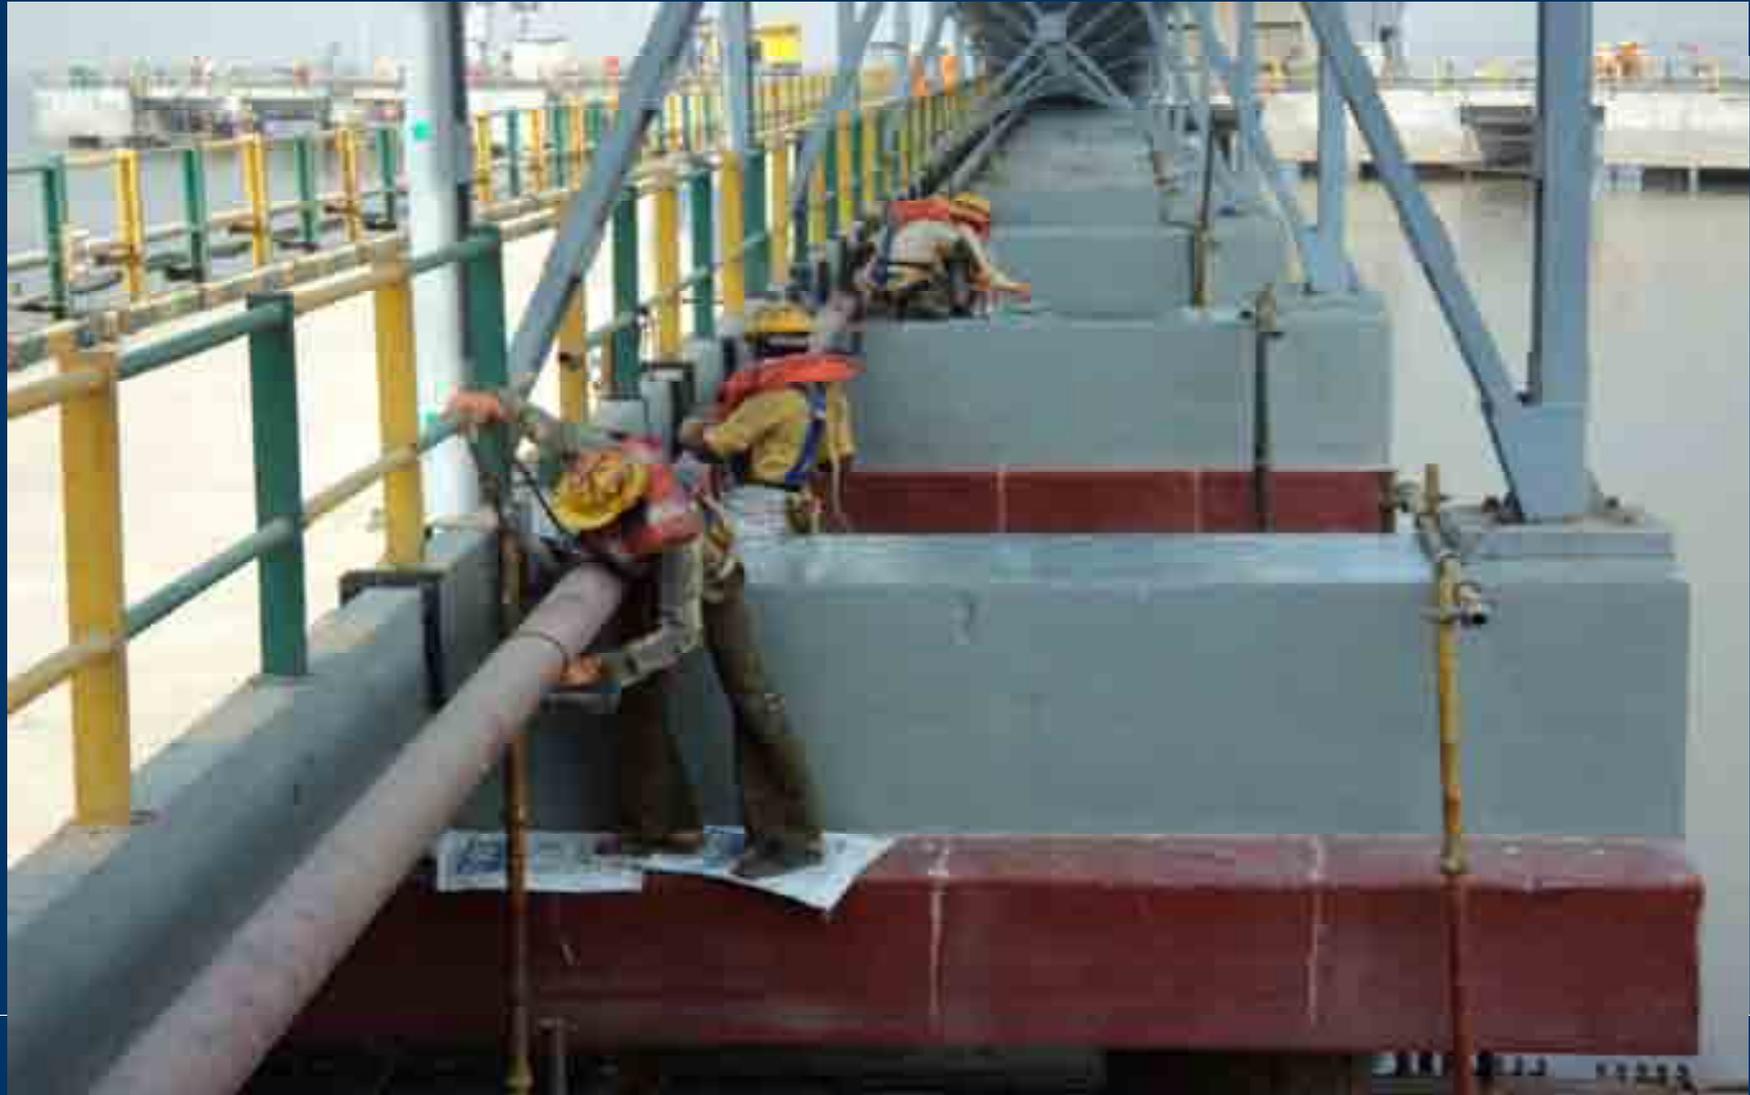
PROTECTIVE COATING IN PROGRESS
