Earthquake Safety and the Indian Subcontinent

SAARC Disaster Management Centre

18 September 2017

Sudhir K Jain

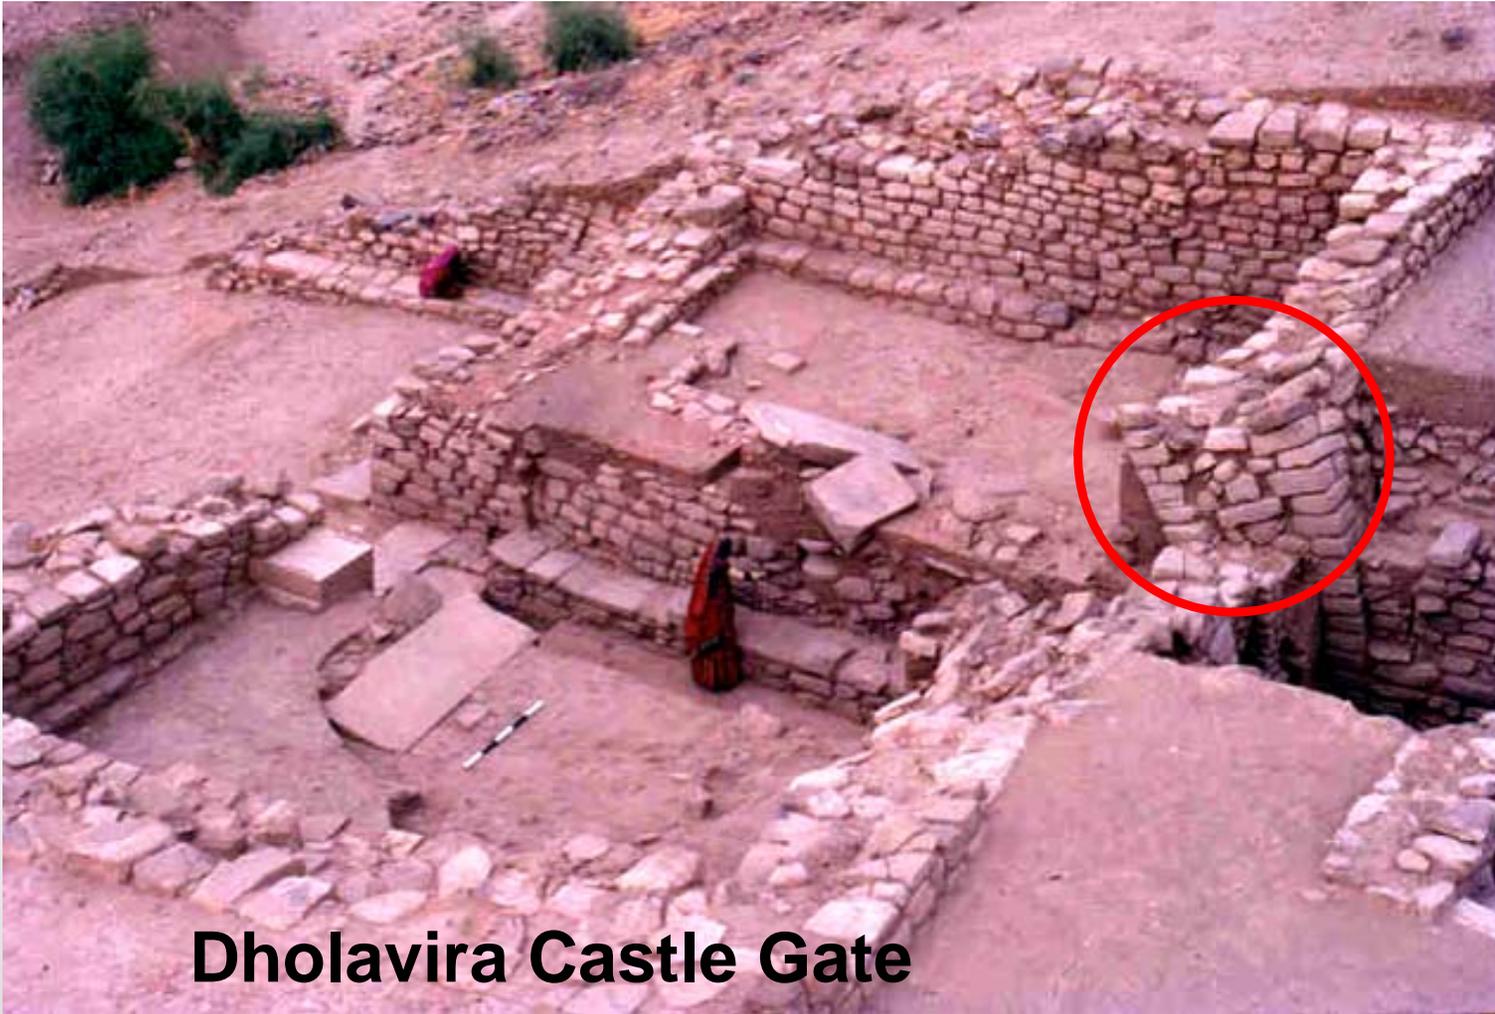
Tilting of walls
indicating an
earthquake

Dholavira Castle Gate

Harrappan site in Kutch (2500 BCE)

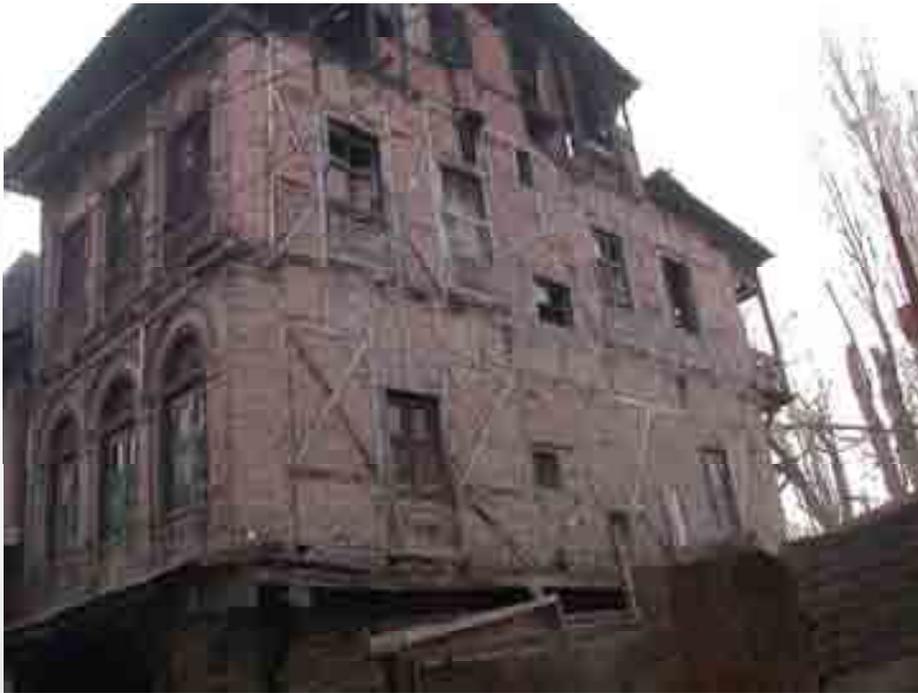
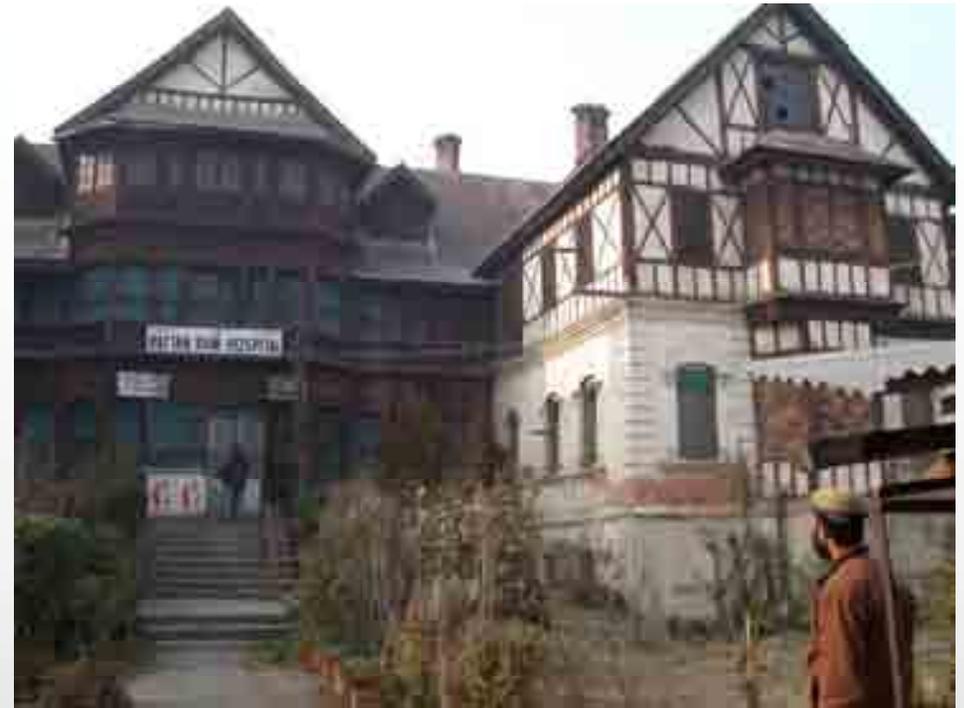
***Dhajji Diwari* construction in Srinagar area, Kashmir**
Patchwork of brick panels confined by timber members

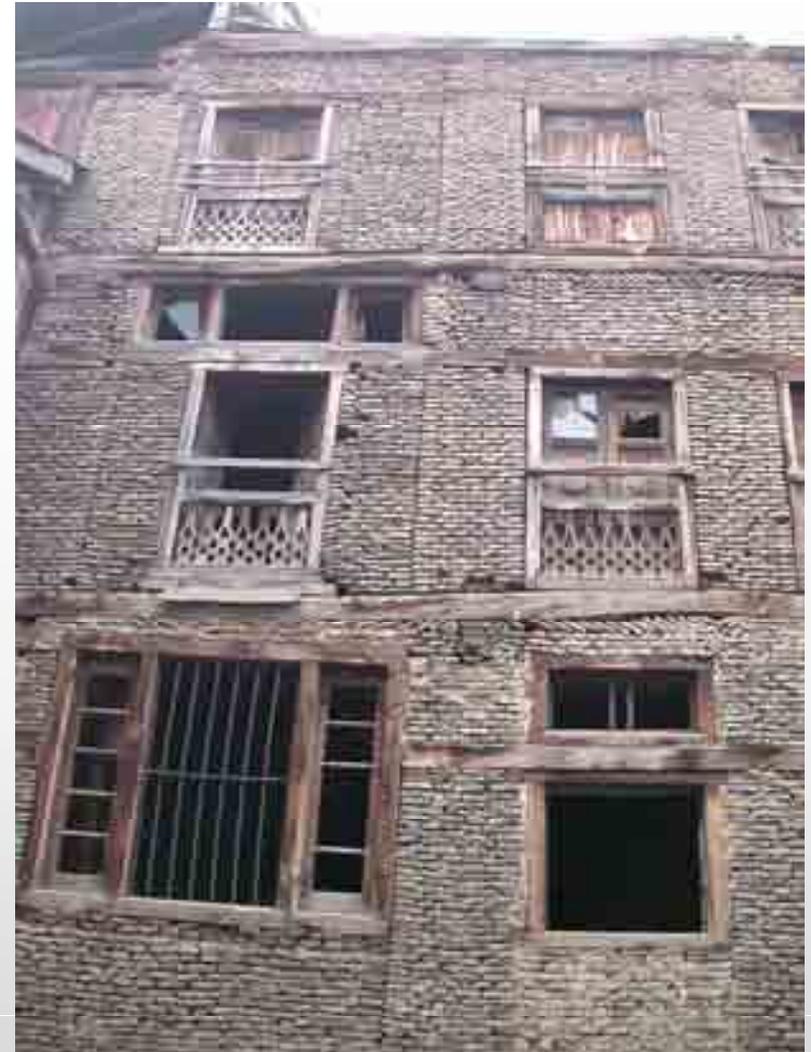
- Taq constructions in Kashmir
- Large wood horizontal runners embedded in masonry walls
 - Improves the lateral load resistance of the building

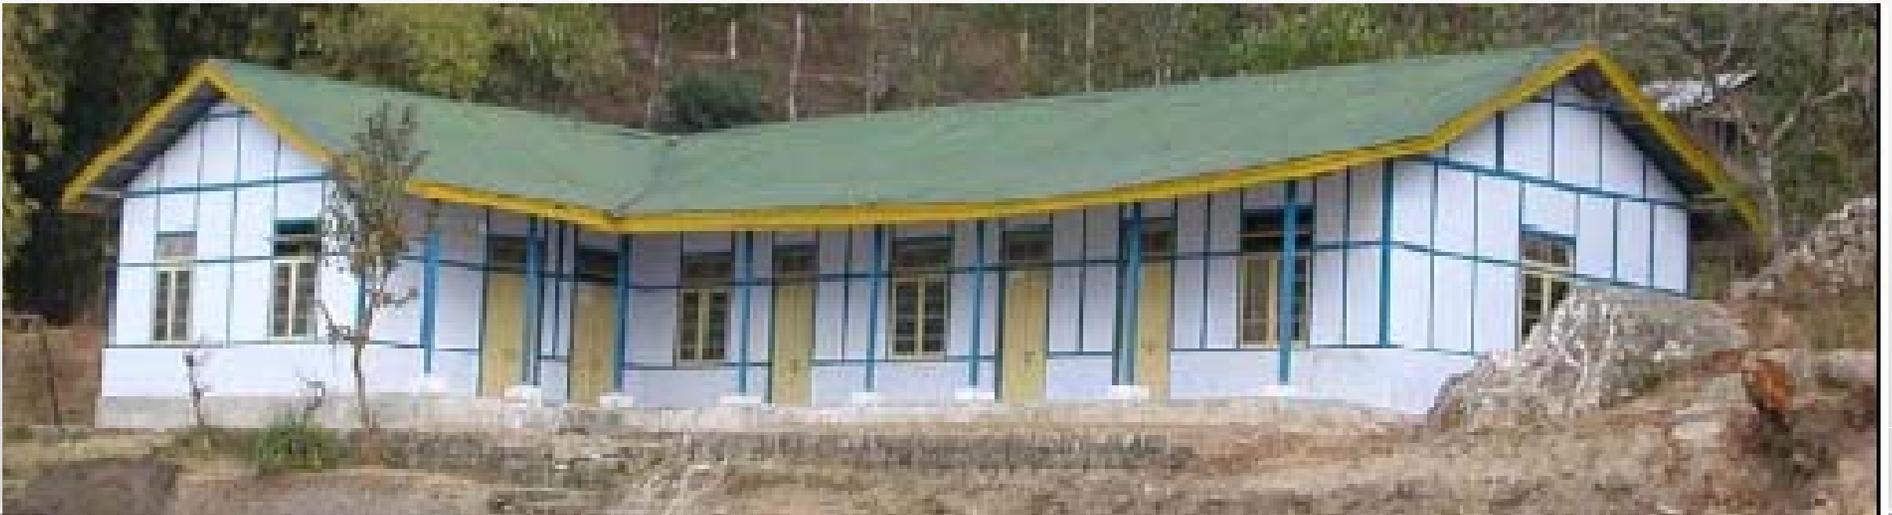
Assam Type House

- Developed after 1897 earthquake in Assam
- Became prevalent in the entire north-eastern India
 - Infills of Ikra panels made of local reeds caked in mud
 - Timber confining members
 - Lightweight roof, and no stone chimneys
- Currently being replaced by poorly-constructed RC and masonry buildings

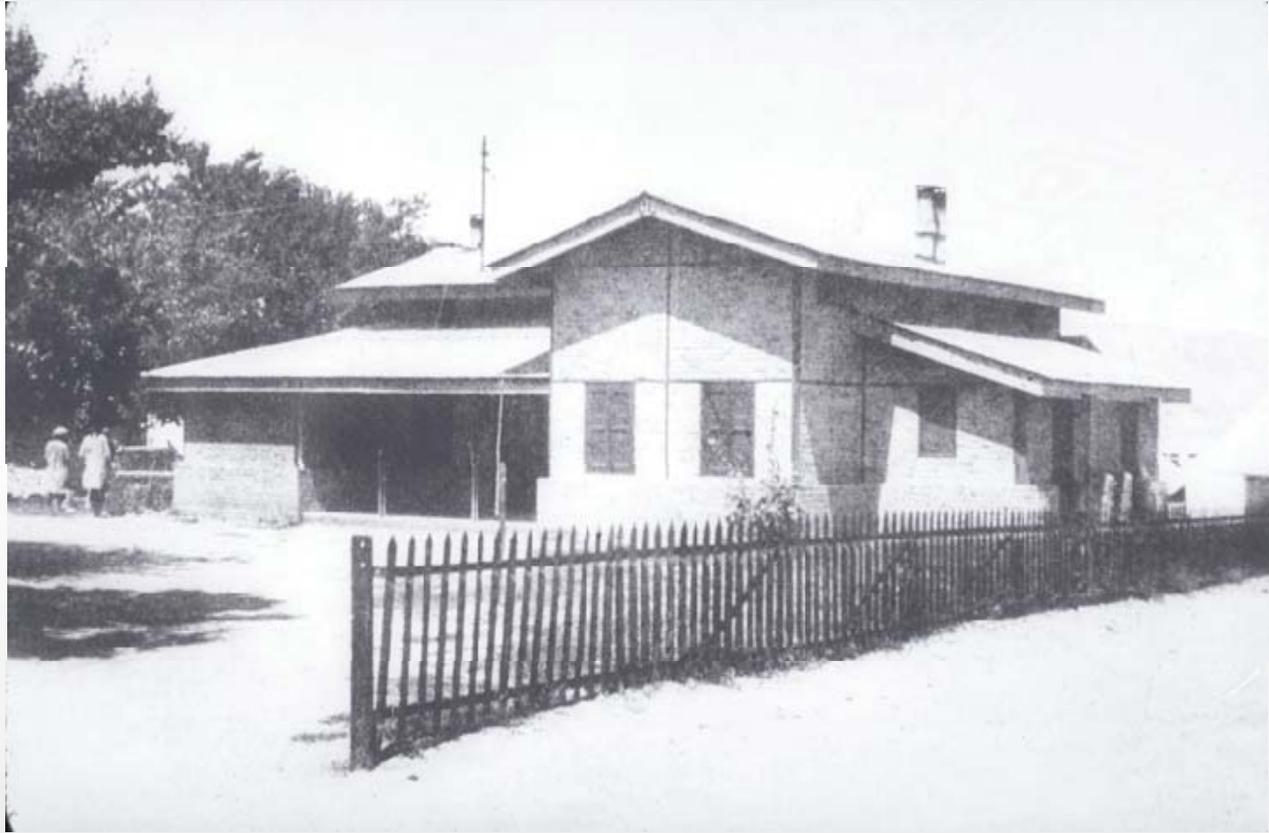
Six bungalows constructed by Kumar

Brick walls braced with vertical and horizontal iron rails

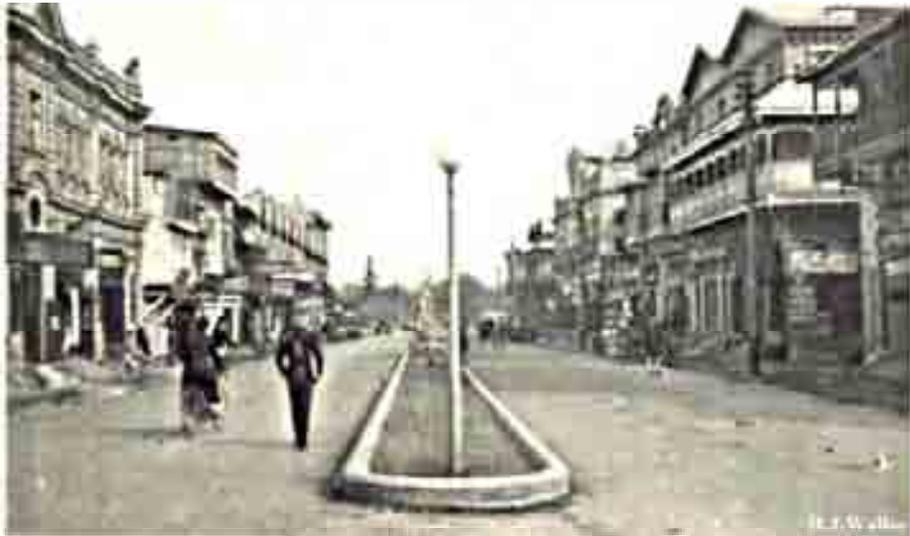
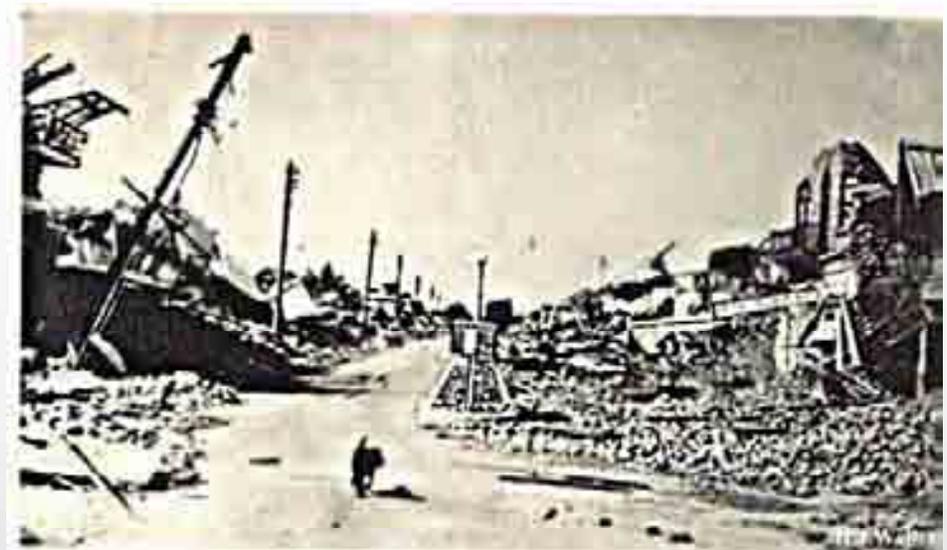
- 1935 Quetta earthquake
 - M7.6; max intensity X;
 - 20,000 to 30,000 persons killed (~ 40-50% population)

- **Exemplary performance of Railway quarters designed by Kumar**

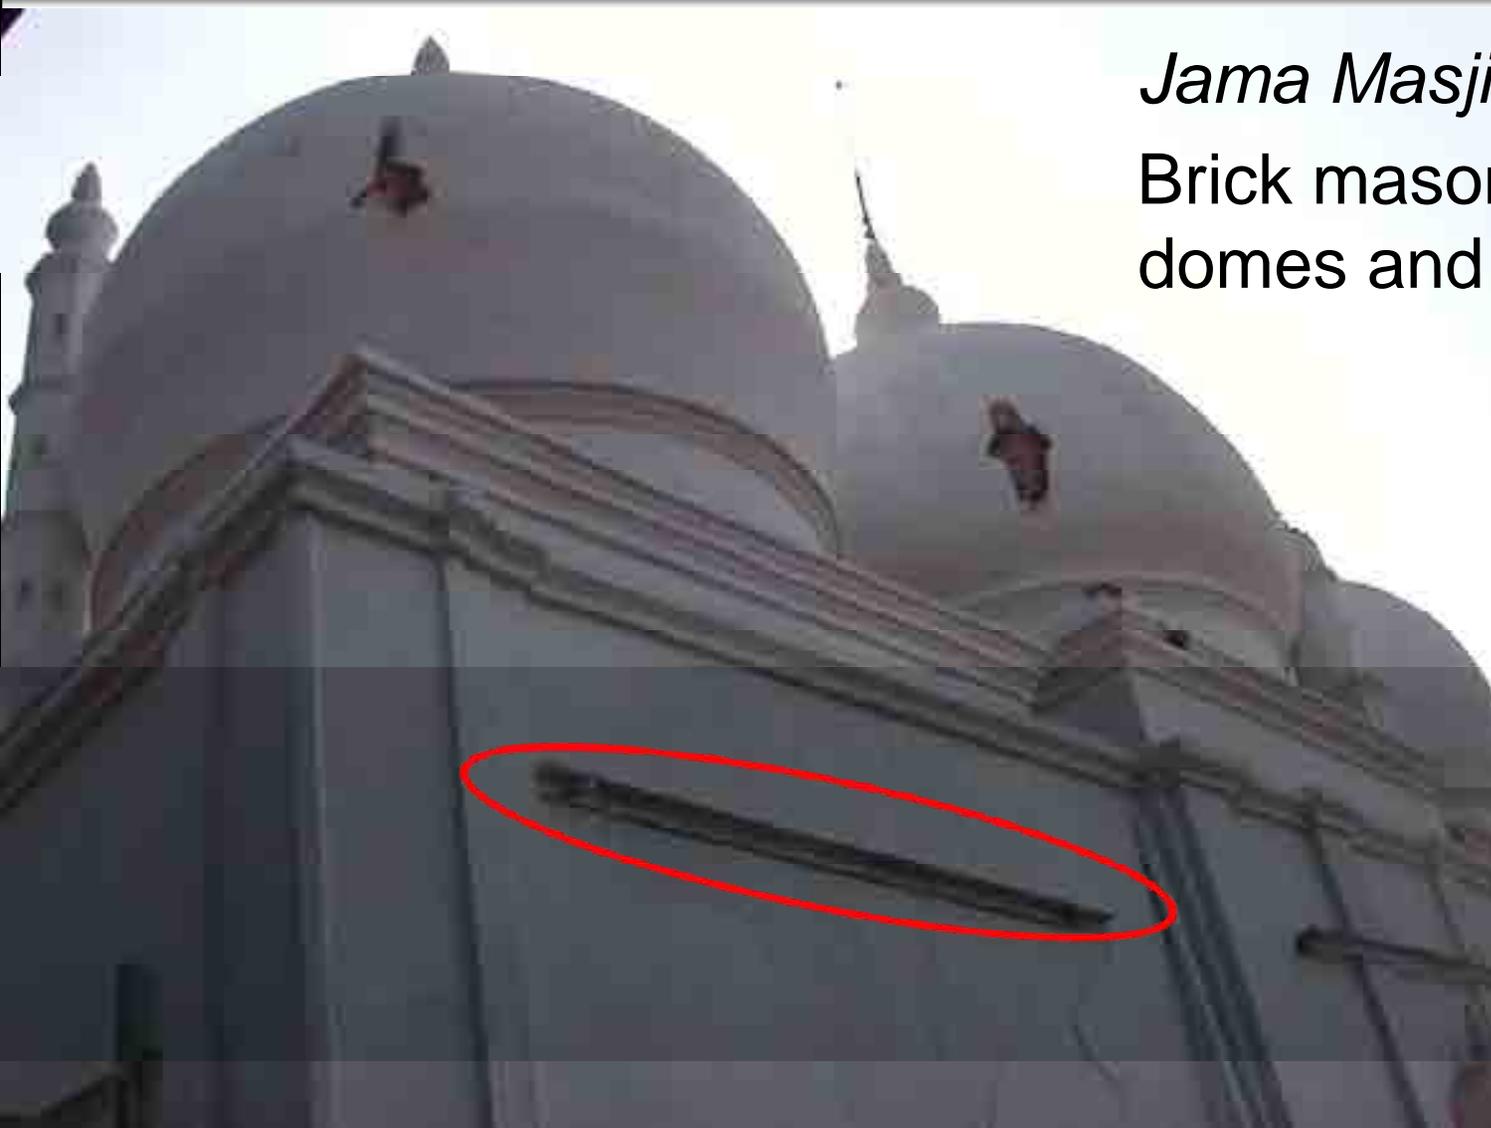
Jama Masjid in Port Blair
Brick masonry with arches,
domes and minarets

**Iron angle for
anchoring the tie
rods**

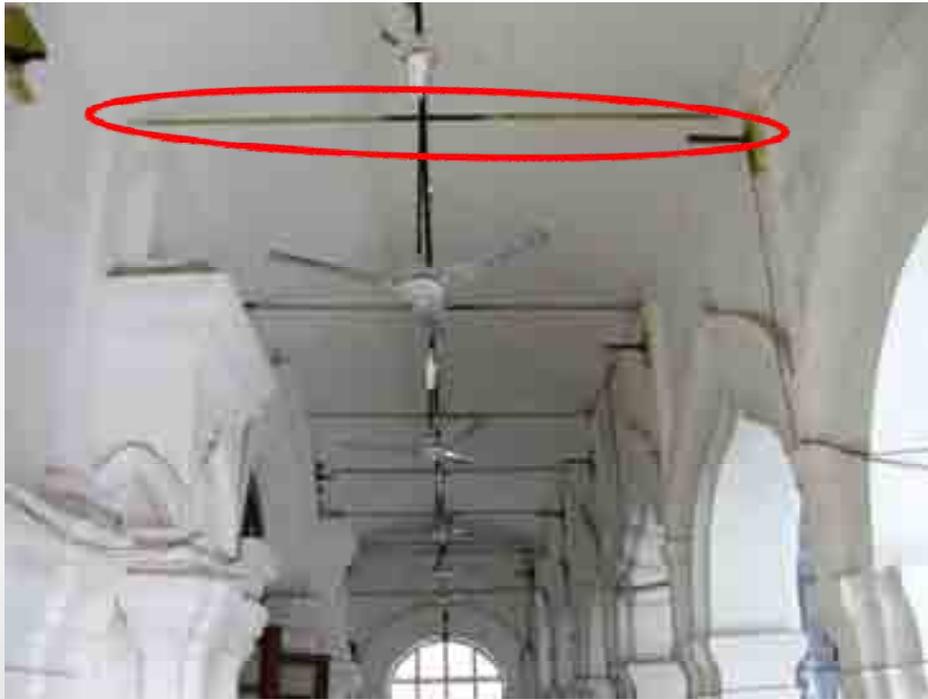
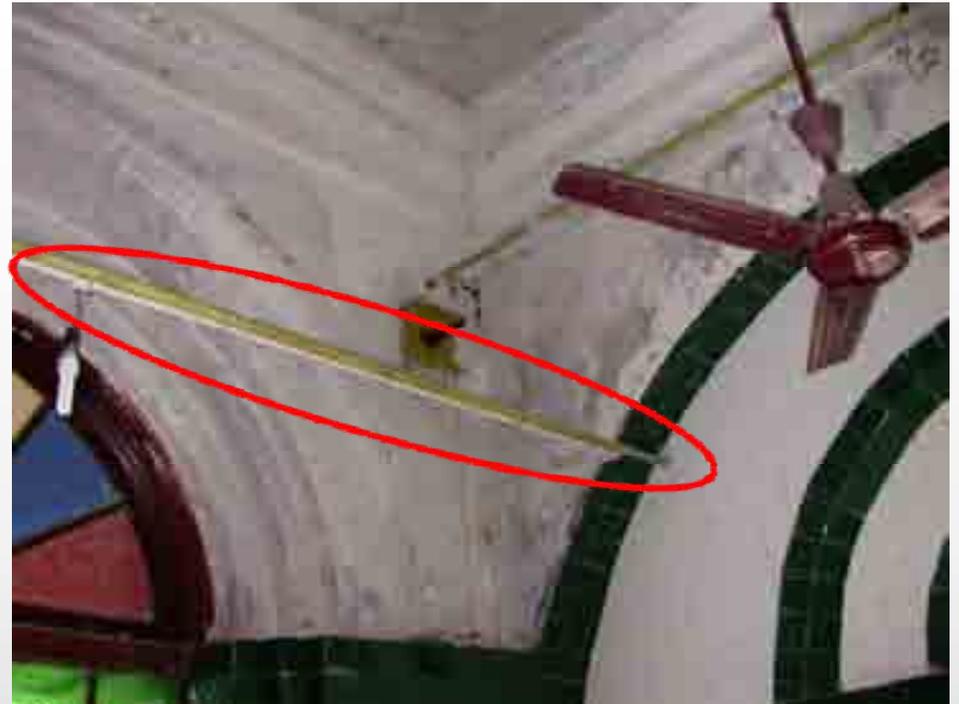
Tie-rods placed in both directions

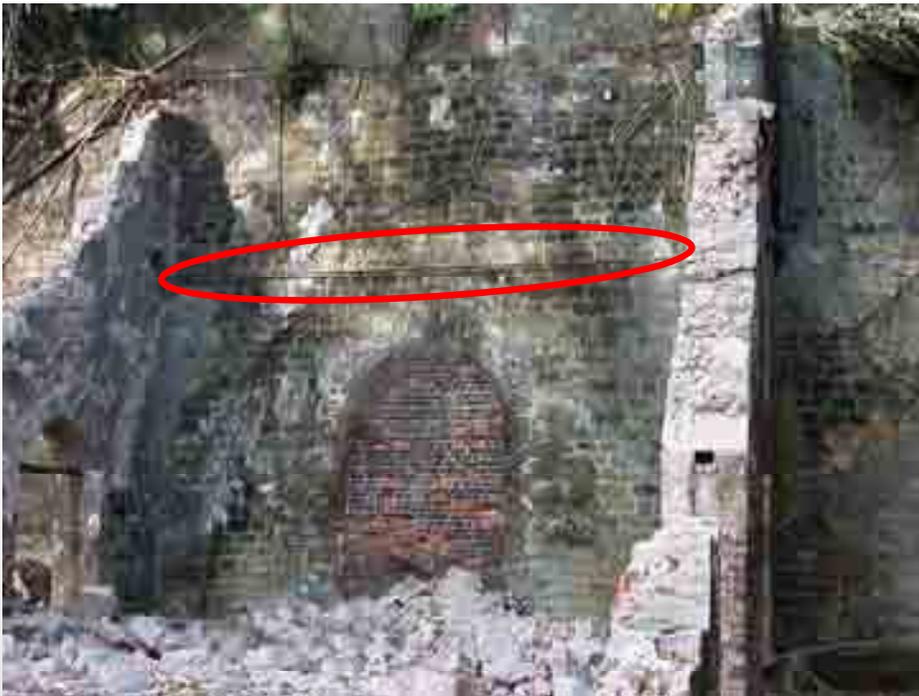
Tie rods in church ruins

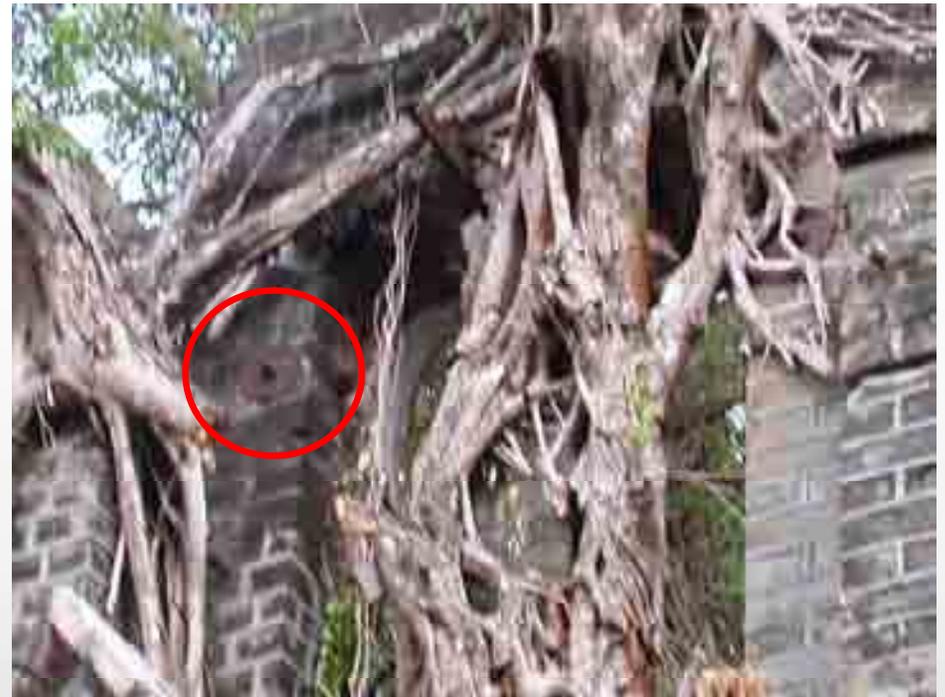
Anchor bolts

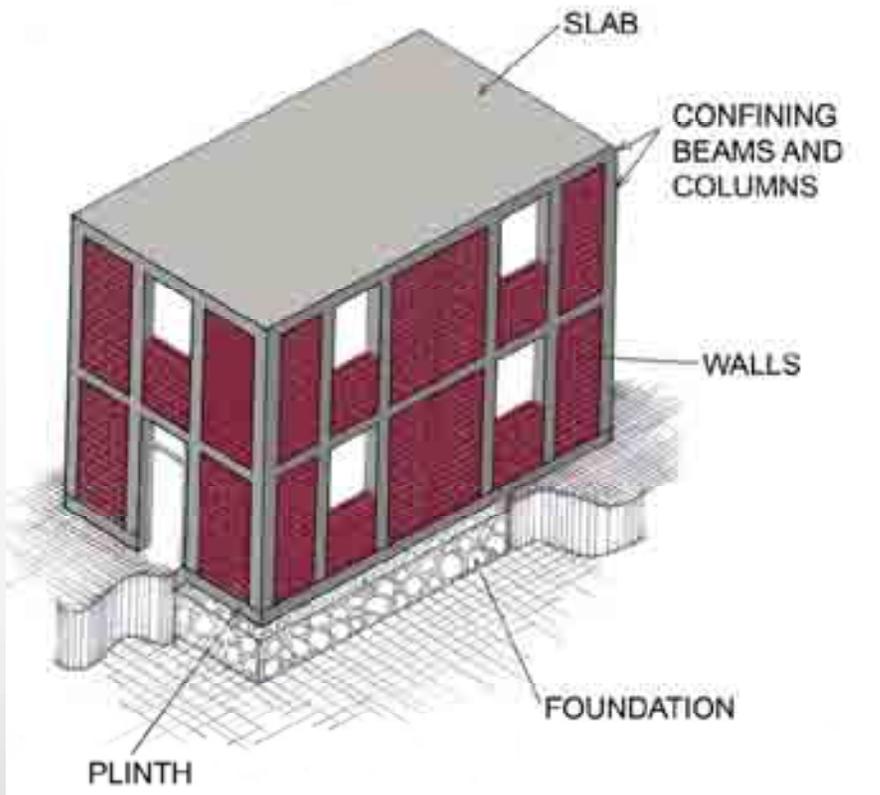
- Proven record of good seismic performance
 - Excellent features for seismic areas
 - Close to traditional construction practices
 - Masonry construction, and
 - RC frame buildings
 - Low in engineering intricacies
- Efforts in last 10 years to propagate in India

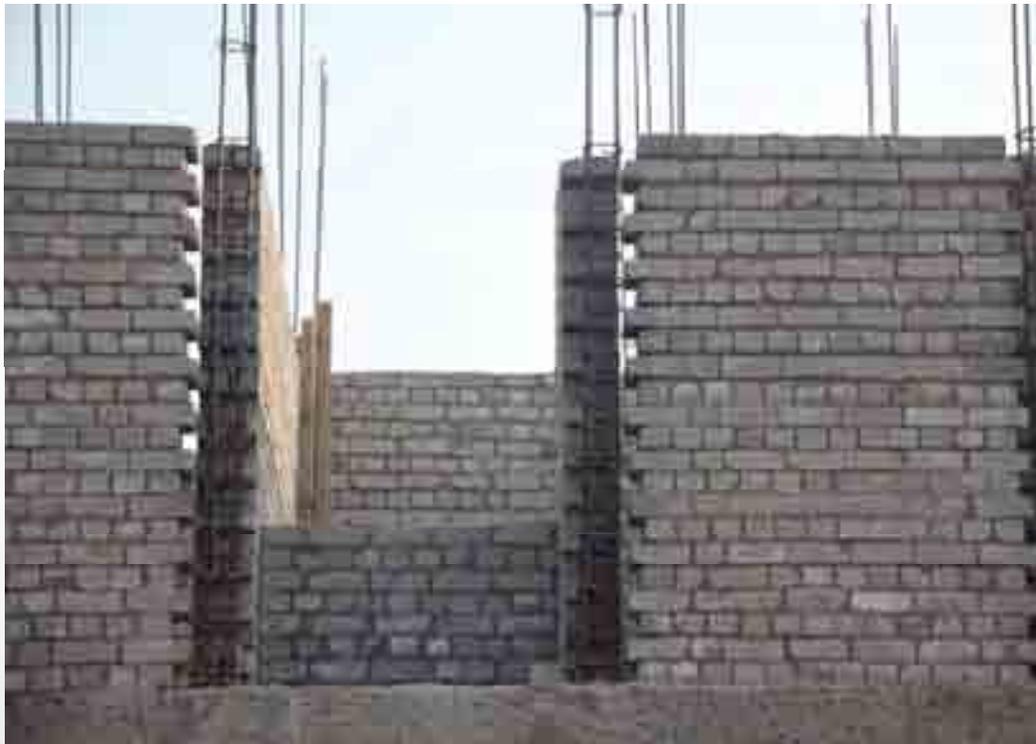
- 400 acre campus
- Student hostels and faculty apartments in confined masonry
 - Small size rooms
 - High wall density
 - 3 and 4 storey
 - 10-15% cost savings over RC frames

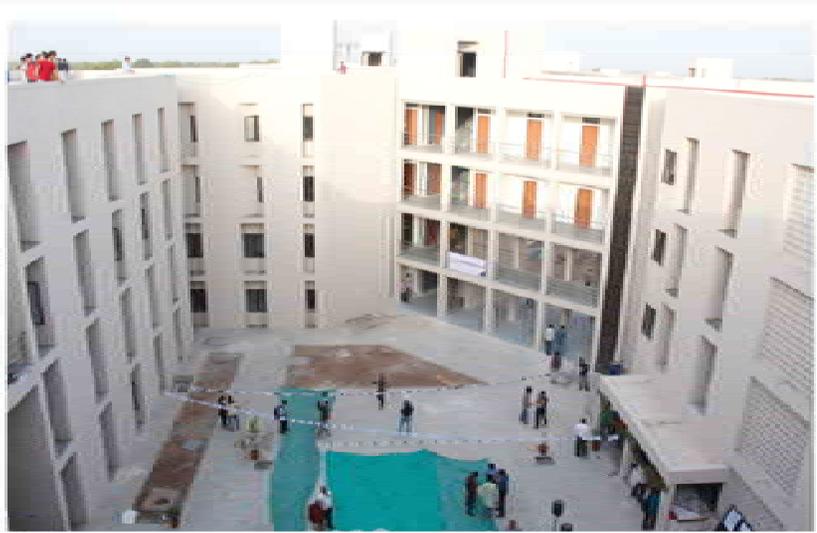
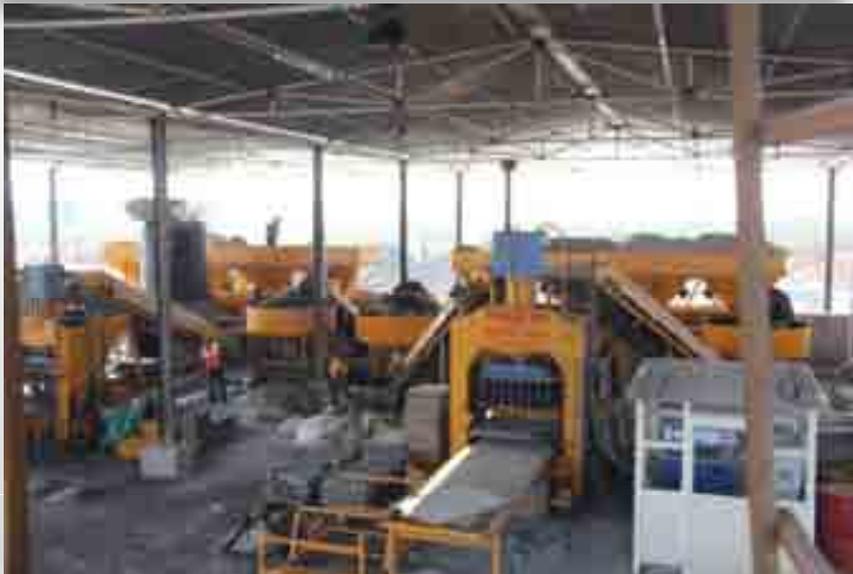
- First large-scale application in India
- Design challenges
 - Architects/structural design team not familiar
 - Many debates about process and provisions
- Construction challenges
 - High strength bricks in large quantity
 - Manufacturing plant for Fly Ash Lime Gypsum bricks at site

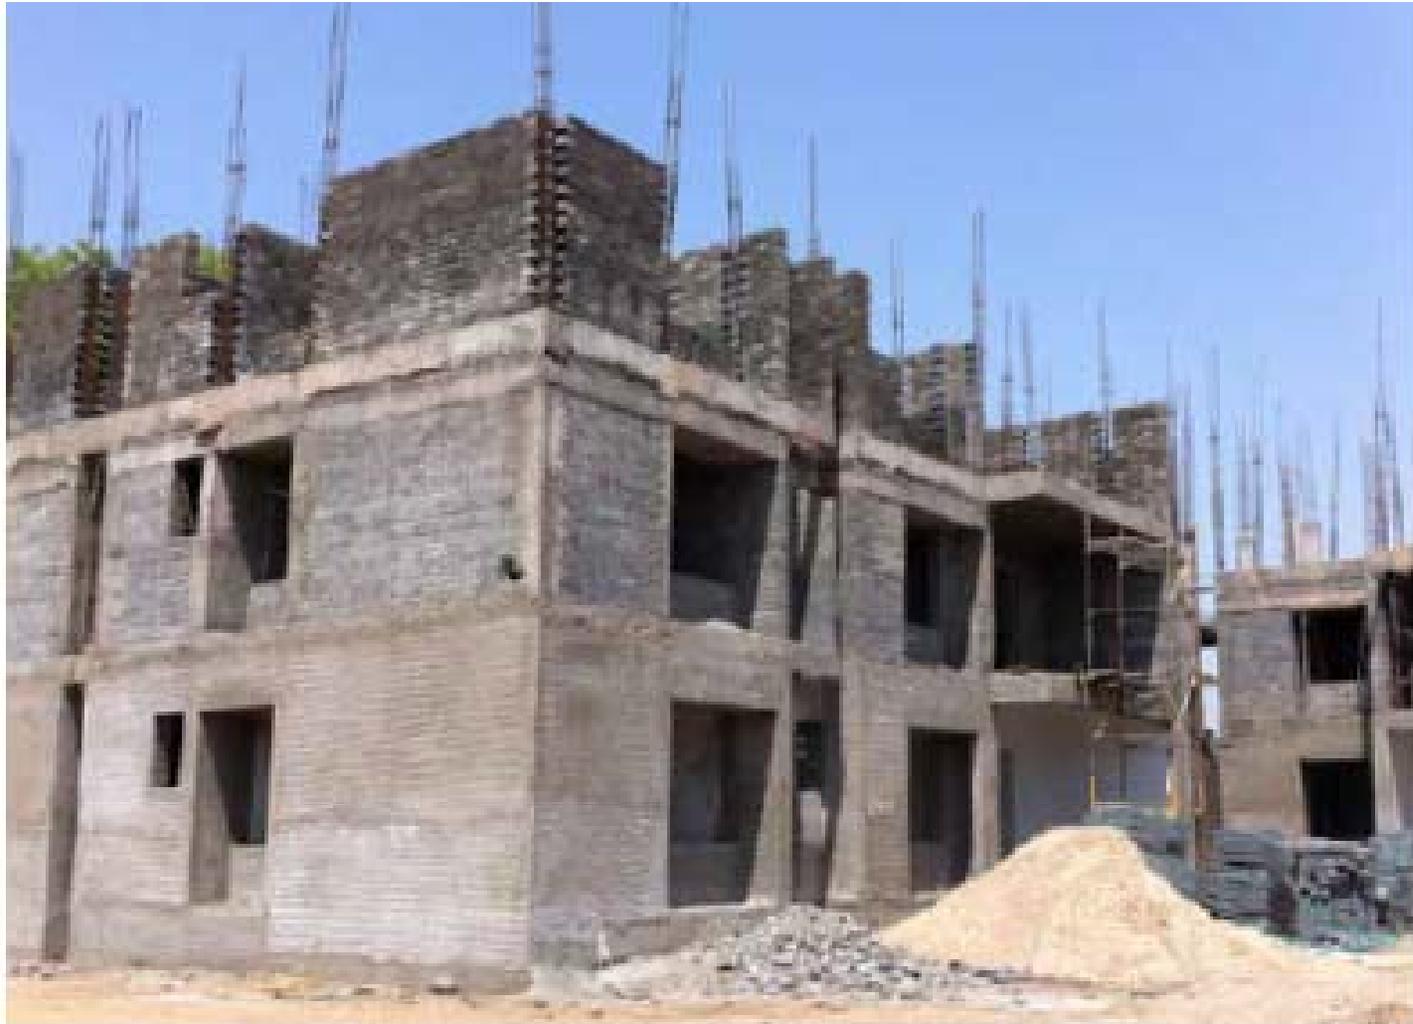
Housing under Construction

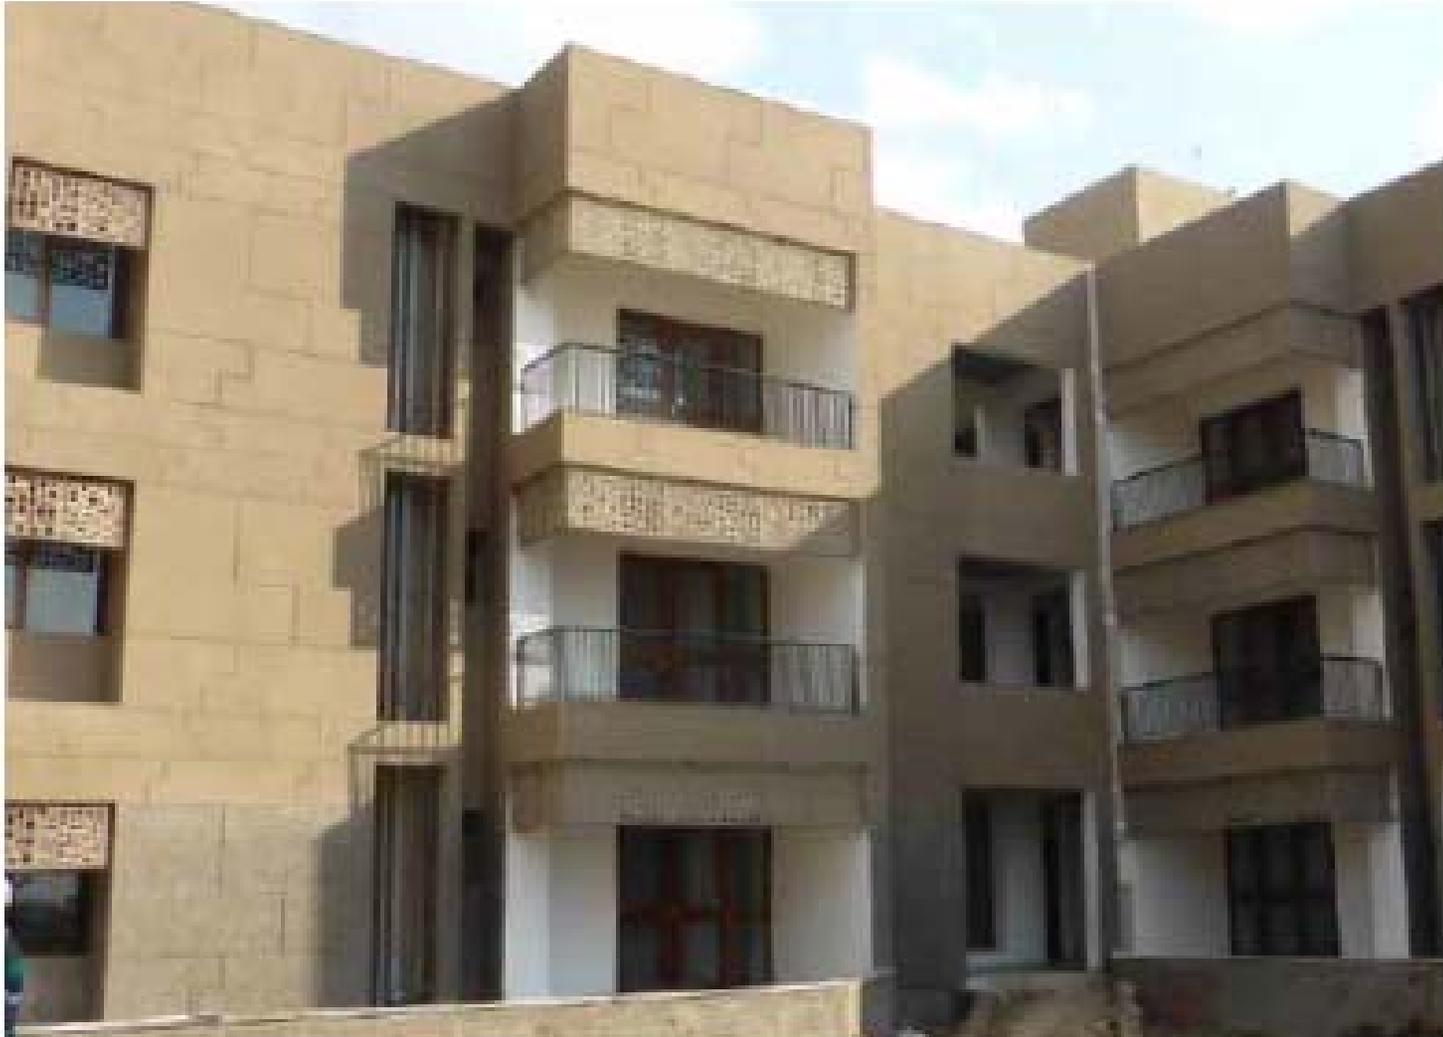
Constructed Housing

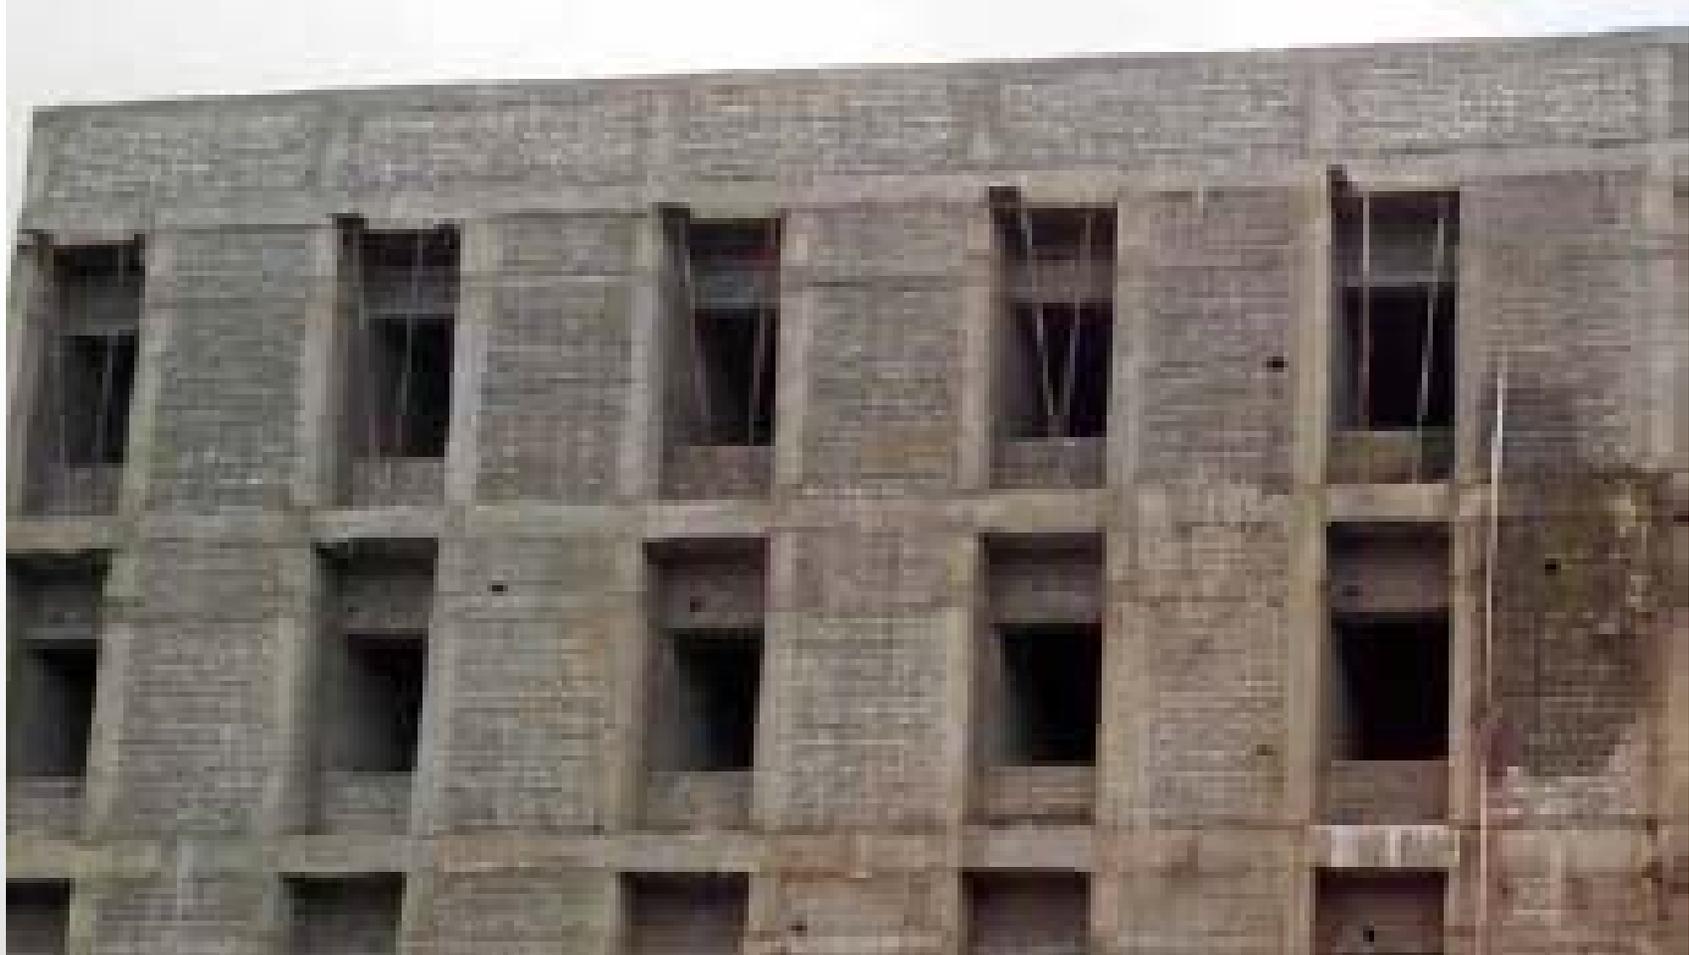
Student Hostel under Construction

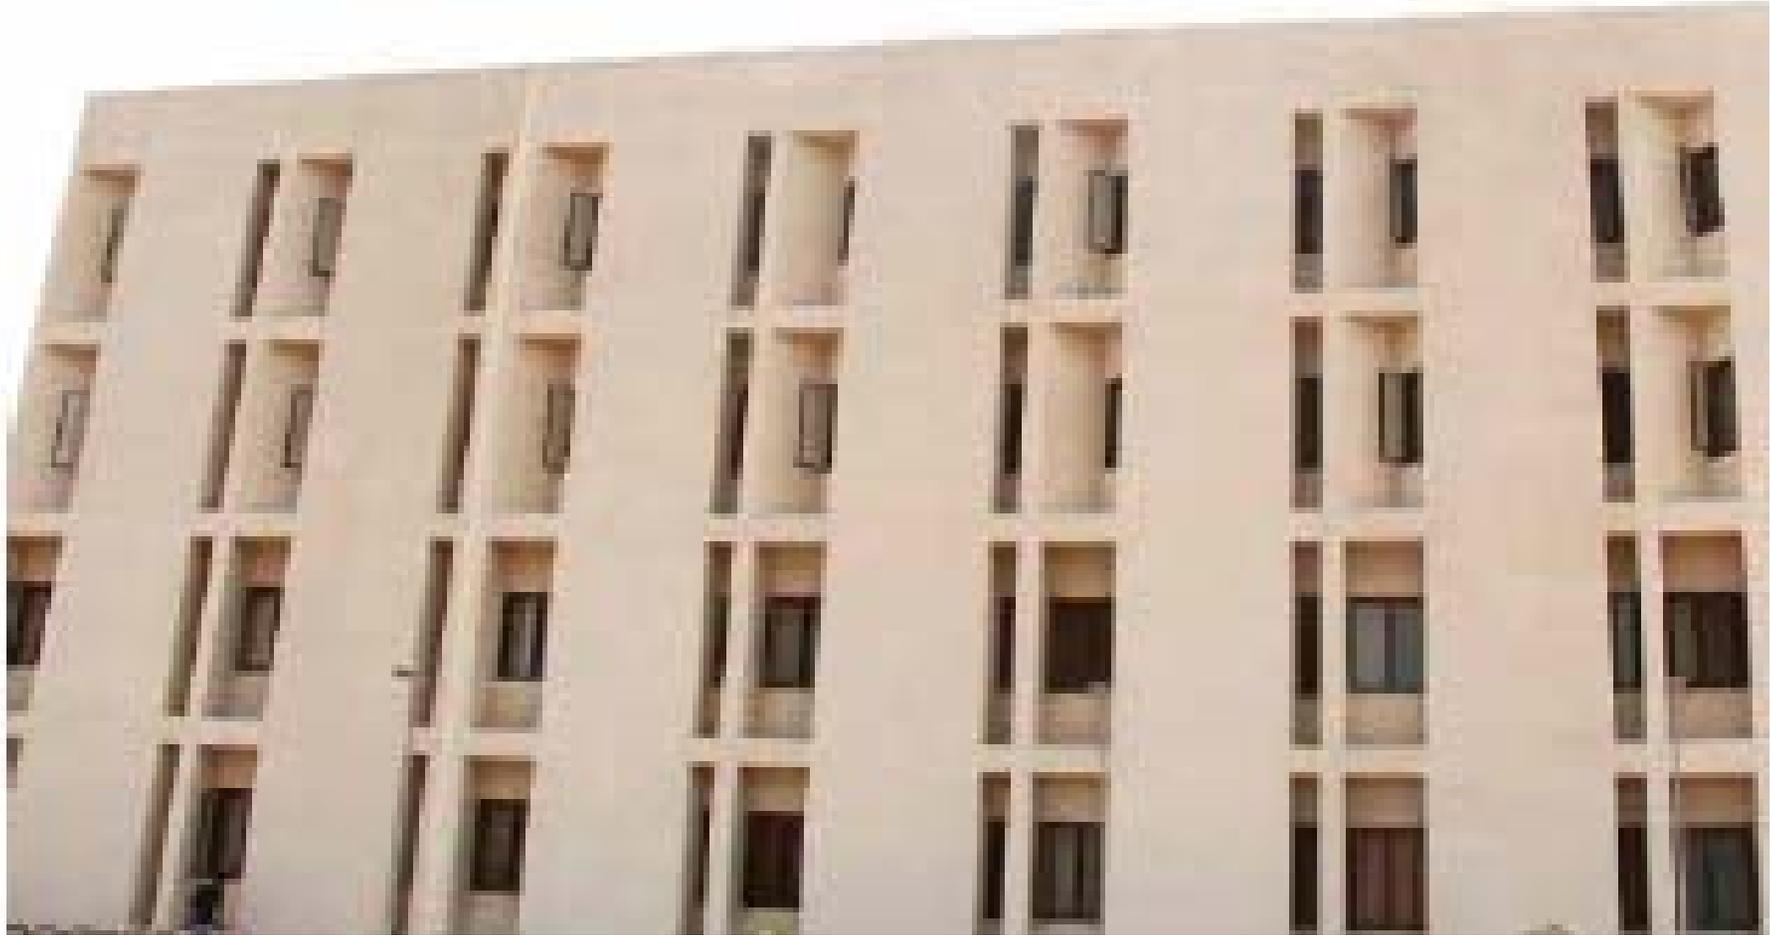
Constructed Hostel

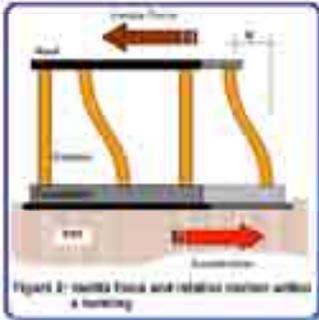
Earthquake causes shaking of the ground, by a building resting on it will experience motion at its base. From Newton's 2nd Law of Motion, even though the base of the building moves with the ground, the rest of the structure tries to do nothing, because the only force available to it is its weight, pointing downwards. The walls and columns are connected to it, they drag the rest along with them. This is what the structure does just as if you were to sit on a car moving in a straight line, you feel you are with the car, but you might feel being jerked if only the car starts or stops suddenly. This happens in a similar manner in the previous problem because as soon as the building starts the walls or columns are jerked, the amount of the jerk is different from that of the ground (Figure 1).

Figure 1: Effect of inertia in a building when ground is in motion

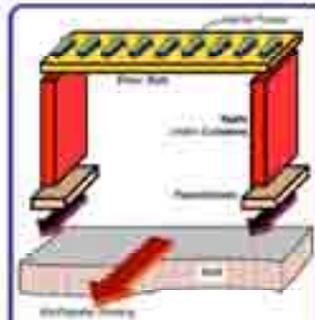
Under horizontal shaking of the ground horizontal inertia forces are generated at level of the mass of the structure usually situated at floor or beam levels. These inertia forces may be transmitted by the floor slab to the walls or columns in the foundations and finally to the soil through exterior walls (Figure 4). In case of base-isolated structures (base slabs, walls, columns, and foundations) and the connections between them need to be designed to safely transfer these inertia forces through them.

Figure 4: Flow of seismic inertia forces through structural components

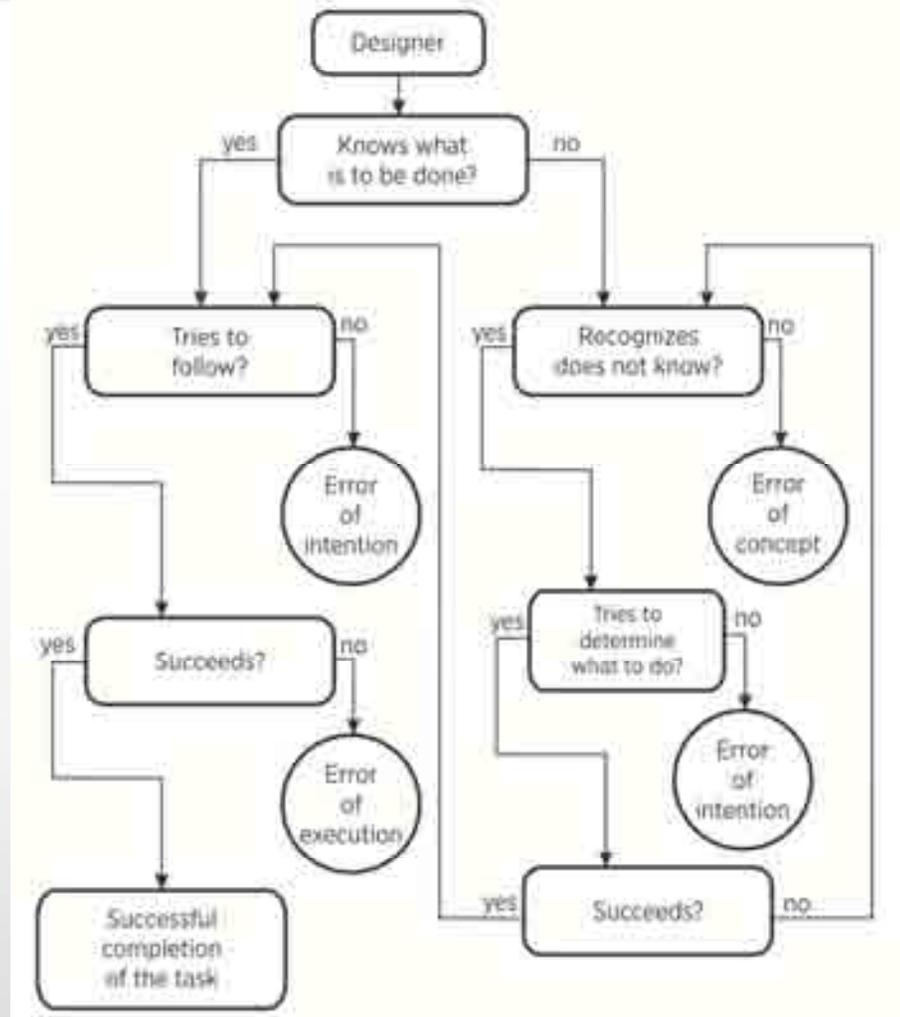
- Error of **intention**
- Error of **concept**
- Error of **execution**

Alternative paths with regard to acceptable practice (Novak and Arafah, 1994)
